Geotechnical Assessment (Cliff Stability)

Witton Bluff, South Australia

30 OCTOBER 2009

Prepared for
City of Onkaparinga

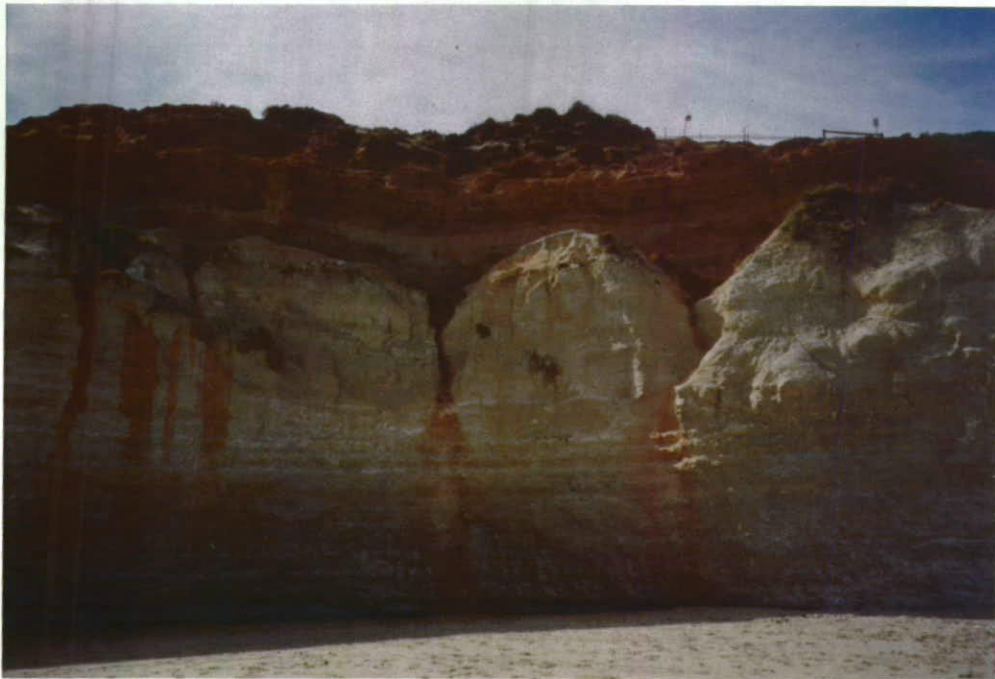
Type 3, that is the formation of caves as shown in Plate A and Plate 38, is a slope stability hazard indicator that in the long term could lead to Type 4 hazards. Where Type 3 erosion leads to caves large enough for access by members of the public to risks are very high. Noting that if a public member is present in the cave during the initiation of a rock mass failure the public member may not have time to retreat safely from the cave. This is considered to be an unacceptable level of risk for the Council.

Plate A: View looking east at the slope, within the large embayment west of Castleton Avenue in March 2006. Refer to Plate D, Plate 37 and Plate 39 for a photograph of the same cliff face taken in September 2009.

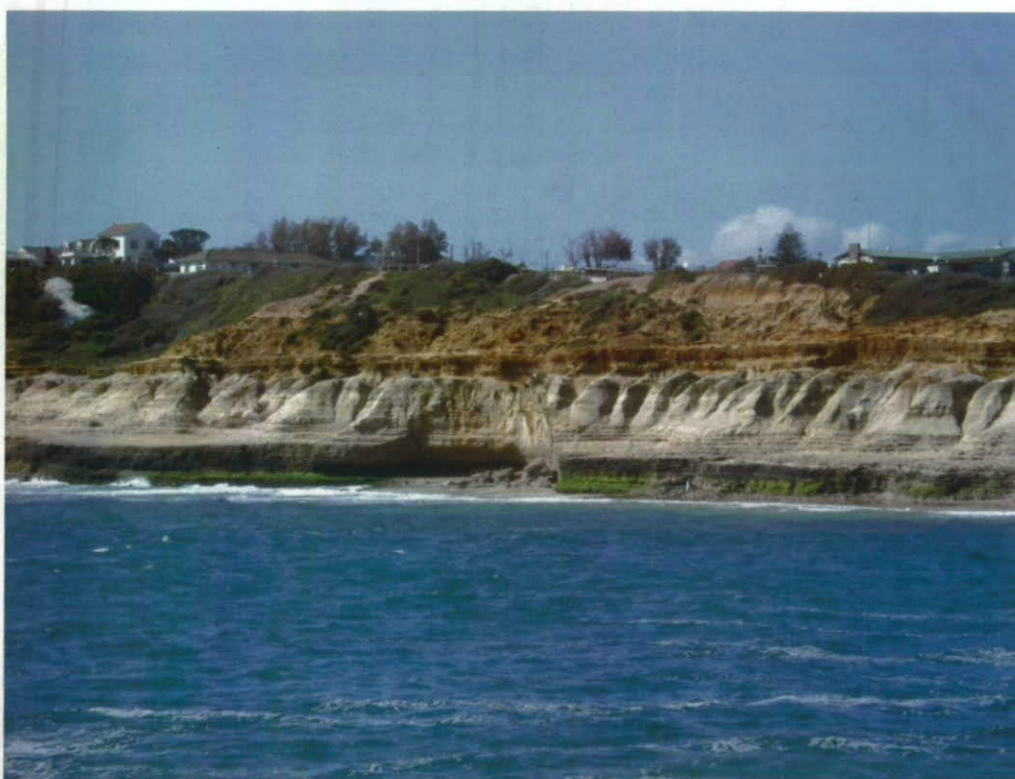
Zone J and Zone H are similar in geotechnical features, however Zone J is currently progressively eroding to the geometry of Zone I due to coastal wave action and subvertical and horizontal defects in the rock mass (Plate A, Plate D, Plate 36 and Plate 39). Note the distance between the cliff toe and road at the crest of the slope in Zone J is a similar distance to the road as within Zone H.

Plate D: General view Zone I, J and K. Cave central to photograph.

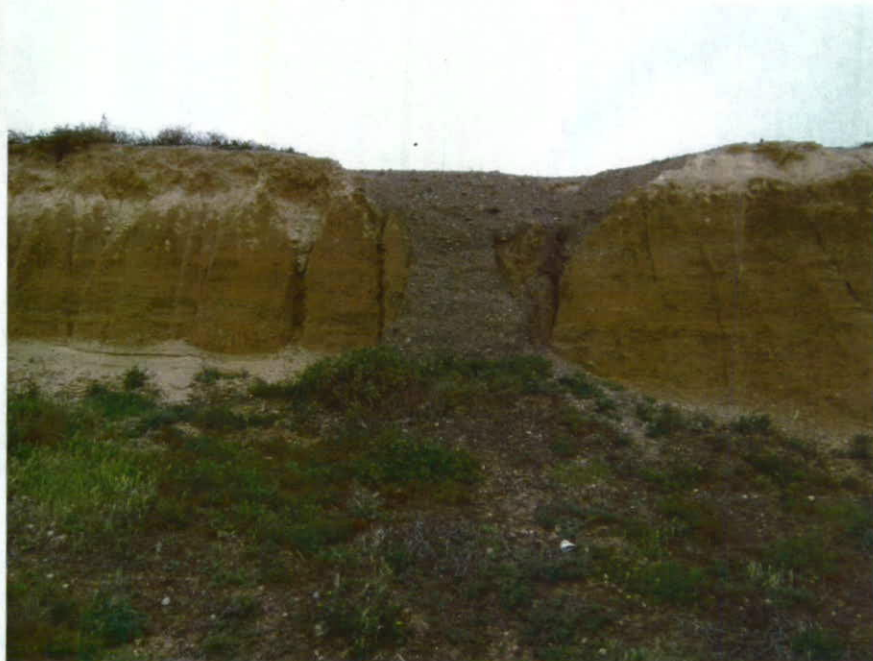
Plate 5: Localised crest erosion remediated in the past with a thin covering of concrete. Concrete partially intact due to erosion. Ongoing minor crest erosion.

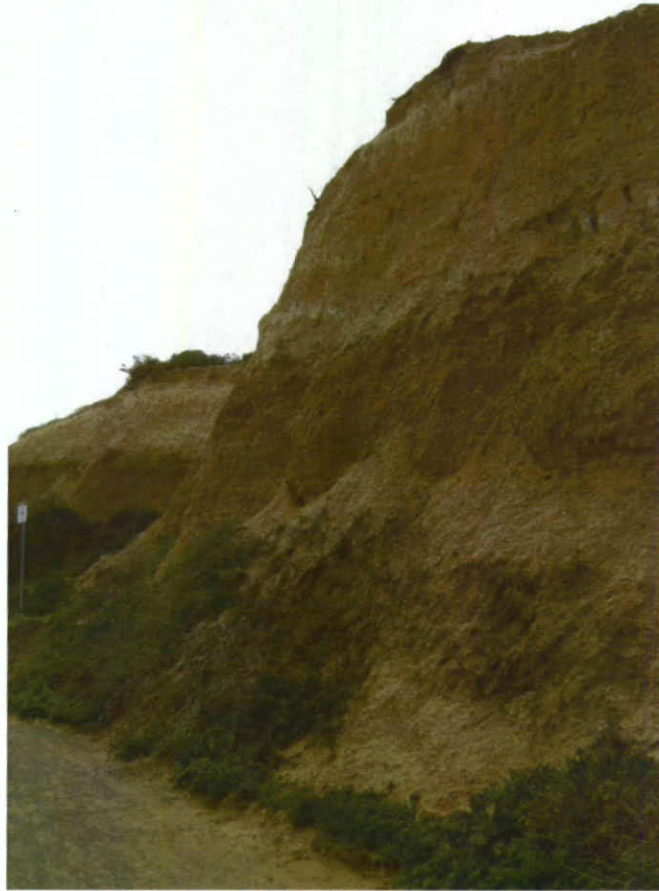
Plate 6: Photo looking east, at the progressive disintegration of the cliff face, creating loose material which covers the vegetation at the base of the slope and the walkway.

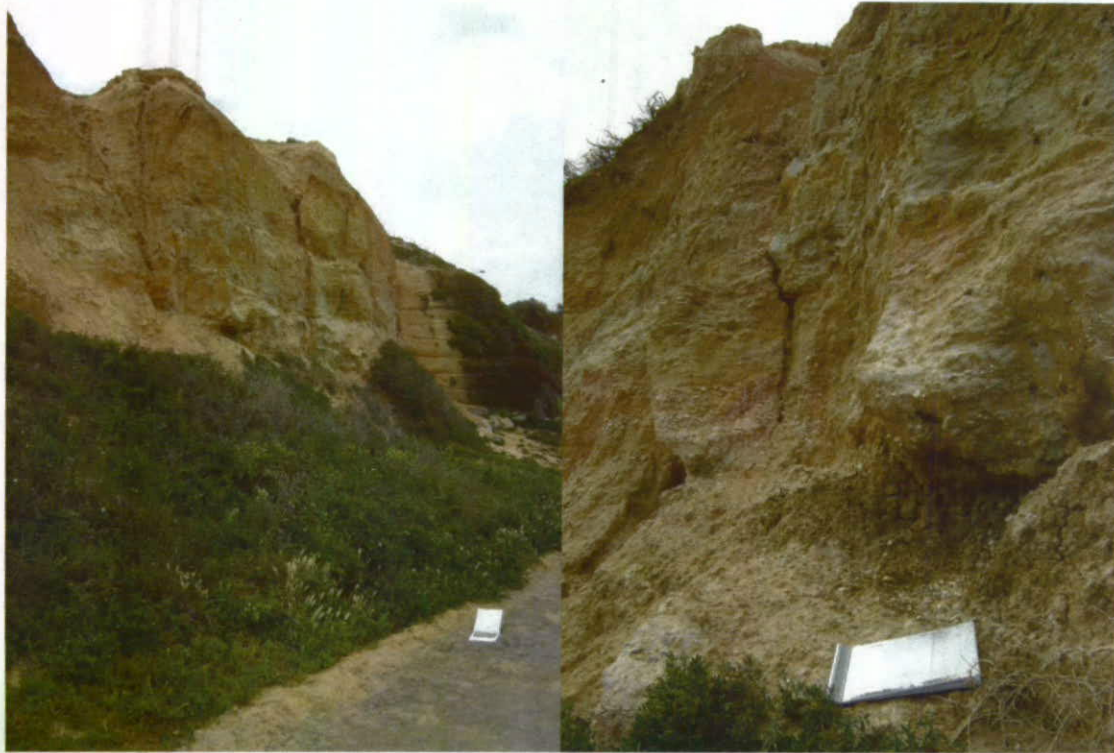
Plate 7: General view of slope on the left and an enlarged photo of the weathering soils on the right. Water erodes gullies in sandy gravelly soils and the undermining of slopes by the dessication of discrete clay layers create potentially unstable subvertical cliffs.

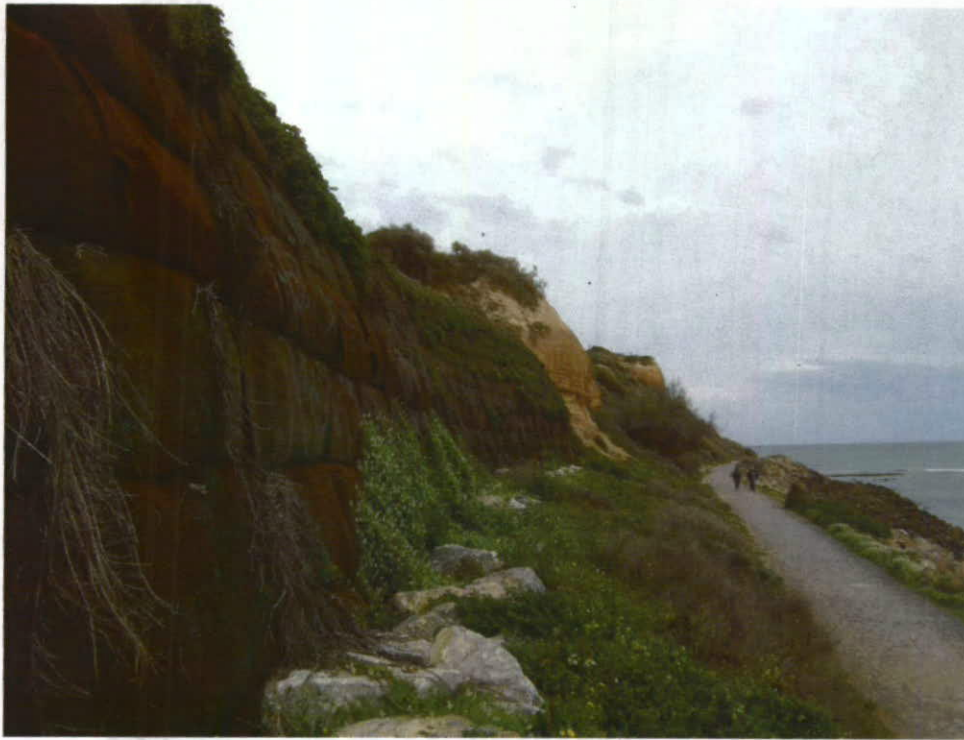
Plate 8: View looking south, at the base of the reinforced earth retaining wall. Wall has limited vegetation and some areas where the jute is torn.

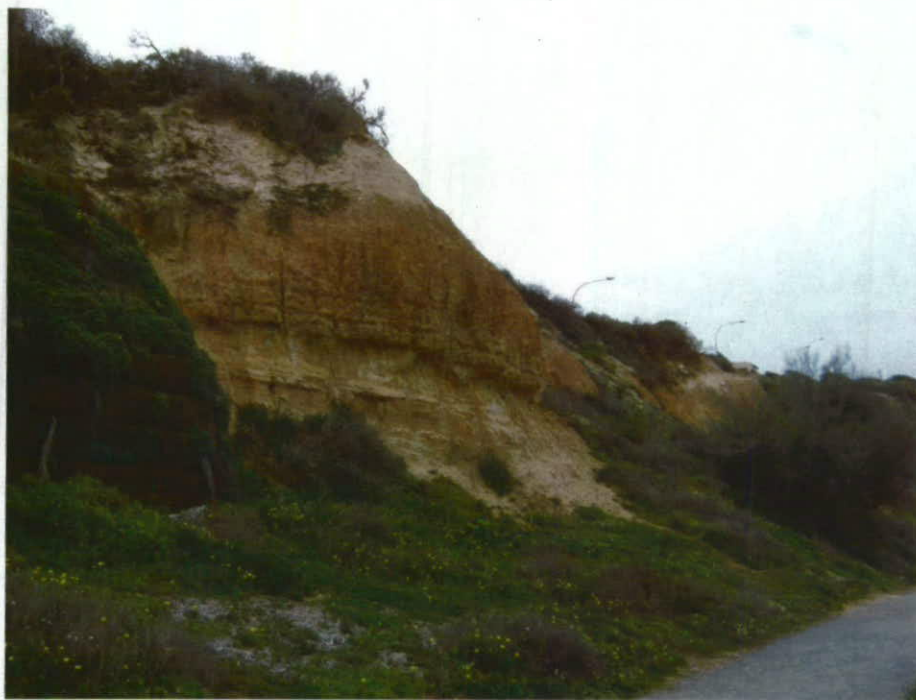
Plate 9: Southern end of retaining wall, cliff erosion is uneven, leading to shallow slopes at crest and undercut sections in the lower portion of the cliff face. No danger signs displayed.

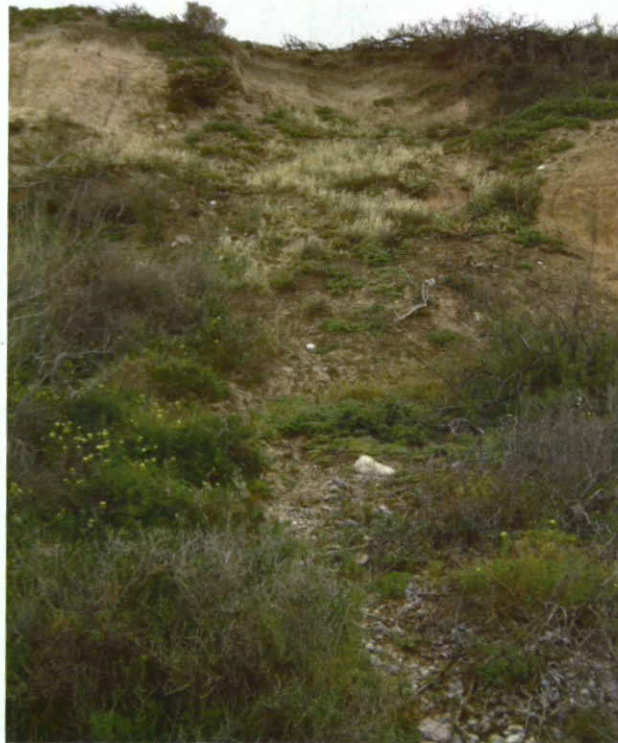
The presence of a number of older and more recent backscars is evident from slumping failures in the upper and mid slope soils of the cliffs (Plate 10, 17, 26, 27 and 28). Typically the backscars were formed in topsoil, calcrete and sand or clay in which overhanging material is created in the failure, which is at risk of further failure by toppling/fall mechanism. The trigger for these failures could have been stormwater run off or more likely erosion due to seaspray, wind and water action in the underlying soils. To undertake remedial works to each of these failures (thirteen recorded over the

Plate 10: Photo of an old slope crest failure. Failure was due a hard calcrete layer at the top of the slope, being undermined by soil erosion (2 m length by 1 m depth).

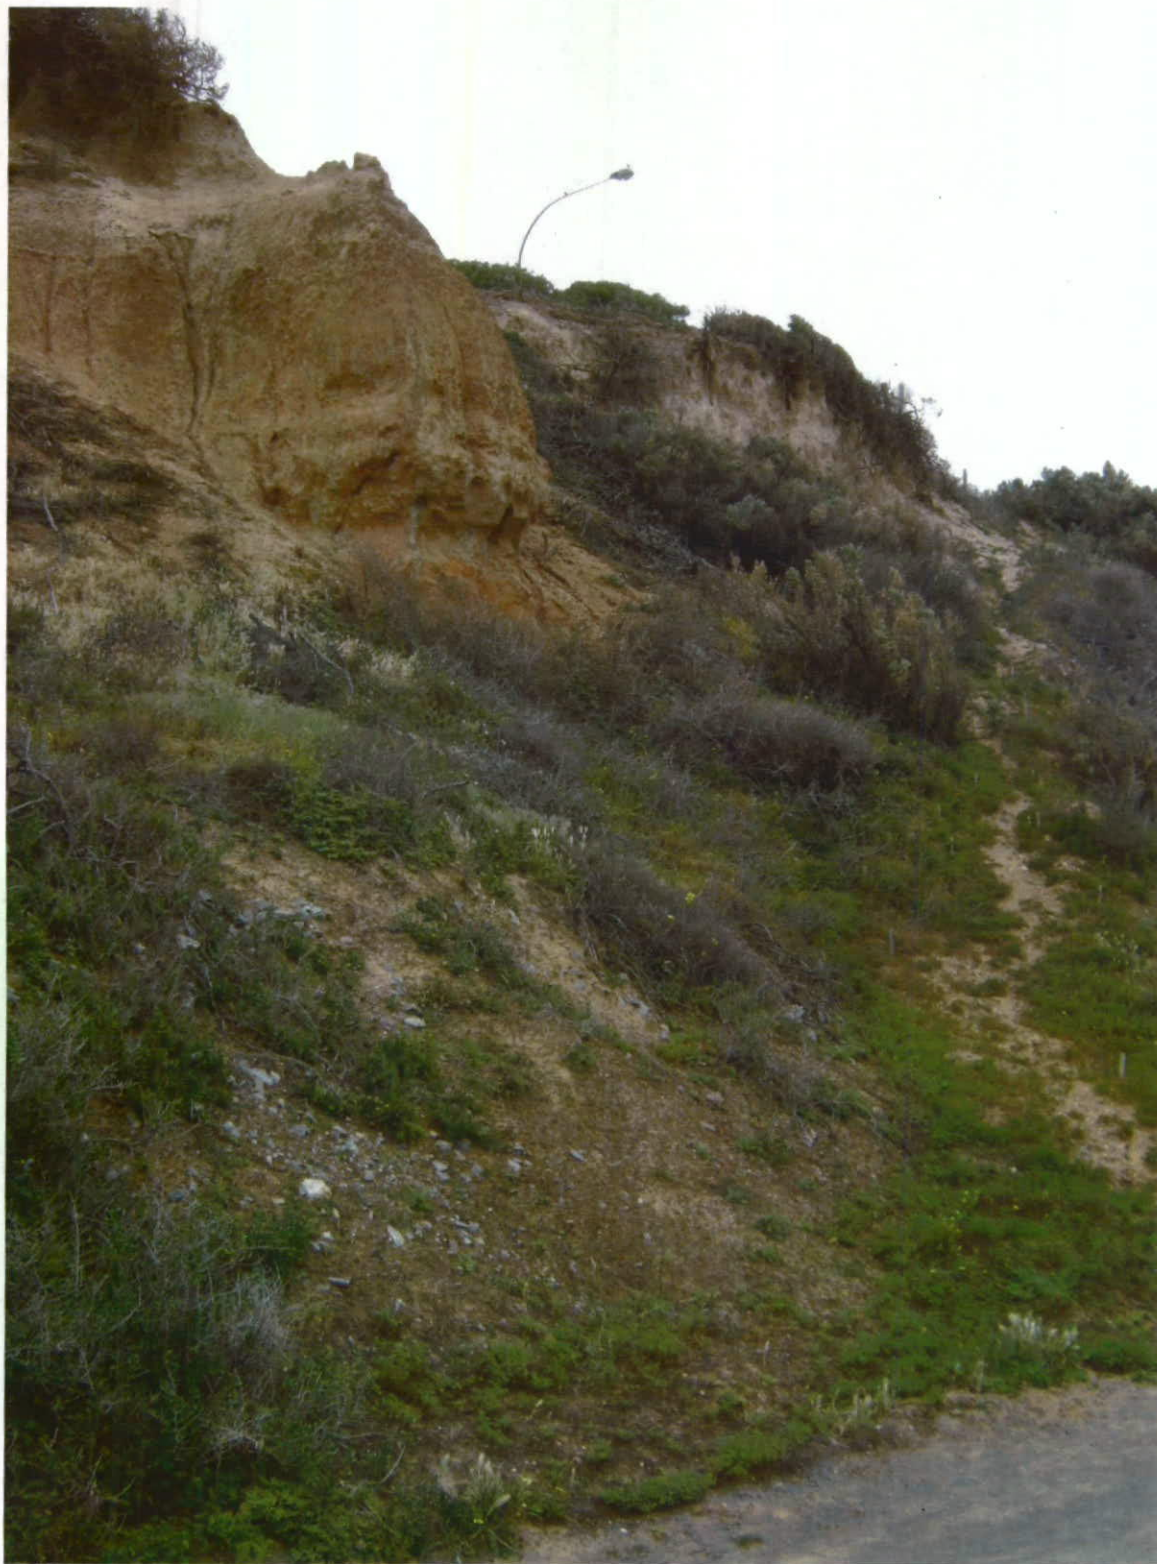
Plate 11: Photo looking south east at an unofficial beach access track with two hazards to the left of the track. Hazard one is subvertical sandy soils at the crest of the slope and Hazard two is the mass of red white sandy clay which is being undercut at the base of cliff by bird and water erosion activity.

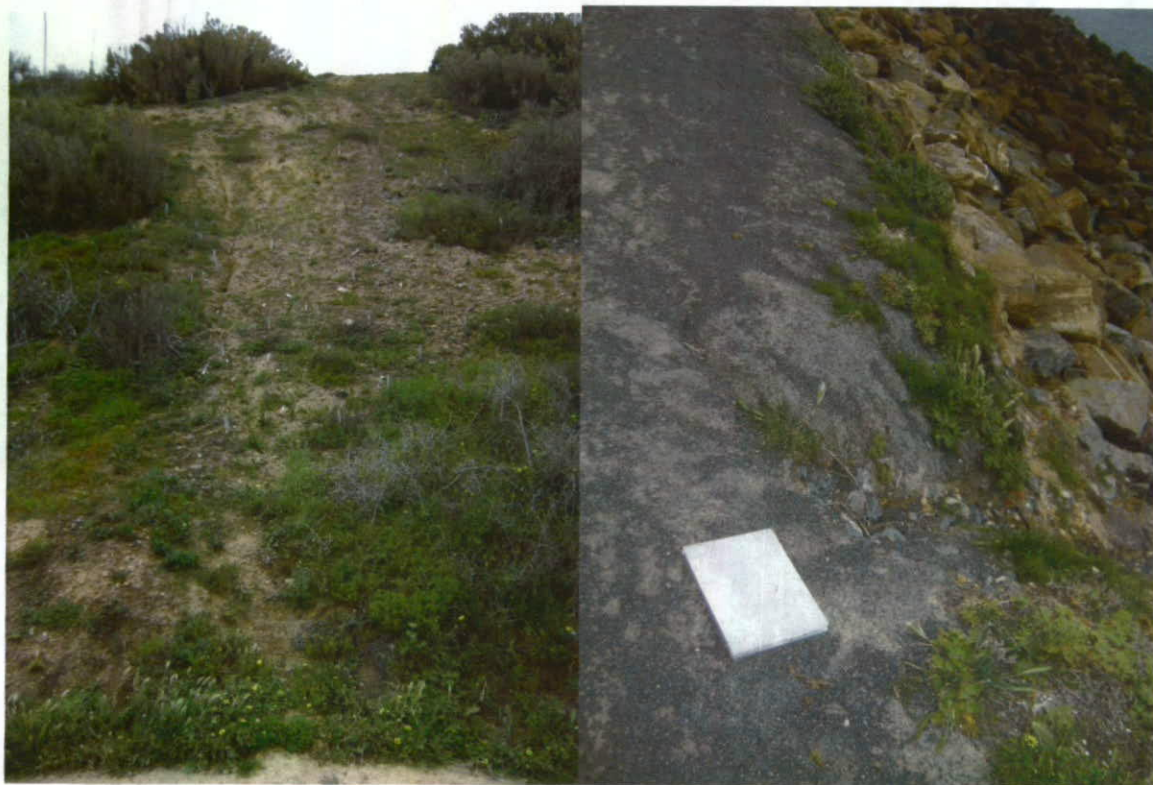
Plate 13: Water erosion has led to rill erosion of sandy soils (left photo) and of the edge of walkways (right photo).

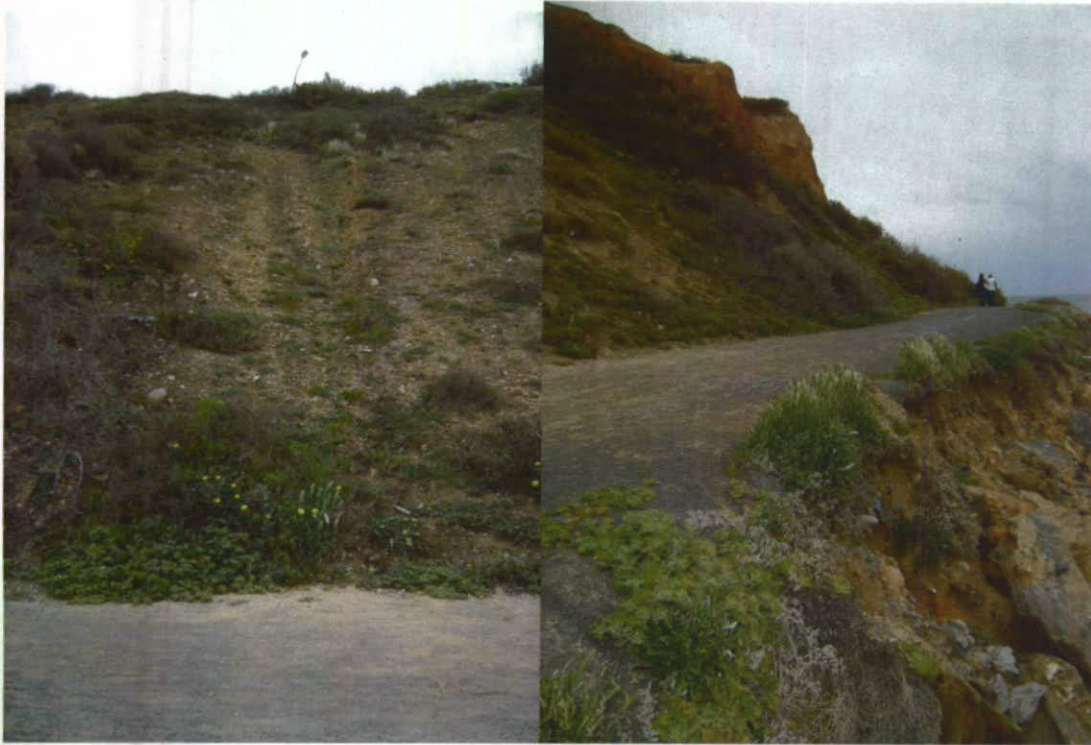
Plate 14: Water erosion has led to rill erosion of sandy slopes (left photo) and of the edge of walkways (right photo).

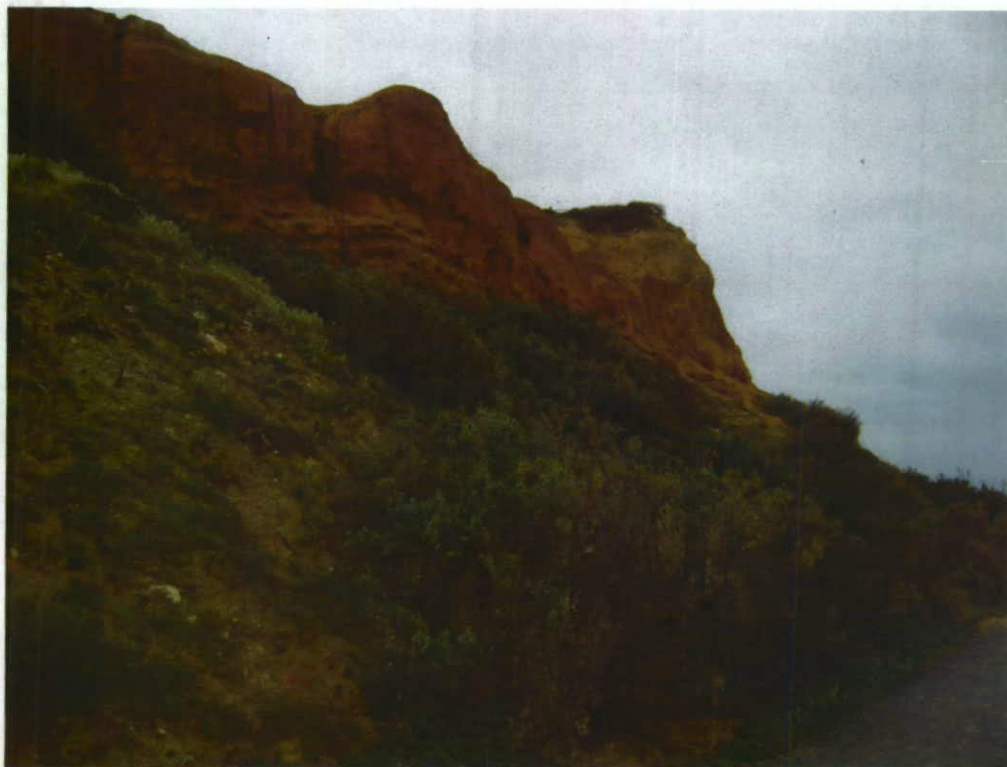
Plate 15: View from north at Witton Bluff and gully eroded subvertical cliffs. No danger signs displayed.

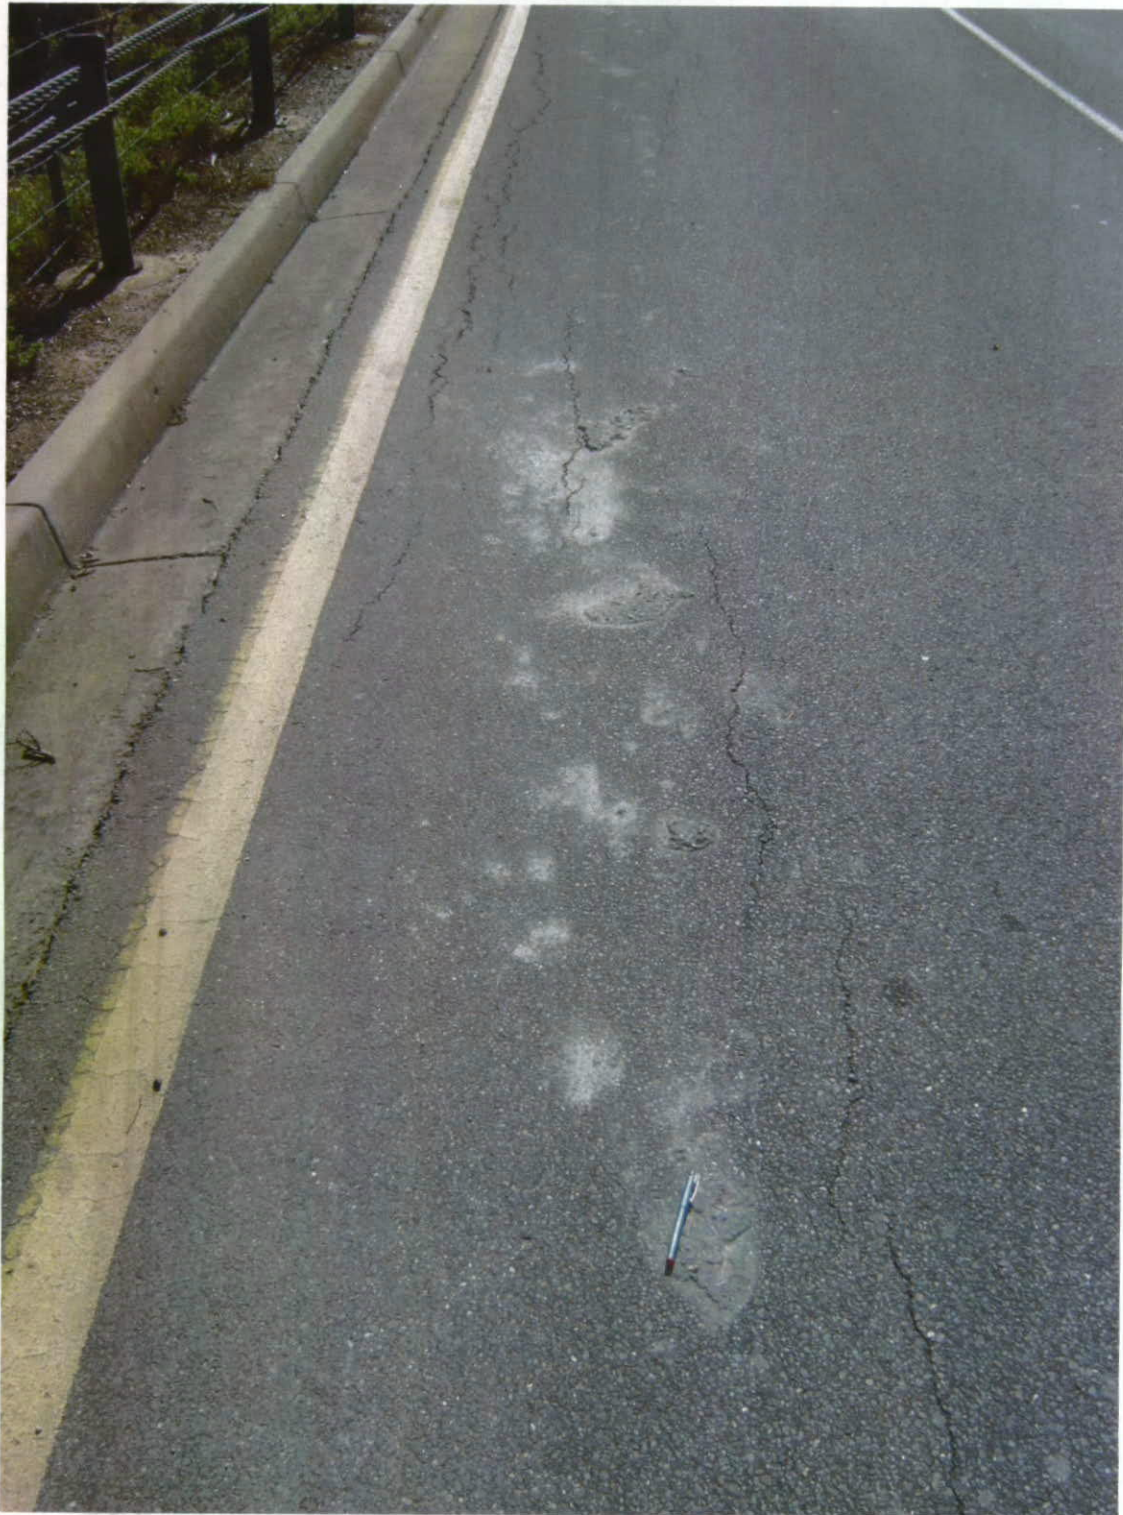
Plate 16: Hairline longitudinal tension cracks on the road

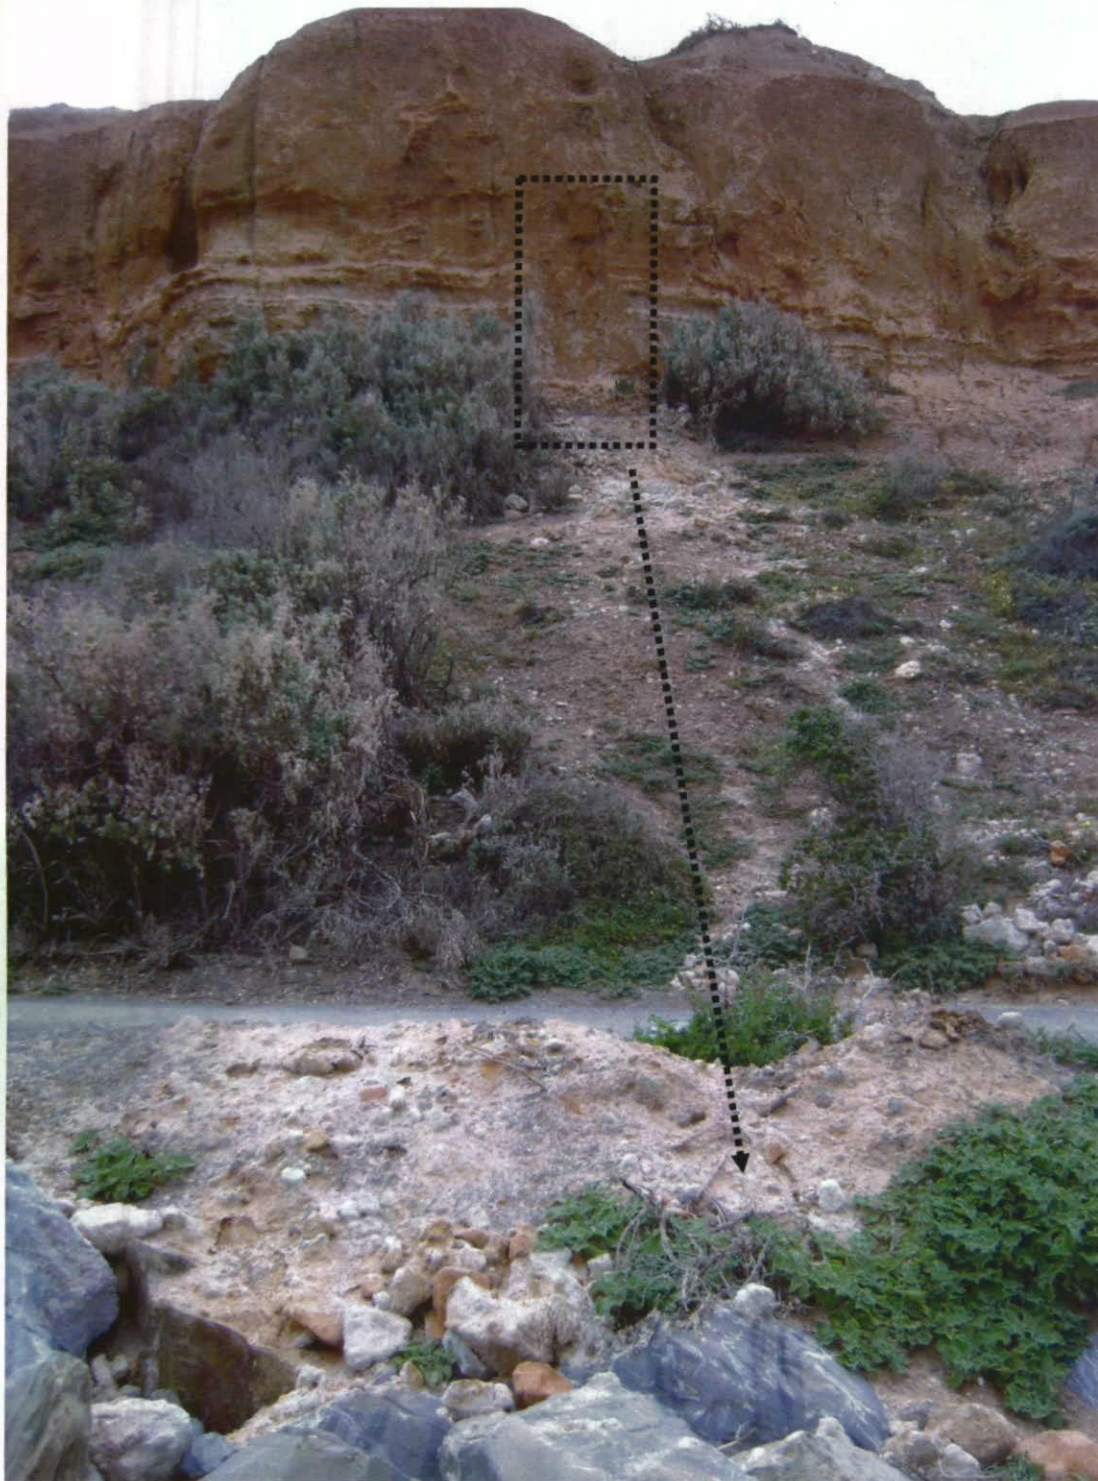
Plate 17: Recent toppling failure of sandy soils from the upper cliff face resulted in shrubs being destroyed and material transported down the slope over the walkway. Failure due to undercutting of cliff and subvertical tension cracks in vertical sandy slopes.

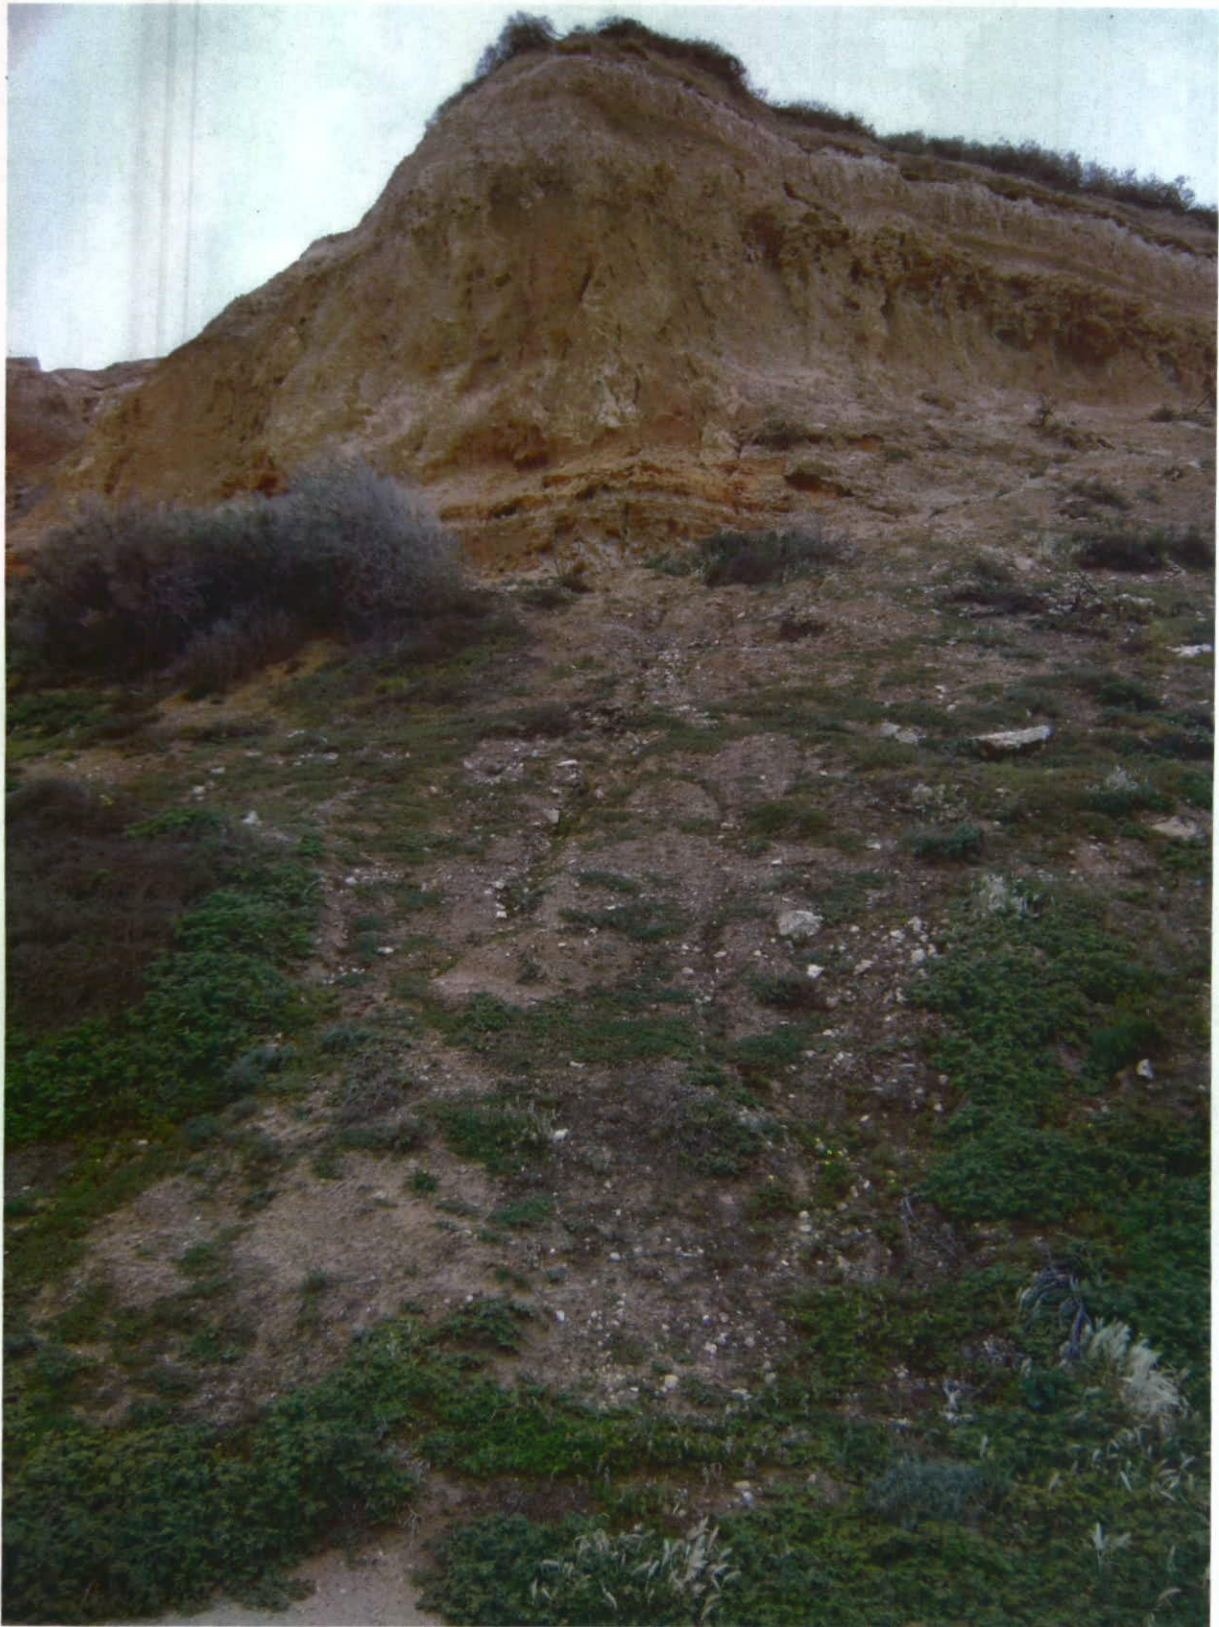
Plate 18: View looking east at Witton Bluff, minor rill erosion in the lower slopes and tension cracks in sandy soils and bird and water erosion leading to undercutting and of upper subvertical slopes.

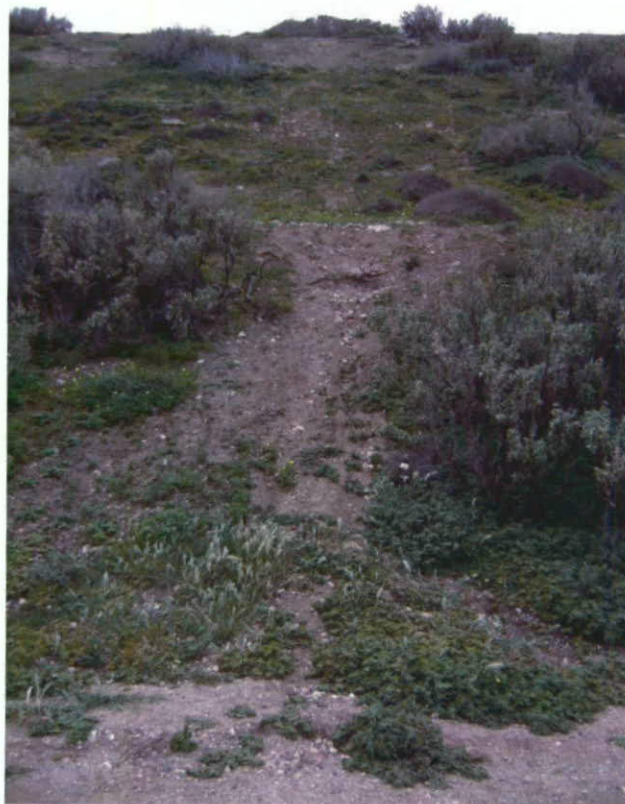
Plate 20: Photograph of typical minor signs of rill erosion within the cliff zone.

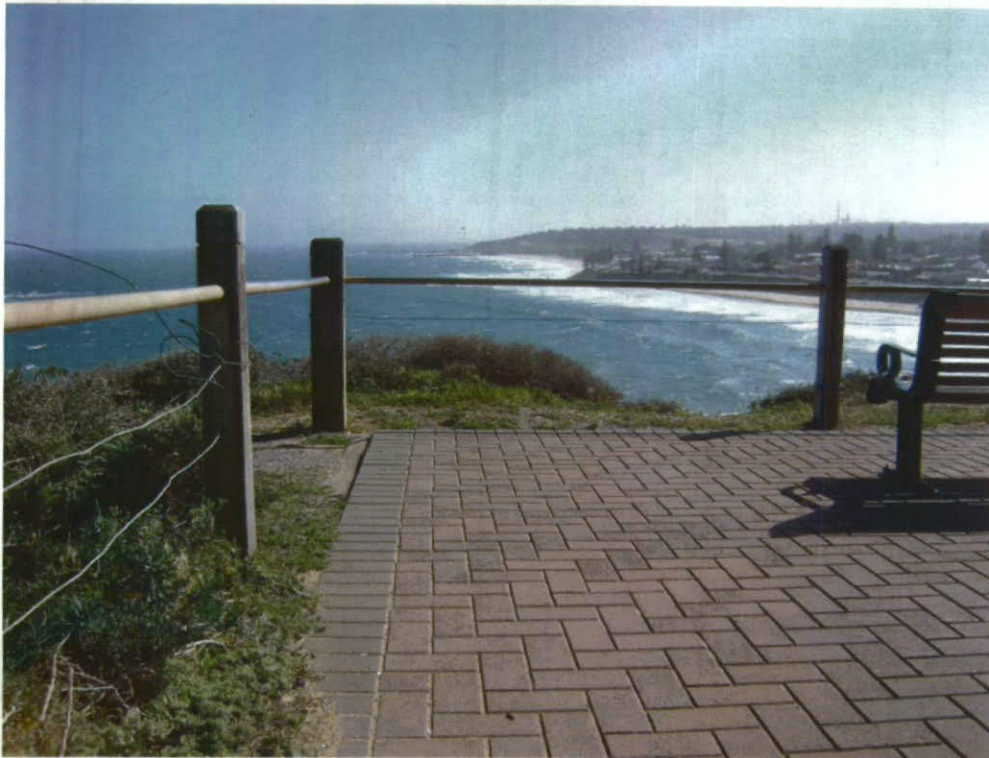
Plate 21: View looking north at broken wires in the lower section of the fence at Witton Bluff Look Out.

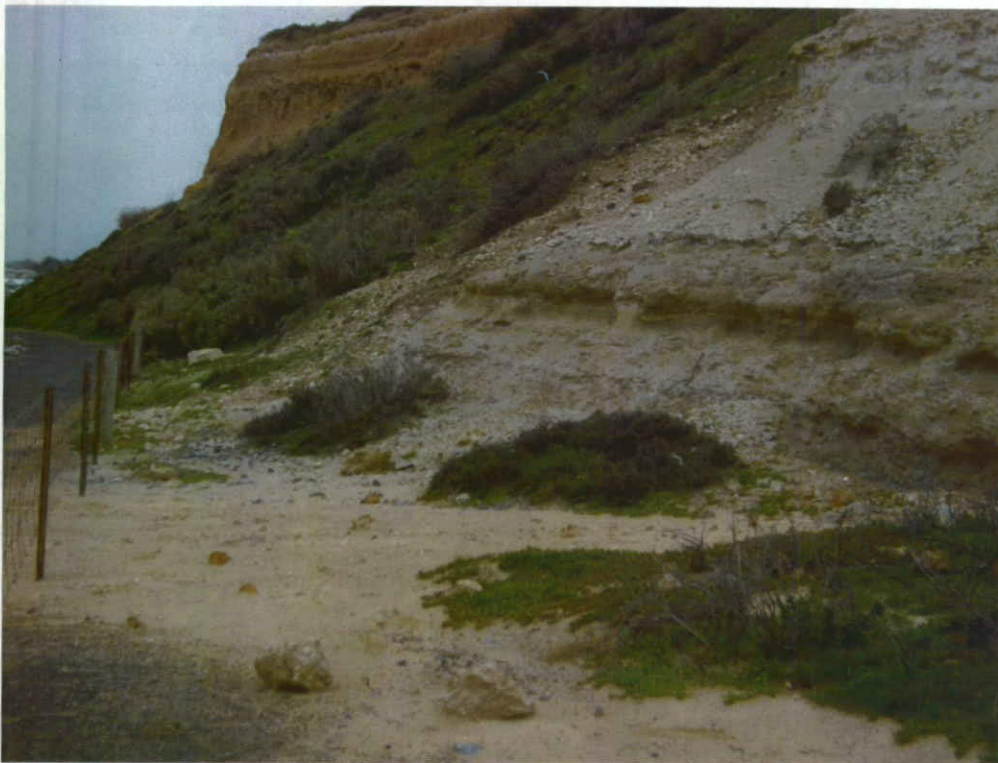
Plate 22: View looking north at the base of the slope. Note the fence and the small 120 x 200 x 300 mm low strength rocks on the walkway.

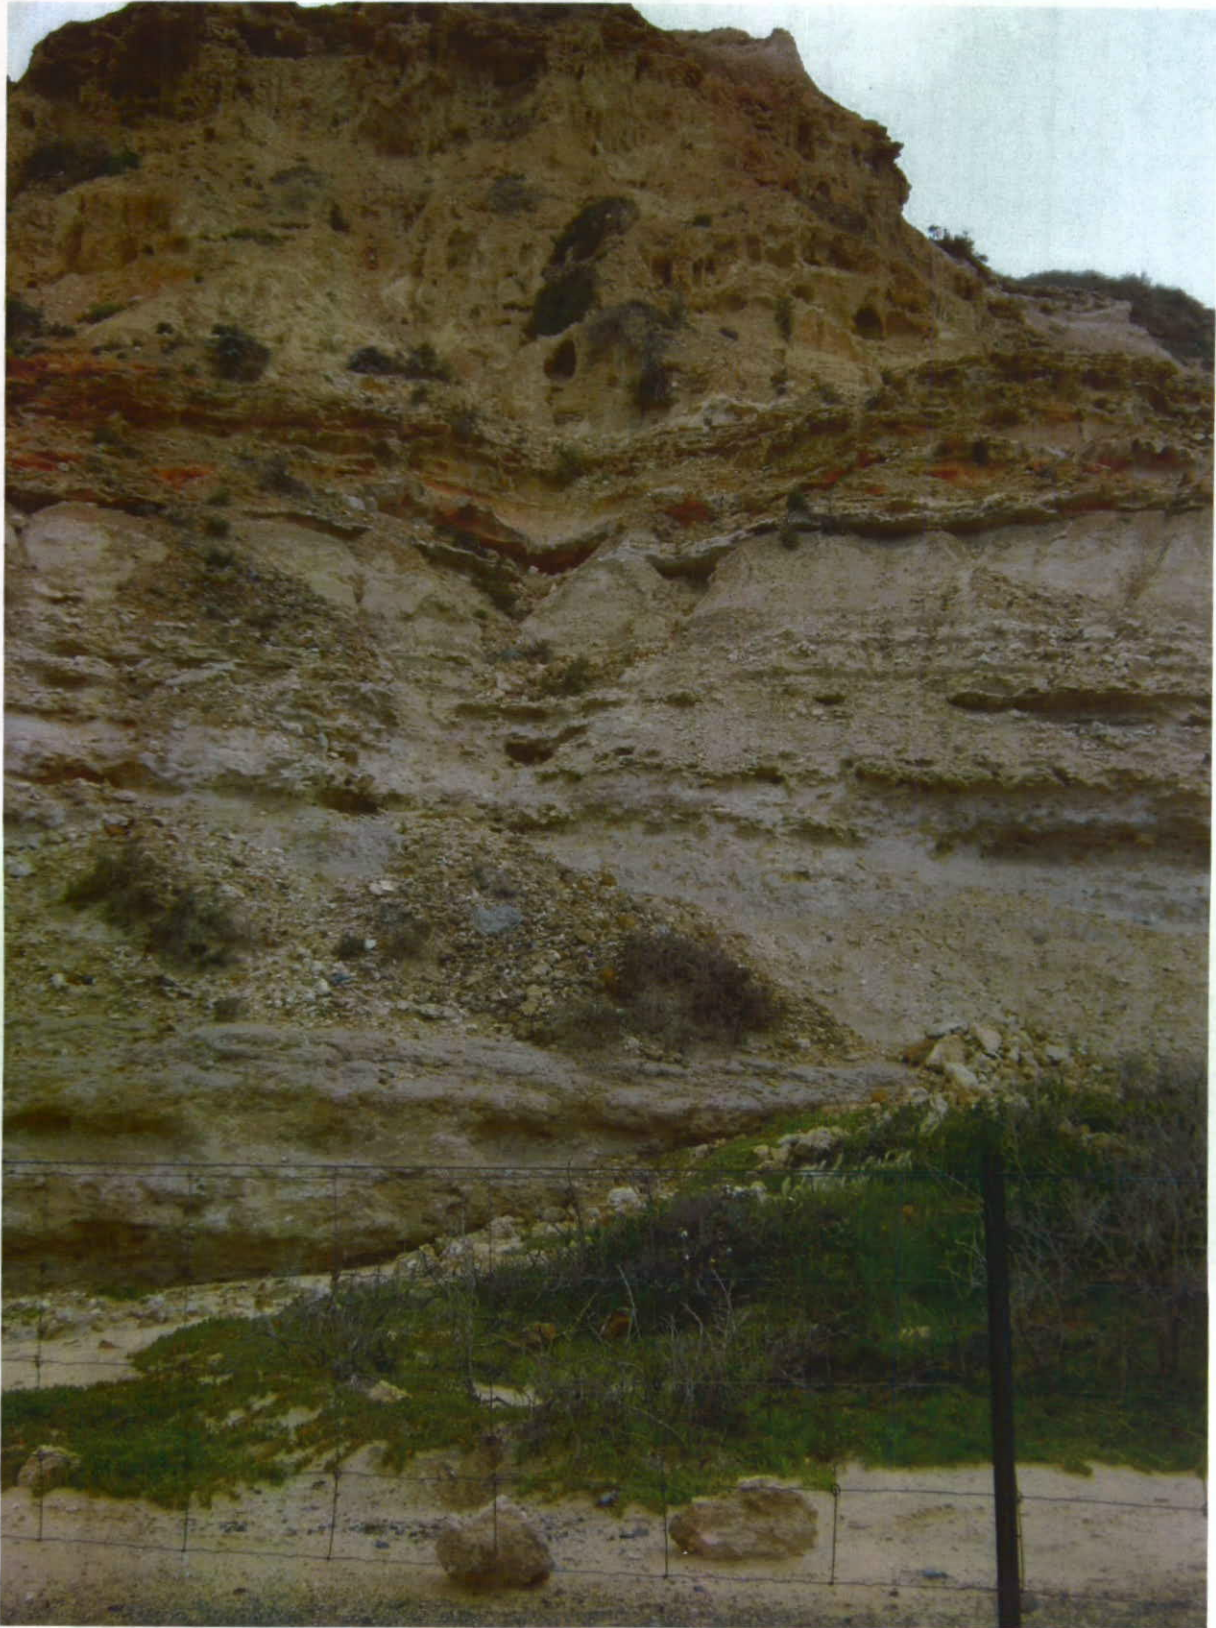
Plate 23: View looking east (towards Benny Avenue) at a typical slope covered with small rocks. Note the dominance of voids and undercut sections in all sections of the slope.

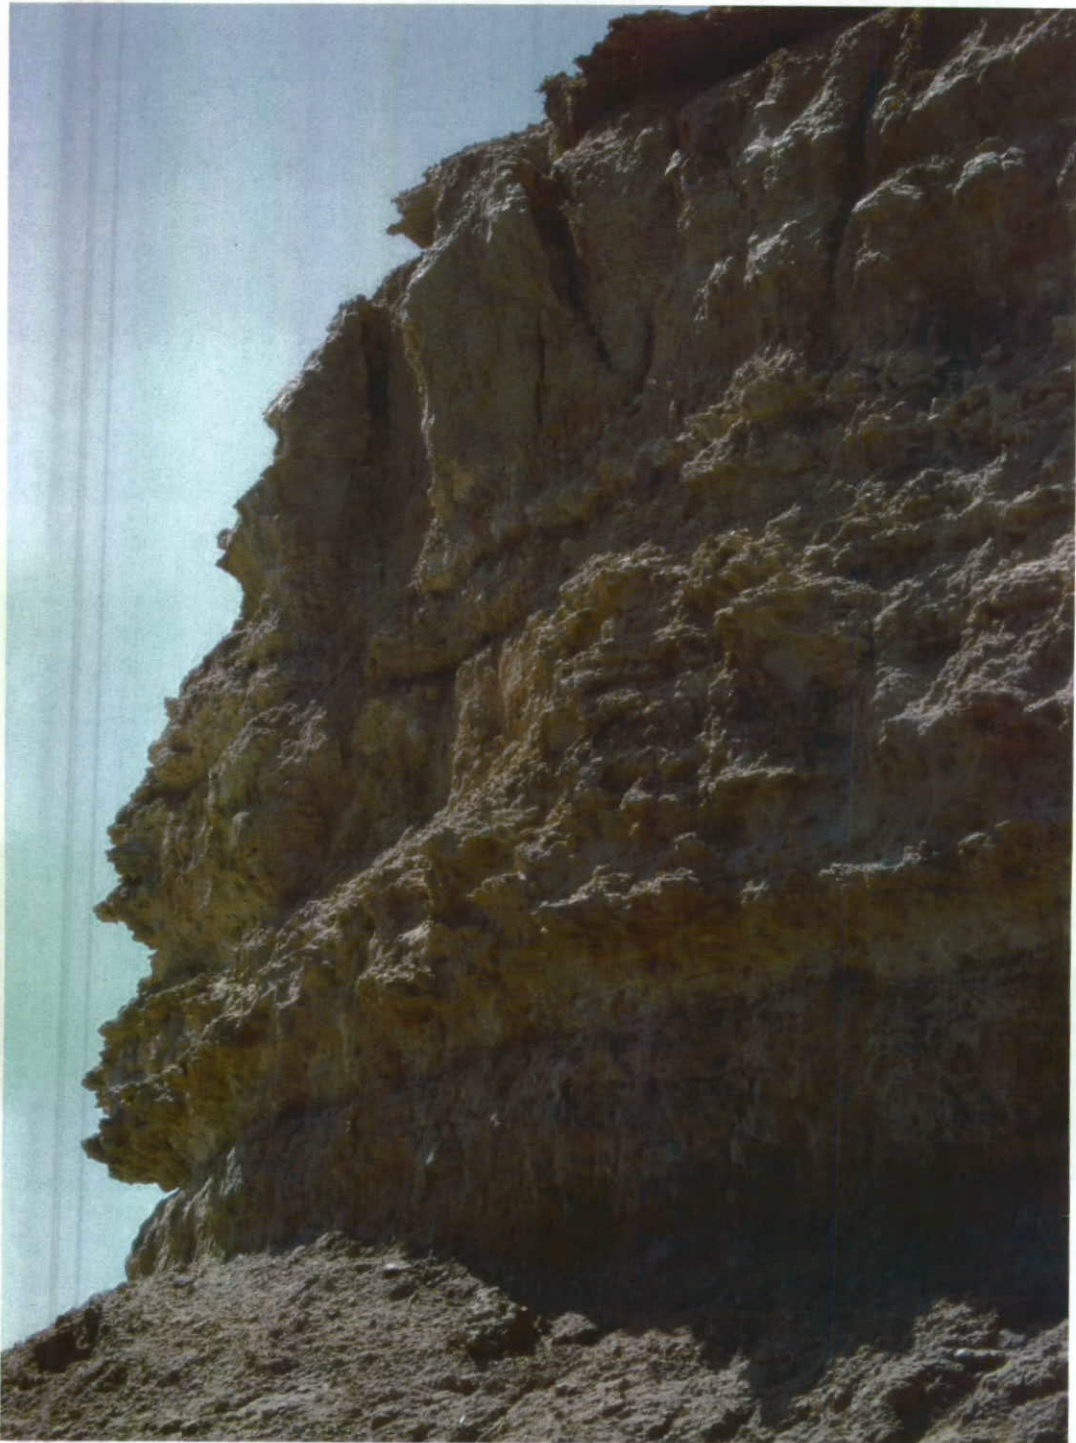
Plate 24: View looking north at the subvertical lower / middle cliff slopes at the headland east of Benny Avenue. Typical erosion of clay units resulting in vertical tension cracks and toppling failure (top of slope) and lower sand and gravel horizons eroded leading to undercutting of the cliff slope and eventual slope failure.

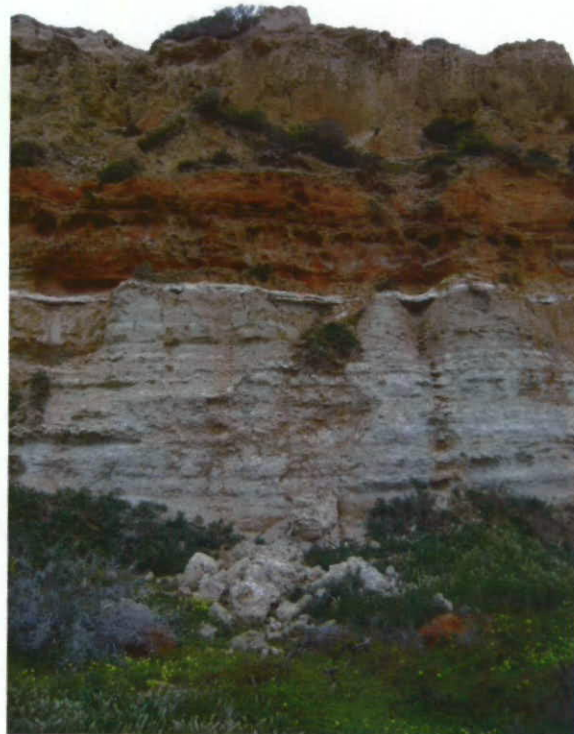
Plate 26: View looking east at a lower slope recent backscar and the material piled at the base of the slope. In the forefront of the photo, red boulders are old failures from the mid to upper slope.

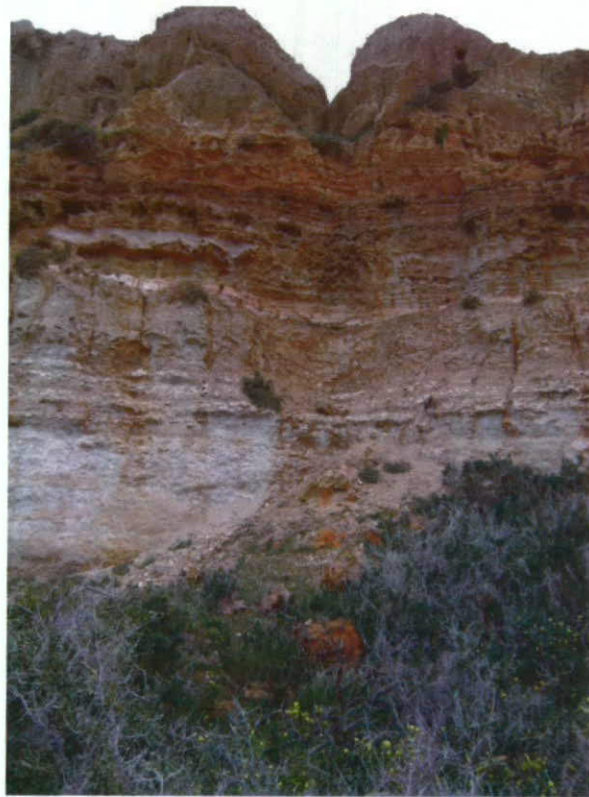
Plate 27: View looking east at an old back scar in the middle of the slope aligned beneath a large erosion gully (upper slope). Boulders from mid to upper slopes at base of cliff.
