Geotechnical Assessment (Cliff Stability)

Witton Bluff, South Australia

30 OCTOBER 2009

Prepared for
City of Onkaparinga

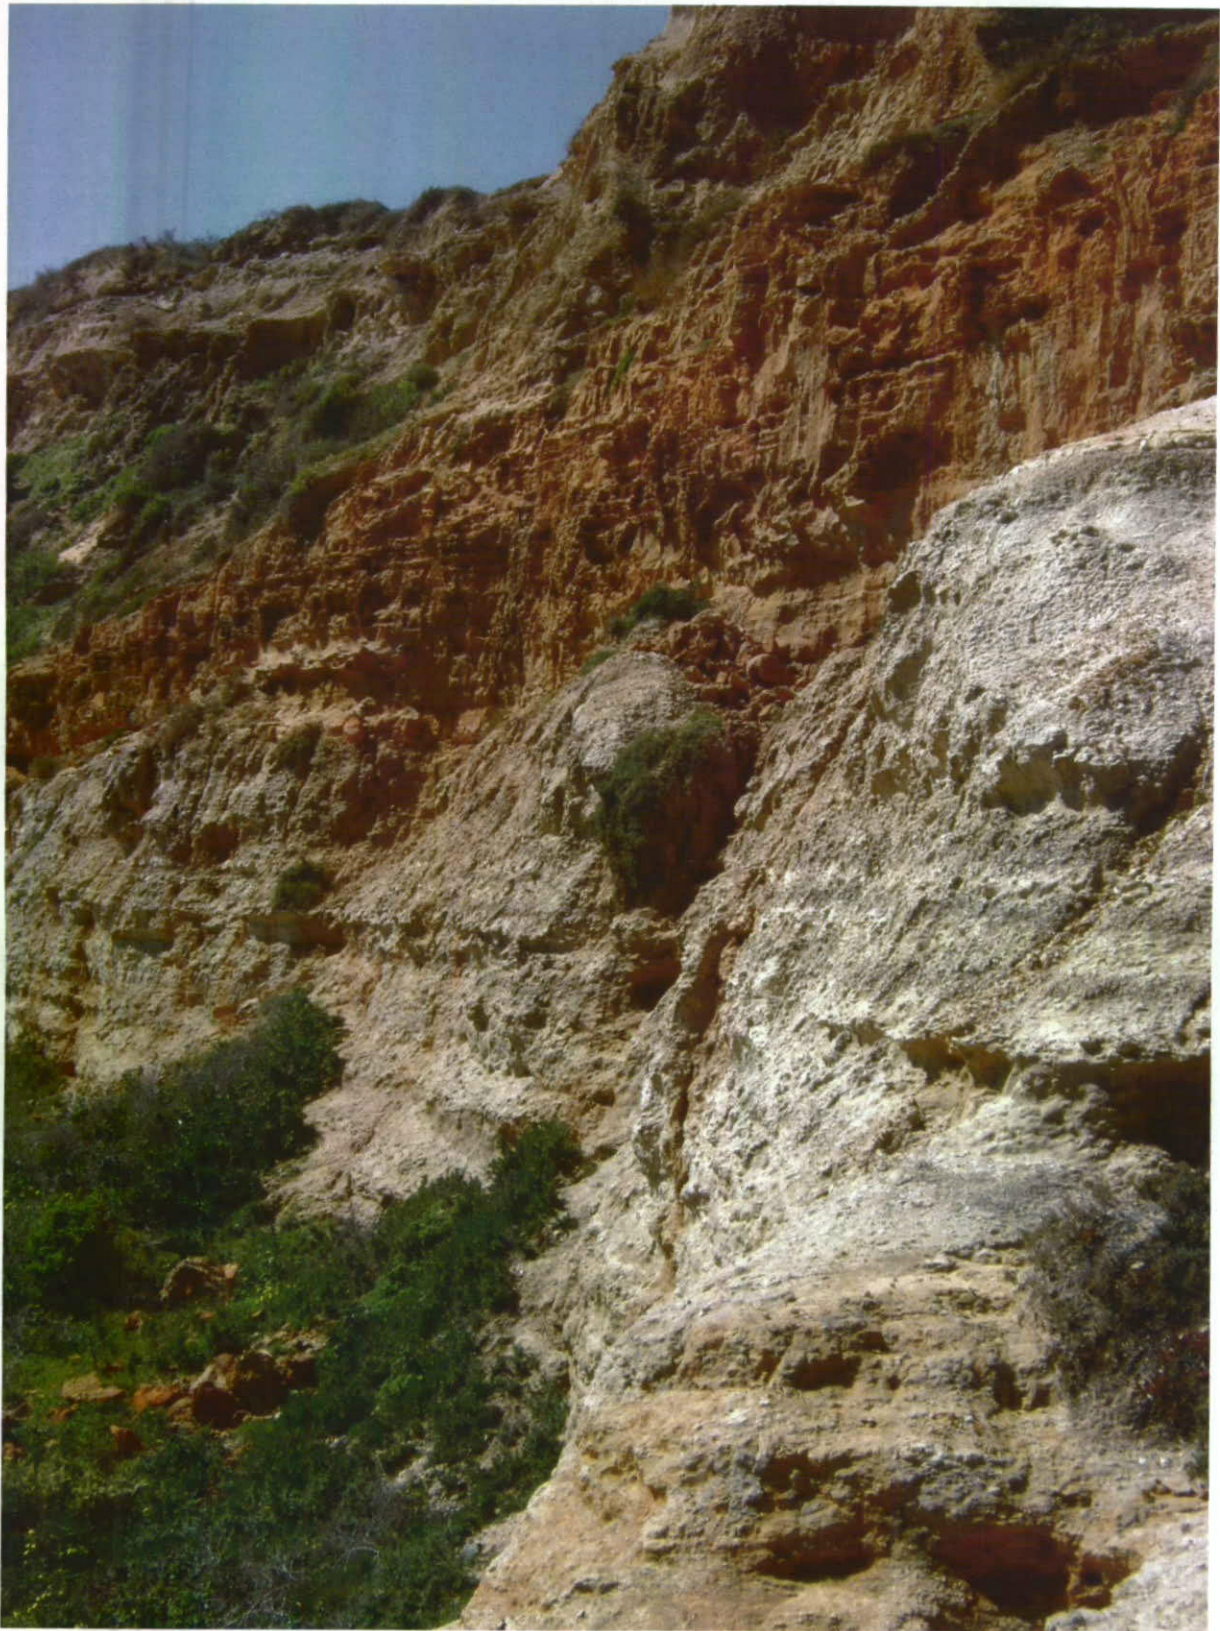
The presence of a number of older and more recent backscars is evident from slumping failures in the upper and mid slope soils of the cliffs (Plate 10, 17, 26, 27 and 28). Typically the backscars were formed in topsoil, calcrete and sand or clay in which overhanging material is created in the failure, which is at risk of further failure by toppling/fall mechanism. The trigger for these failures could have been stormwater run off or more likely erosion due to seaspray, wind and water action in the underlying soils. To undertake remedial works to each of these failures (thirteen recorded over the

Plate 28: View looking north at recent backscars with mid slope red sandy soils and the overall irregular shape of the cliff due to the progressive atmospheric, bird and stormwater erosion.

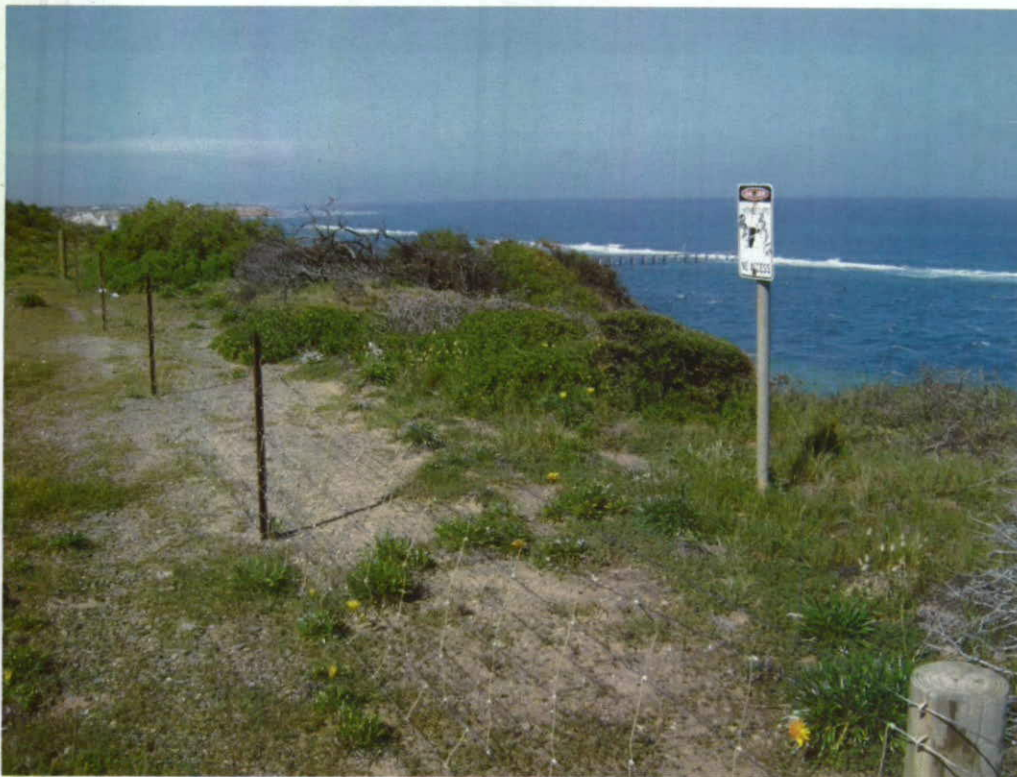
Plate 32: Danger sign obscured by graffiti.

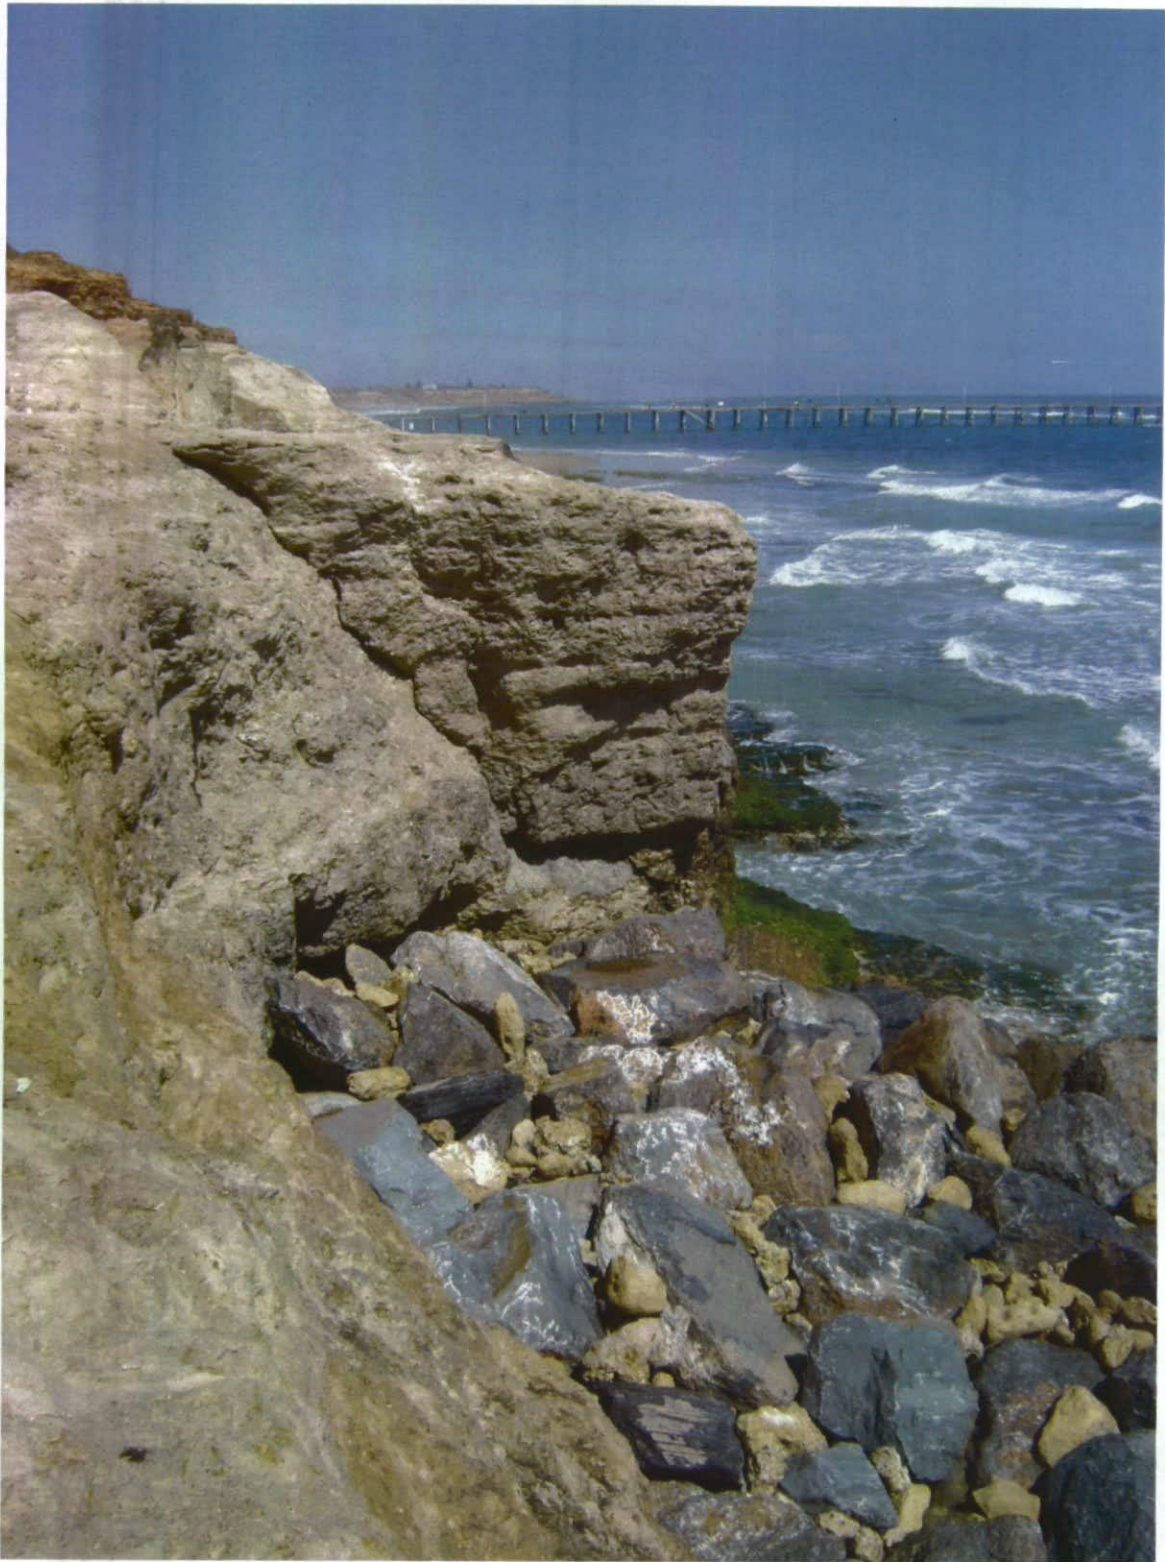
Plate 33: View looking south from the old wave cut platform down onto the present wavecut platform. Blue boulders have been placed within old caves as part of previous council hazard mitigation actions. Also large crack in platform has been sealed at the base with concrete. Large wedge still present.

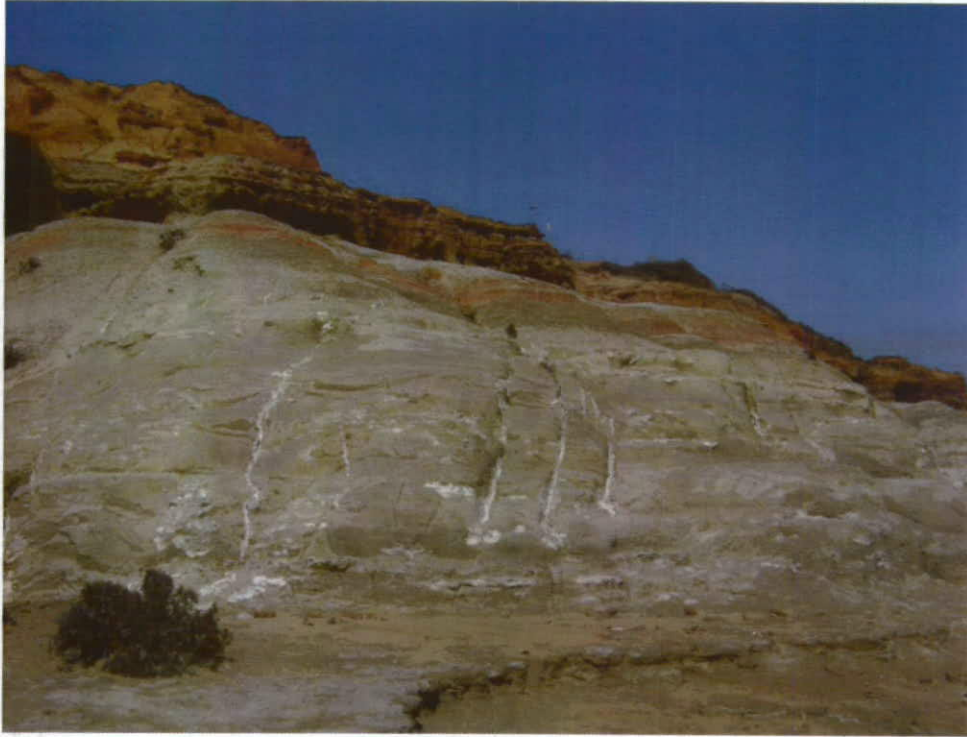
Plate 34: Subvertical joints in the Blanche Point Formation siltstone / limestone, with white calcareous infill. Joints are regularly spaced at approx 0.5m and have a strike length of >20 m.

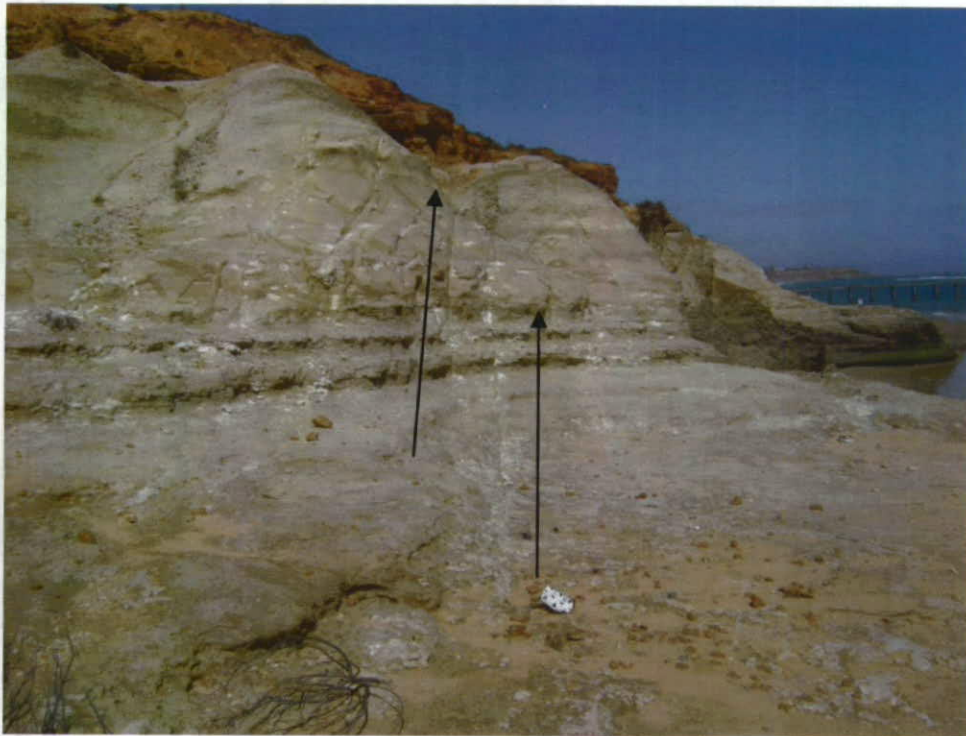
Plate 35: View looking south at the cliff containing regularly spaced subvertical joints in the siltstone / limestone that project into the cliff behind the site were a recent large scale slope failure has occurred.

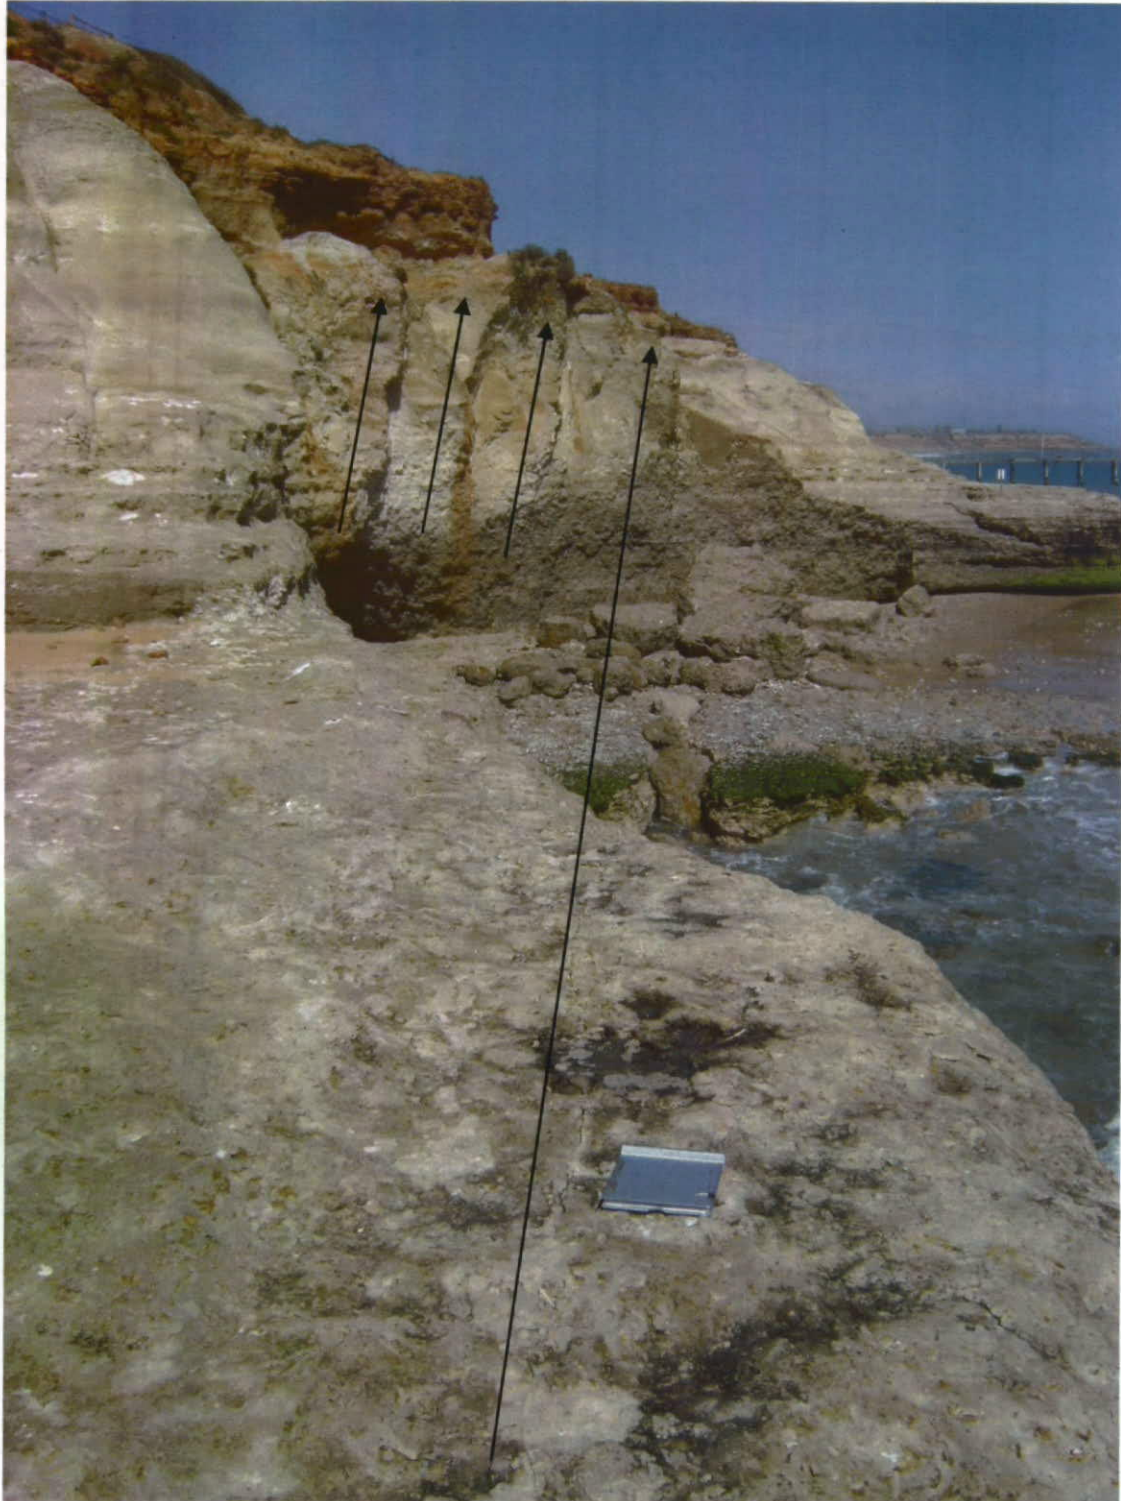
Plate 36: View looking south down onto large boulders that have recently fallen onto the current wave cut platform. In the foreground, left of the silver folder, tension cracks in the rock align with subvertical joints observed in the area where the slope failed (refer to arrows). Note the persistence of these structures is greater than 20 m in length.

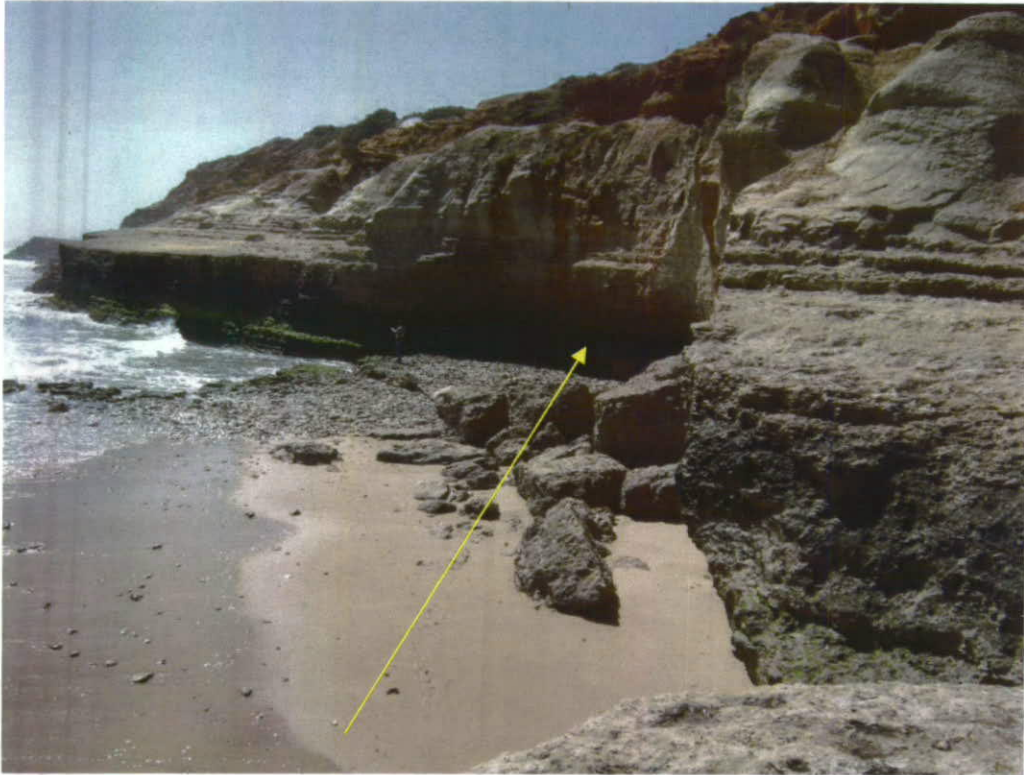
Plate 37: View looking north down onto the wave cut platform at the large slabs fallen. Man in the middle of the photos for scale. To the right of the man is an actively forming cave/undercut slope.

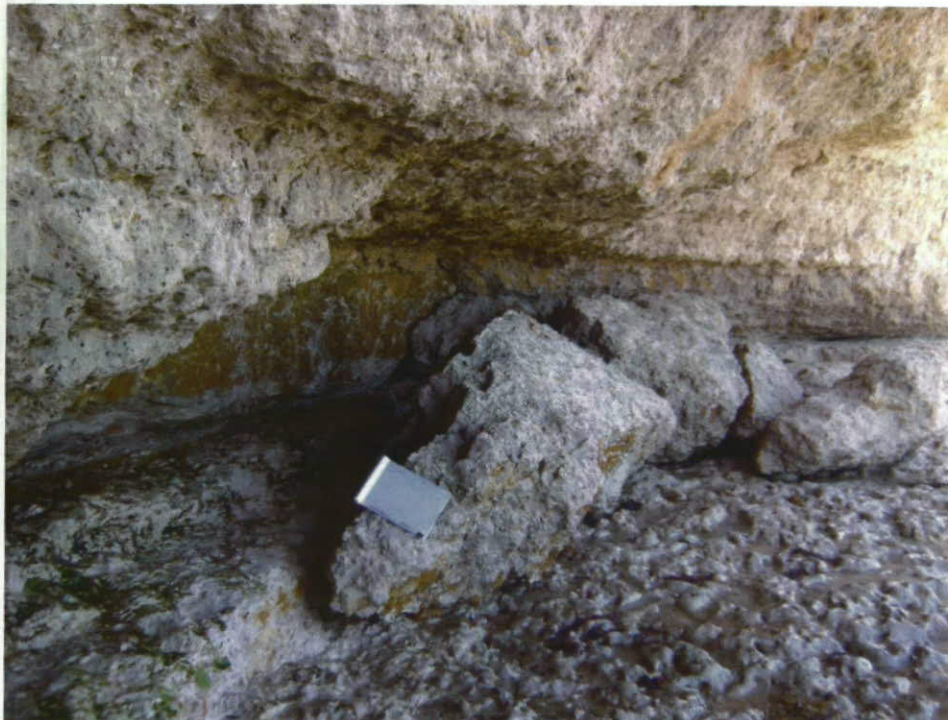
Type 3, that is the formation of caves as shown in Plate A and Plate 38, is a slope stability hazard indicator that in the long term could lead to Type 4 hazards. Where Type 3 erosion leads to caves large enough for access by members of the public to risks are very high. Noting that if a public member is present in the cave during the initiation of a rock mass failure the public member may not have time to retreat safely from the cave. This is considered to be an unacceptable level of risk for the Council.

Plate 38: Close up of recent rocks fallen due to the forces of wave action which have undercut the cliff and have formed a cave. Cave depth is >5 m and >10 m in length. Rock failure due to horizontal defects and gravity, leading to tensile failure of the rock mass.

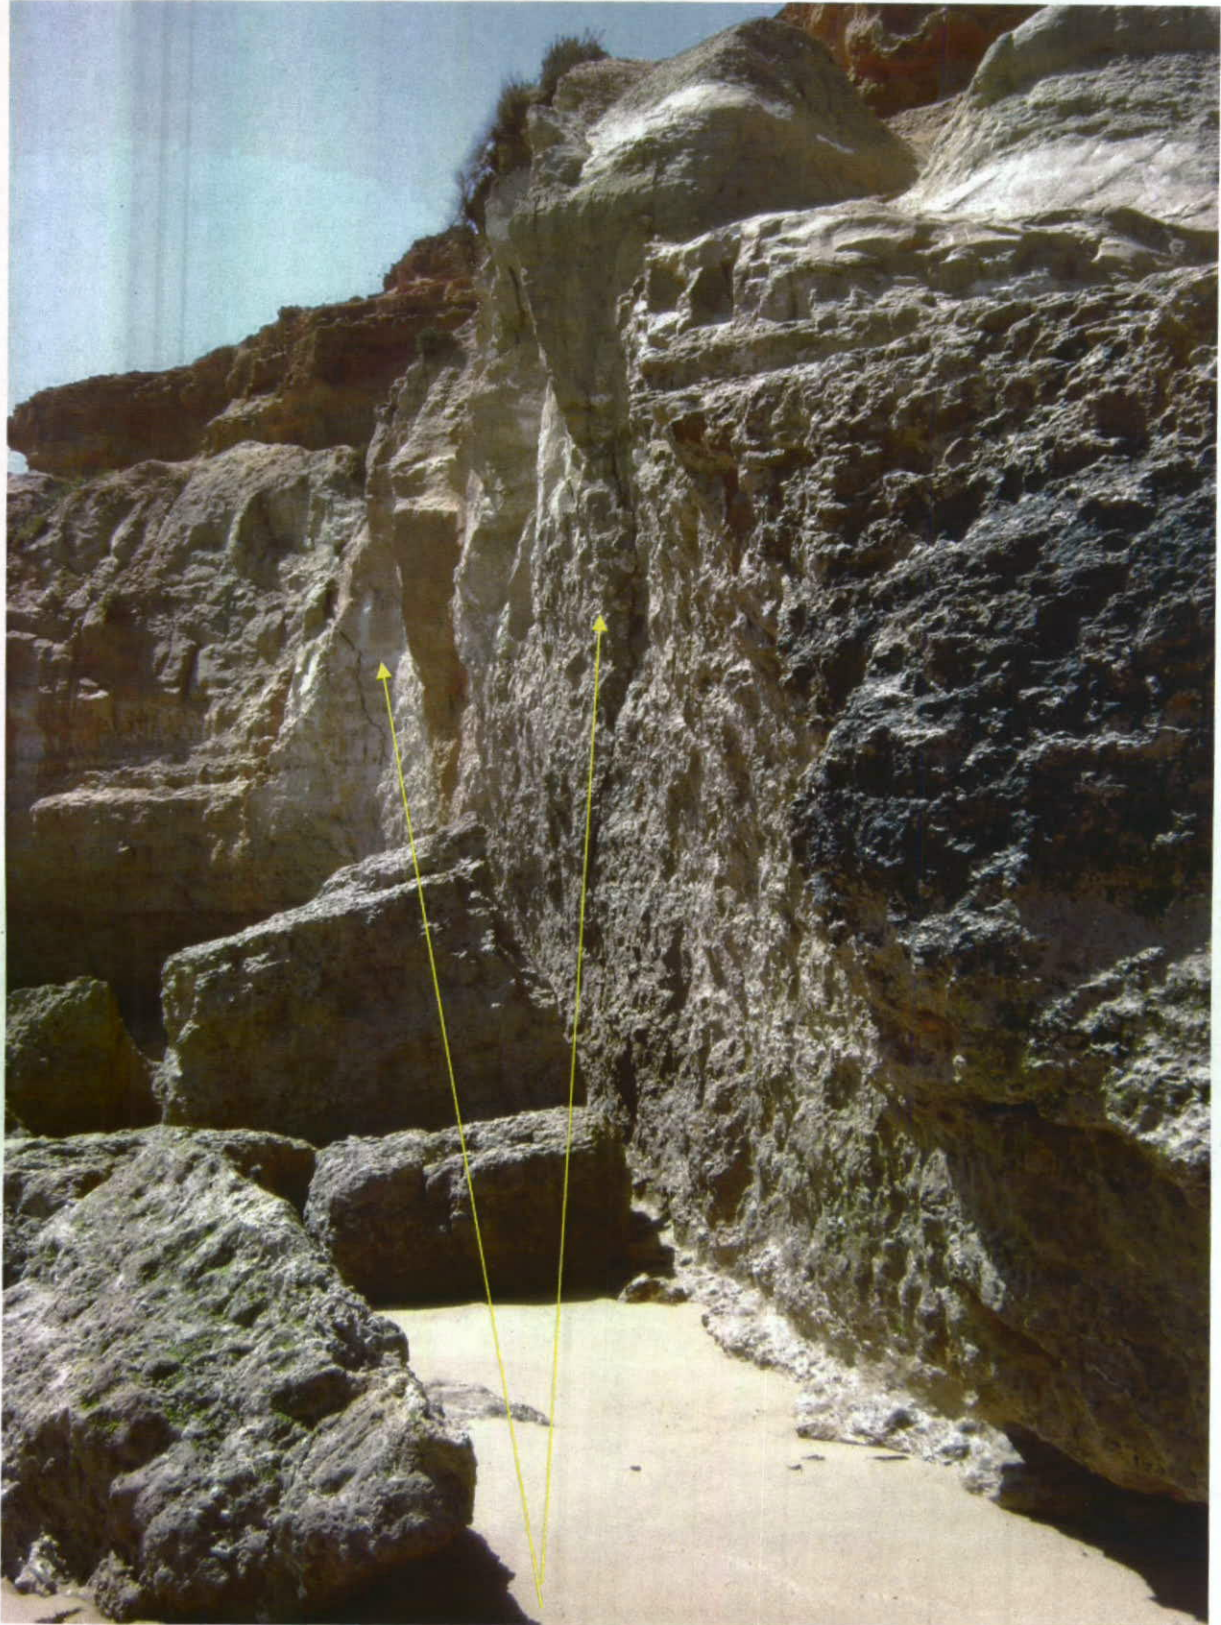
Plate 39: View looking north east showing recent failure backscar and undercut sections at the crest of the slope. Note the large >3 m tension cracks in the upper section of the overhanging slope.

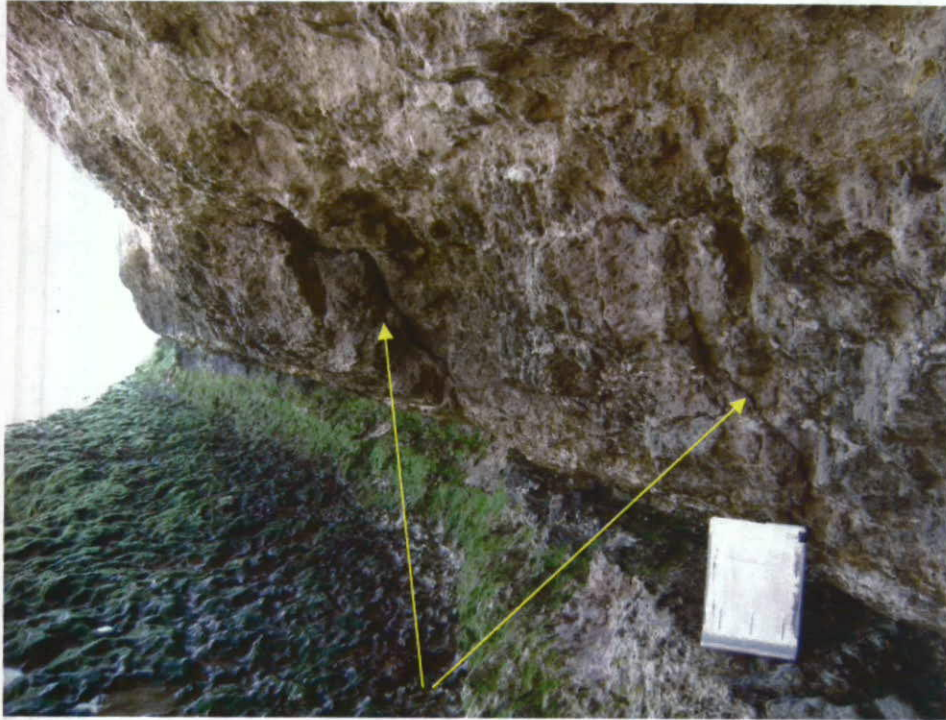
Plate 40: View of shallow seated scalloping fracturing of the rock, above the moss covered tidal influenced wave cut platform. Cracks will lead to failure of the rock in the short term.

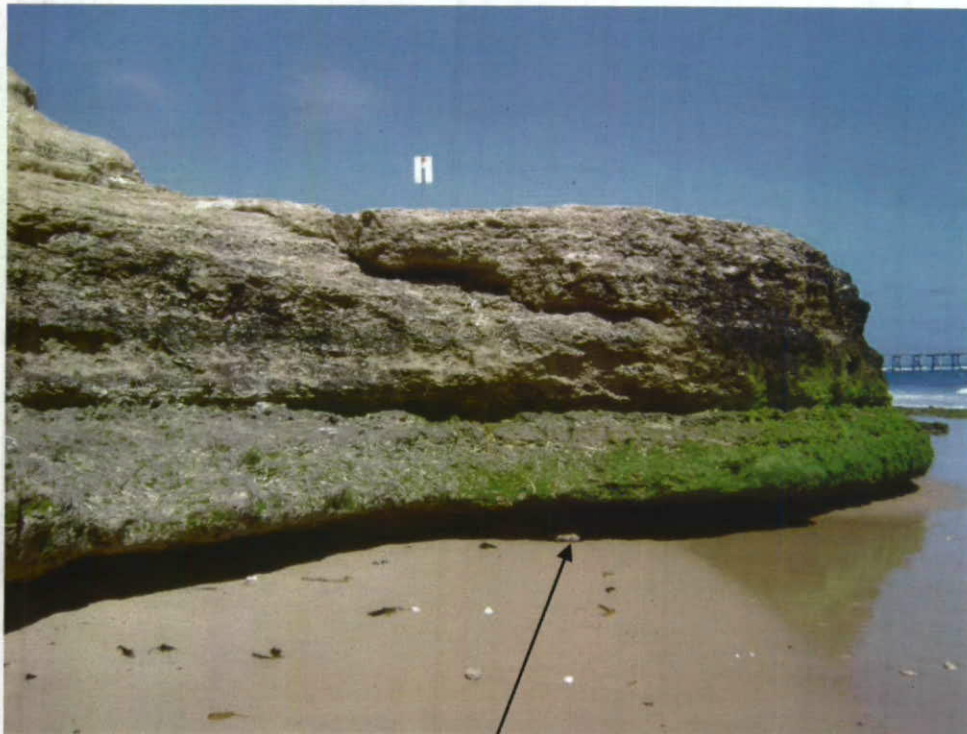
Plate 41: General view of the undercut in the slope due to wave action (approx. height 300 mm x 300 mm depth).

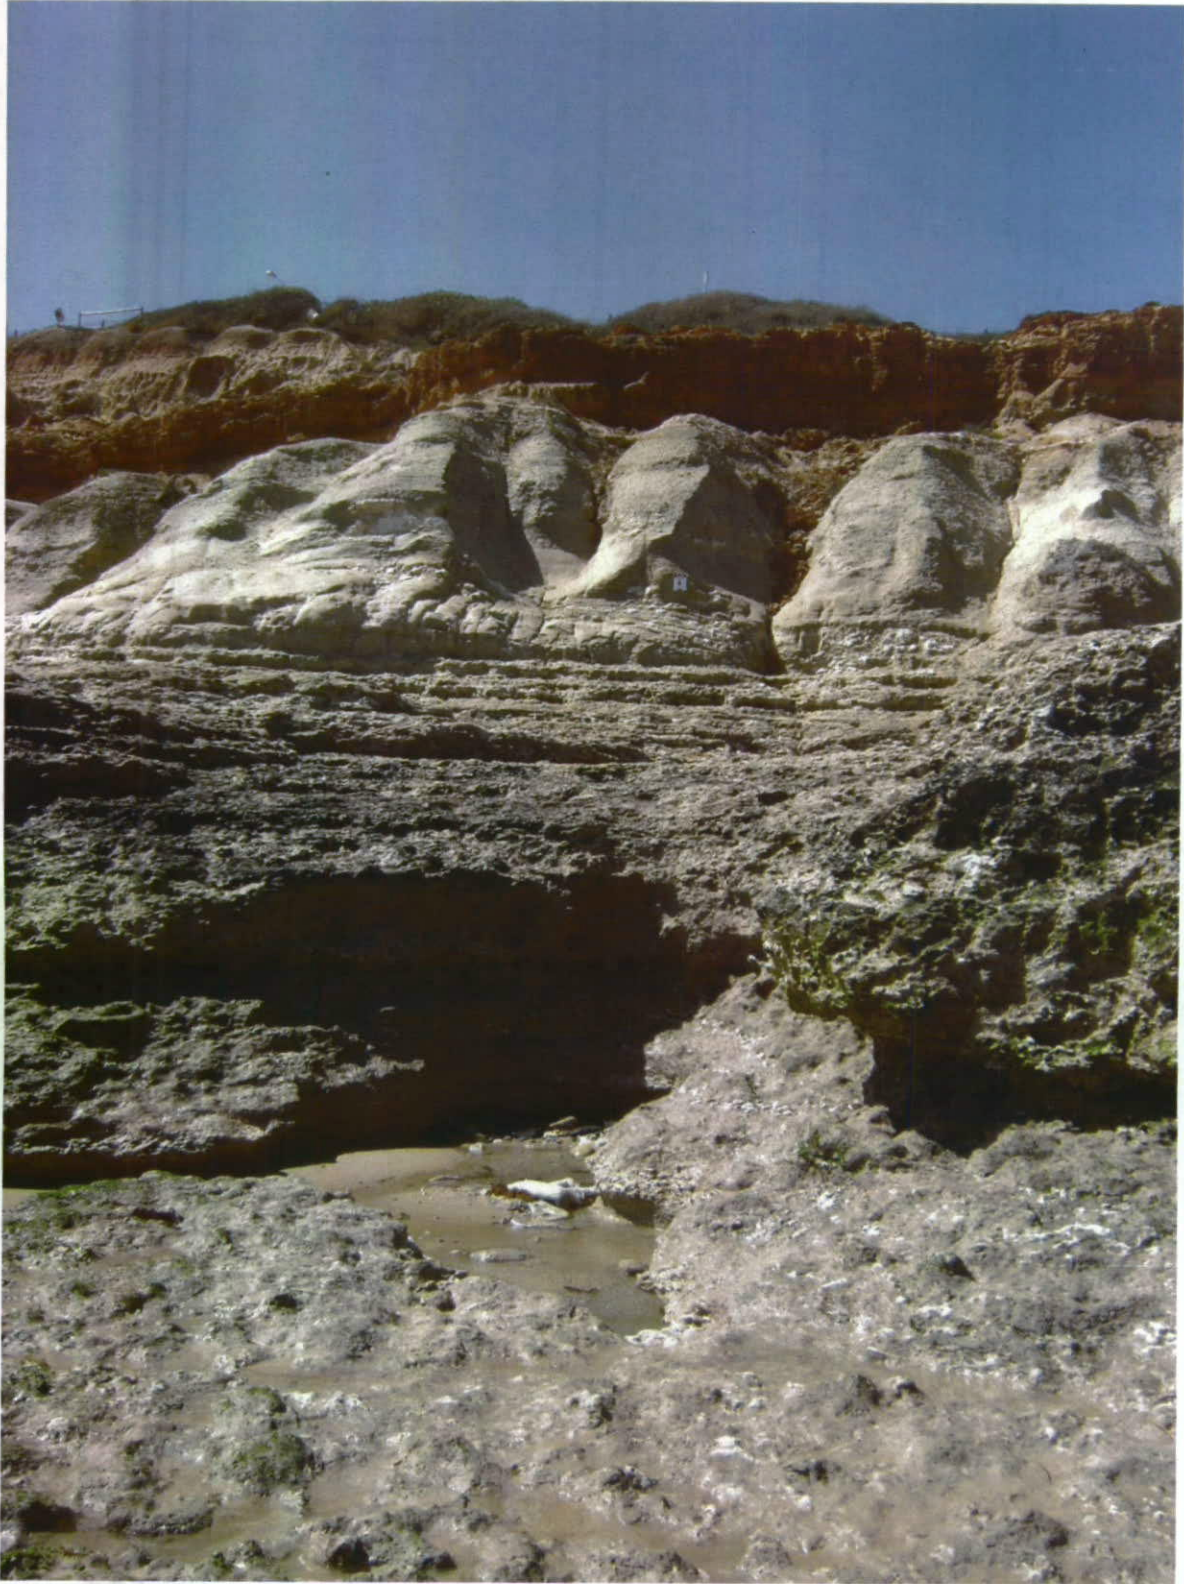
Plate 42: General view of the cliff from shoreline to cliff top (road), slope 30 m high, 1V:1.7H (30° inclination), where red sandy clay boulders (300 x 300 x 300 mm) fall down the slope, within large erosion gullies.

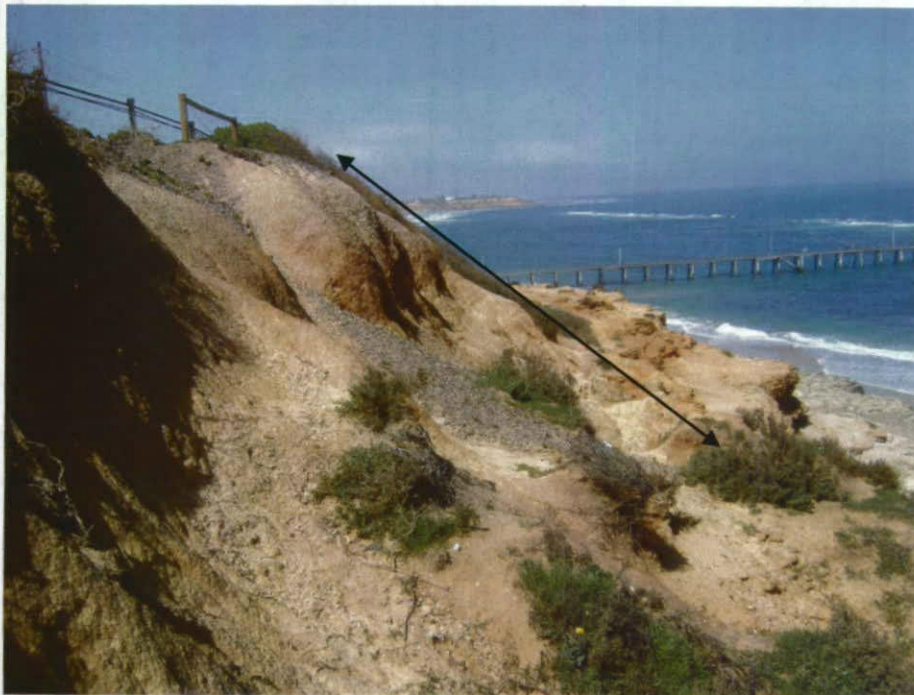
Plate 44: General view south highlighting the proximity of the road to the crest of the cliff slope immediately above the coastal site of active cave formation and recent rock falls. Slope 30 m high, 1V:0.7H (55° inclination).

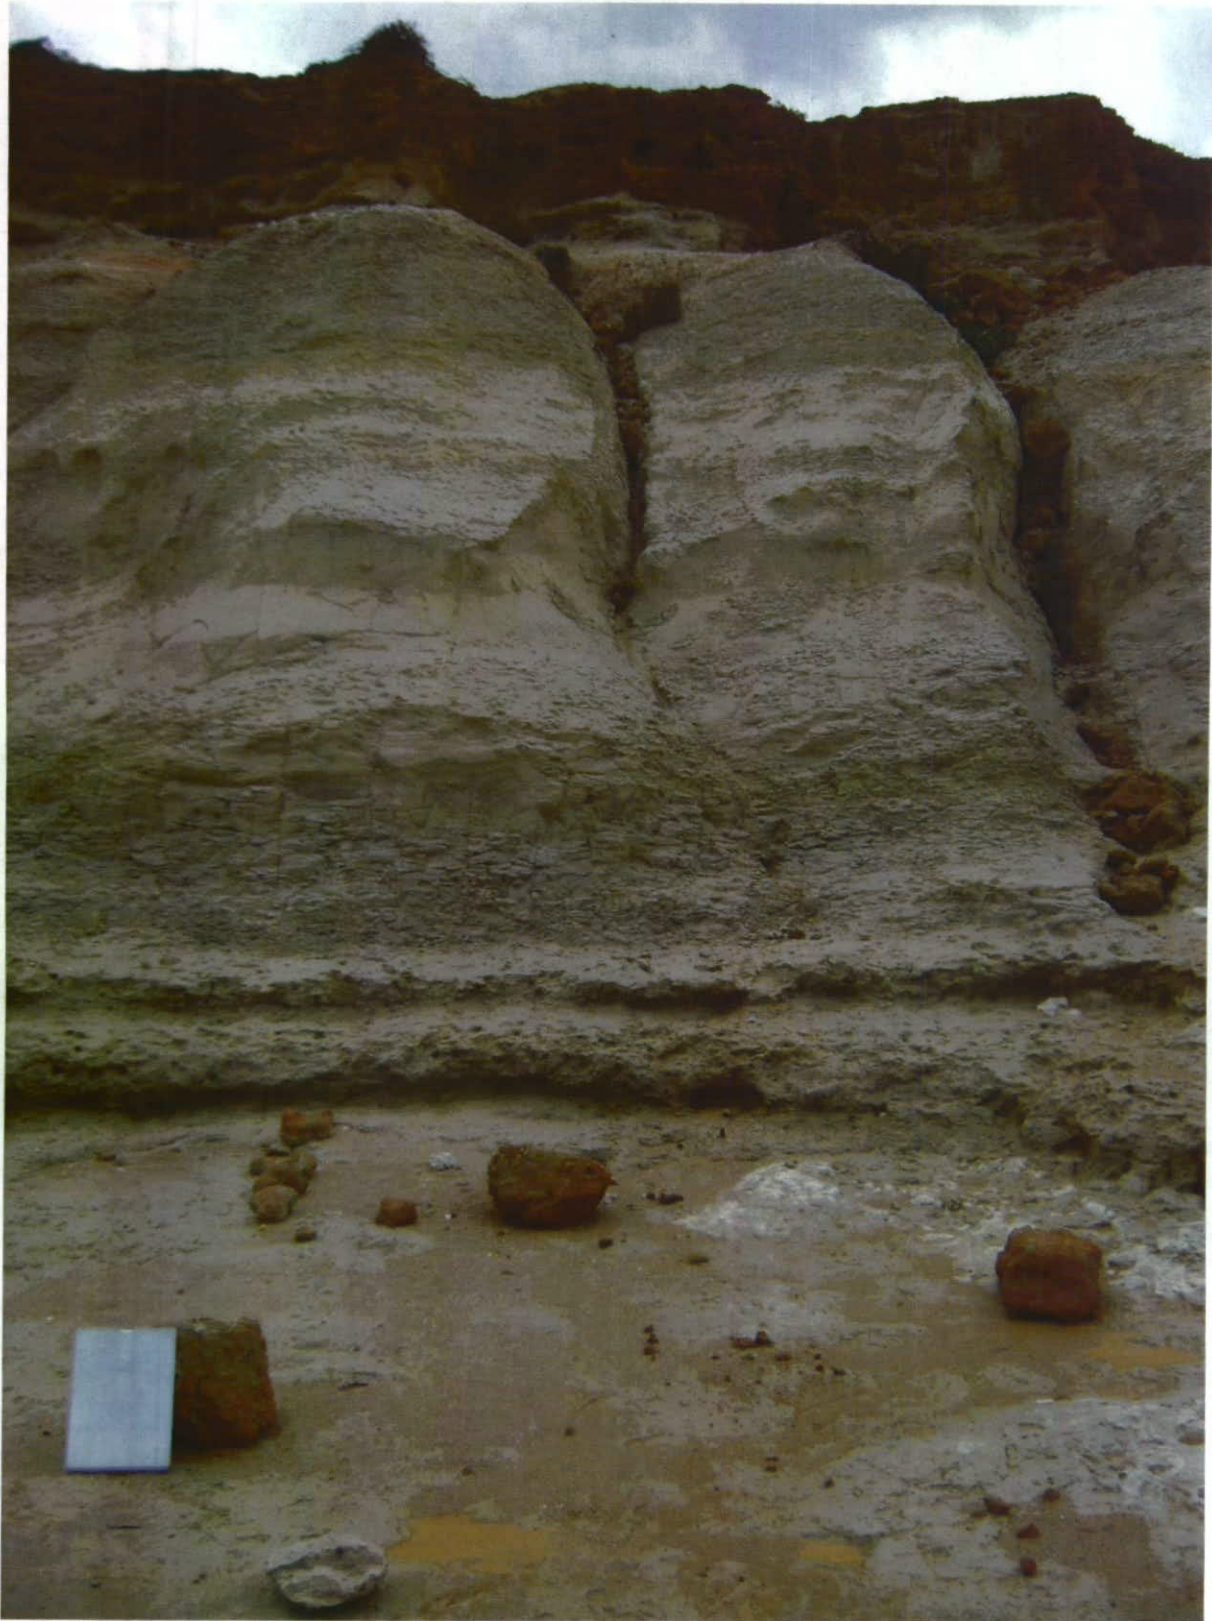
Plate 45: General view of the cliff above the platform in Zone K. Note the small 200 x 200 x 300 mm sandy clay boulders that have eroded and fallen down large erosion gullies from the steep upper slope.

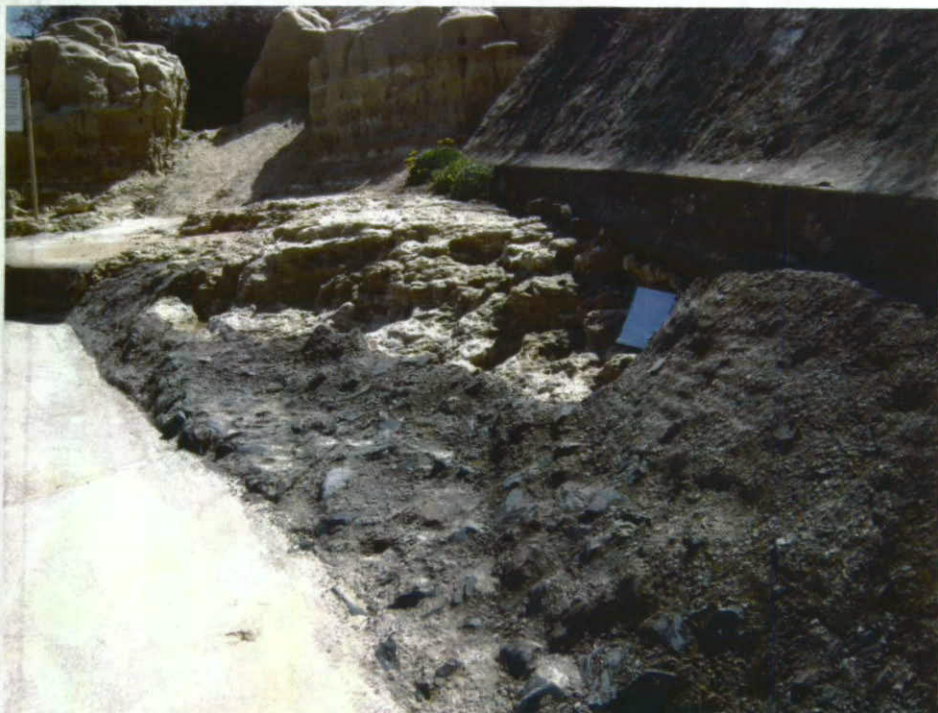
In Zone M, wave action has eroded parts of the lower cement covered slopes resulting in the undercutting of the '1954' stone retaining wall adjacent the boat ramp (Plate 47). Wave action is also fracturing the rock in the cliff adjacent the boat ramp (Plate 48).

Plate 47: View looking north at the ongoing erosion leading to undercutting of the base of stone retaining wall (built in 1954).

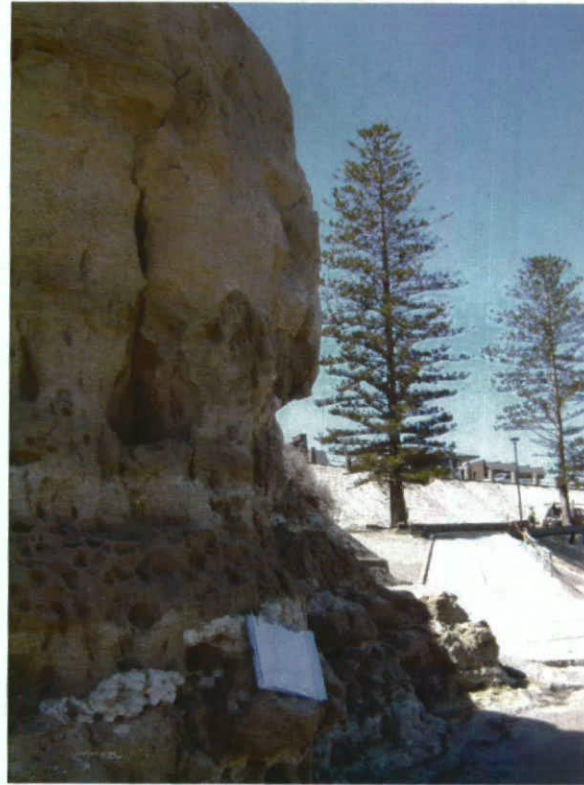
Plate 48: Adjacent to the boat ramp, high tide wave action is progressively undercutting the cliff. Cliff rock mass has vertical defects which in time may lead to the failure of wedges in the cliff upon the beach.

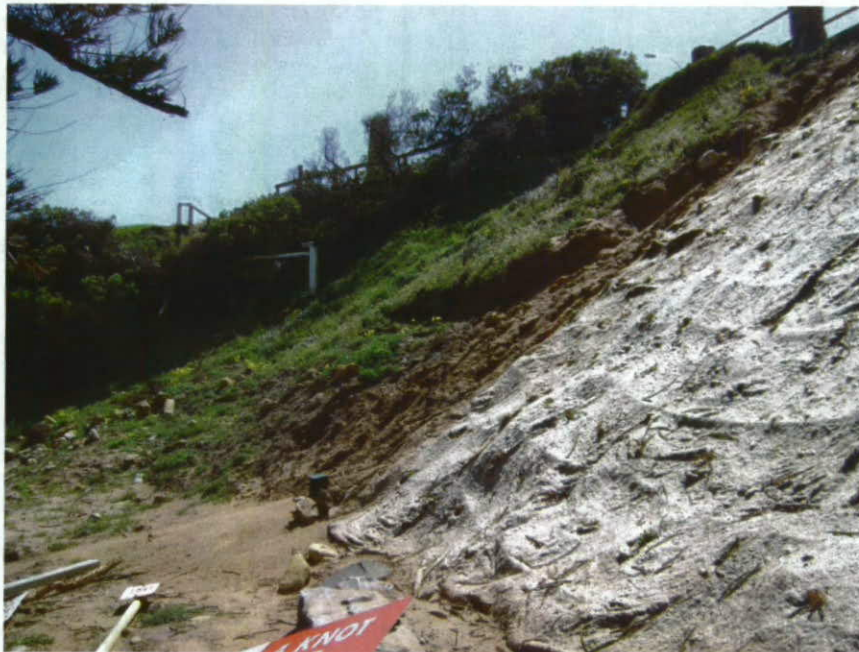
Plate 49: View looking north at Zone N where the remediated slope abuts a stone and cement rock armour of the slope. This armouring has been recently disturbed and through time will expose soils to erosion.
