Document Ref: ADL2020-0176AB Rev2

**RE: Geotechnical Stability Assessment
Witton Bluff Base Trial**

The City of Onkaparinga (Council) have engaged CMW Geosciences Pty Ltd (CMW) to undertake a cliff stability assessment along the Witton Bluff Base Trail (WBBT) from Christies Beach to Port Noarlunga, SA.

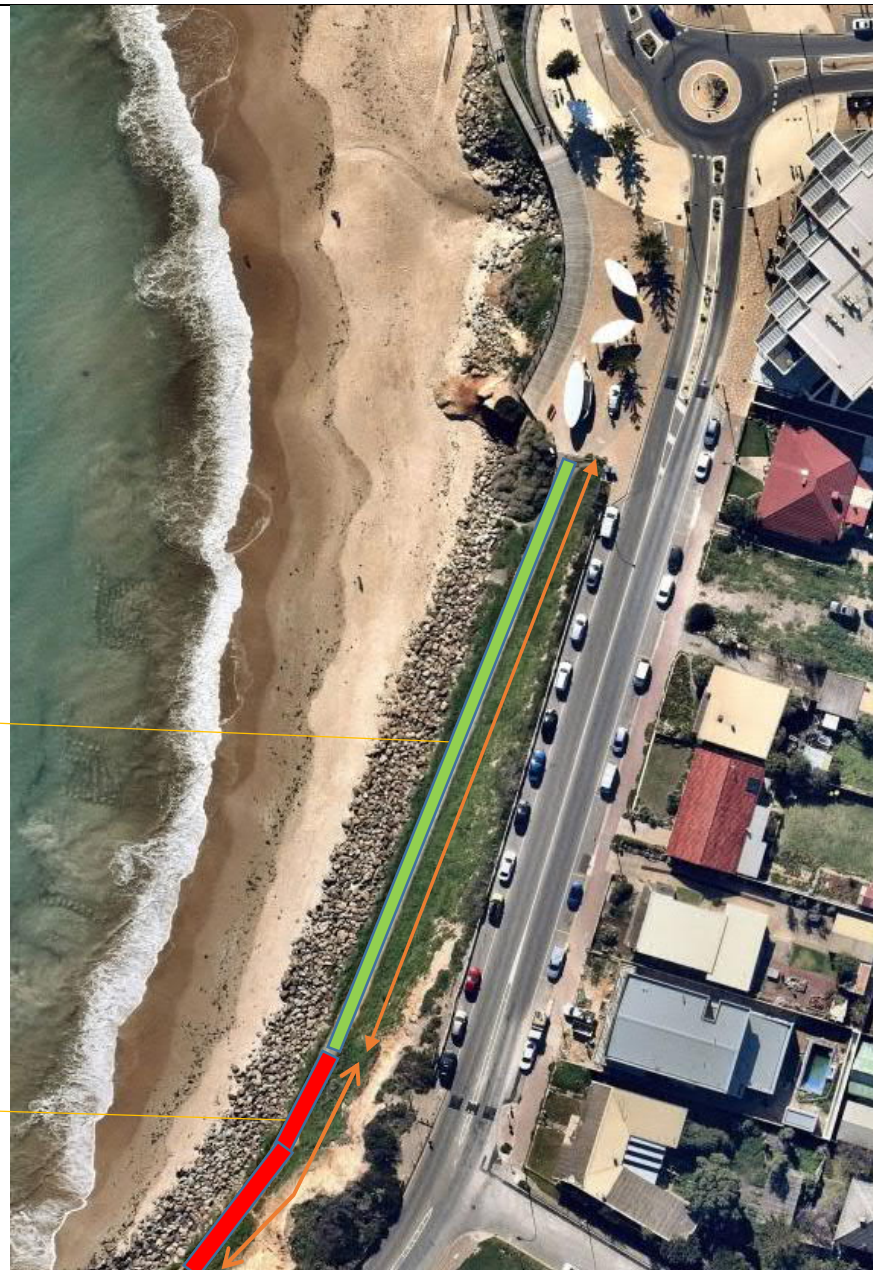
City of Onkaparinga
Christies Beach and Port Noarlunga Slope Stability - Path Relocation
Figure 3a: Path Realignment
ADL2020-0176
23/07/20 J. Slade

Cliff Zone A
Low instability Risk

Cliff Zone B
High instability Risk

Based on our assessment and prior site assessments, the area of greatest concern to the increased risk of slope instability are areas where there is a steep cliff segment immediately adjacent to the WBBT (Area B). In this area moving the WBBT seaward or raising the WBBT (or a boardwalk) is recommended.

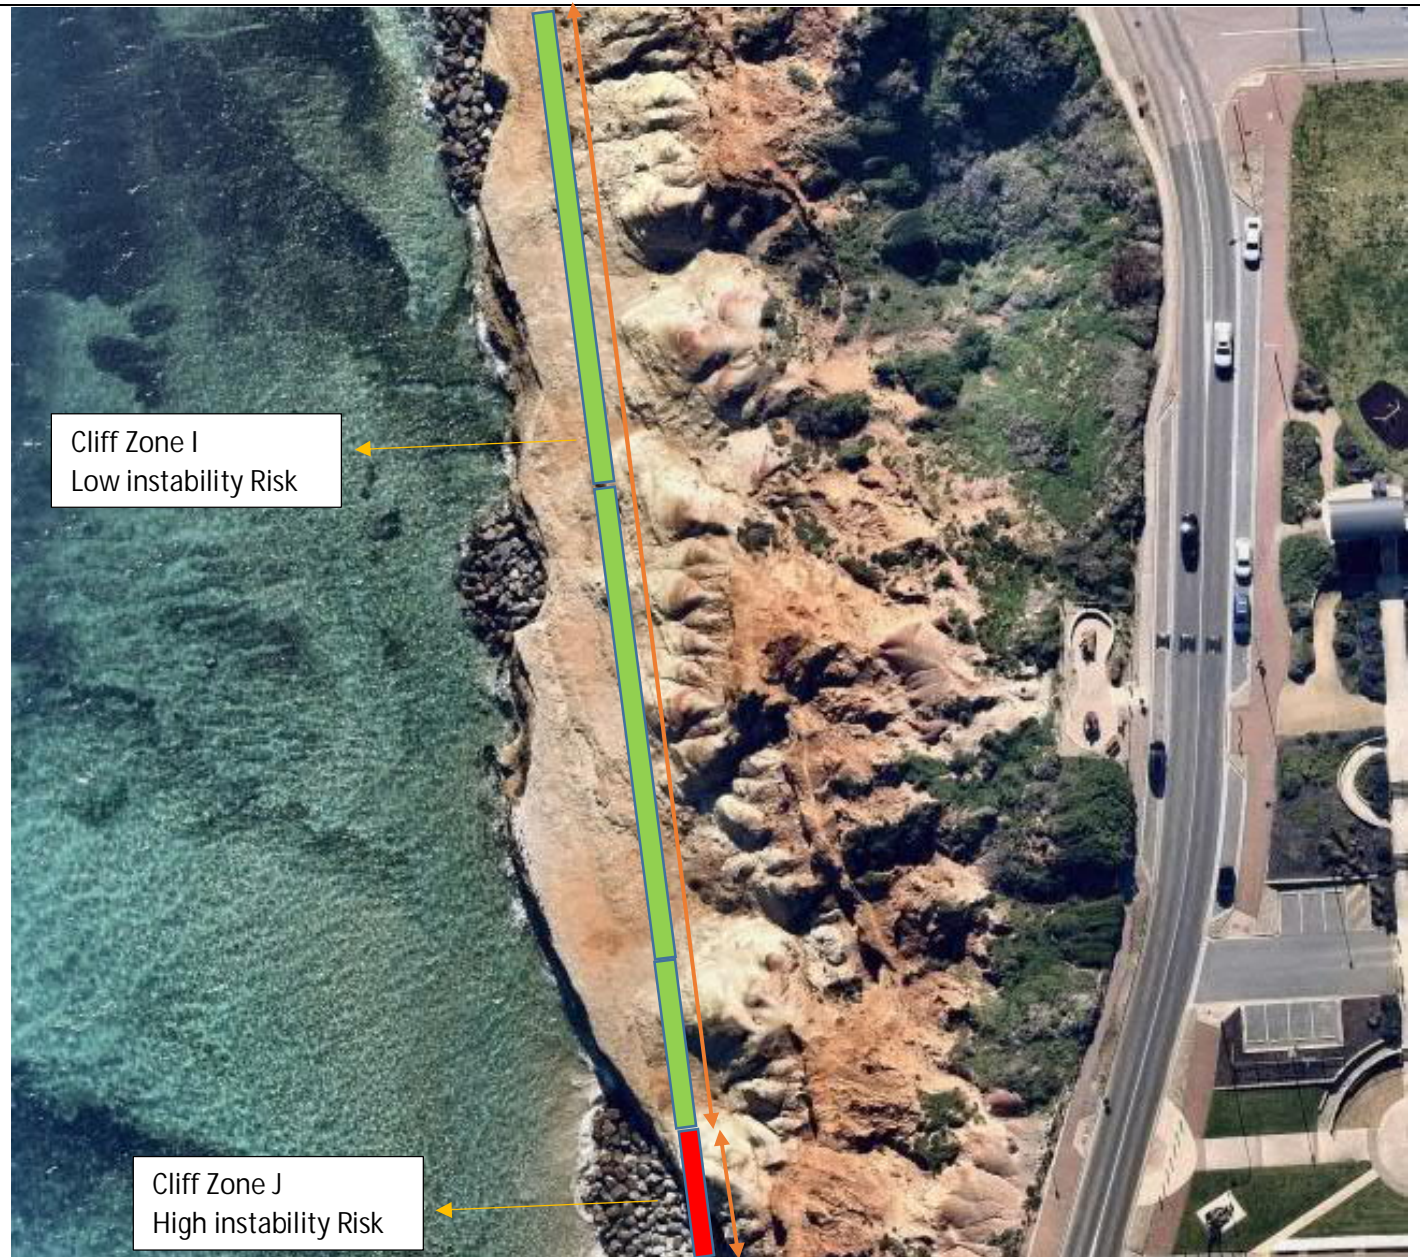
It is noted that this Zone J present the highest likelihood of instability but if the walkway is offset from the cliff the risk of interaction with falling soil and rocks can be separated.

Is it recommended to make this structure is made out of steel or wood and be a small diameter footing will be difficult and therefore gravity not bored pile footings are suggested.

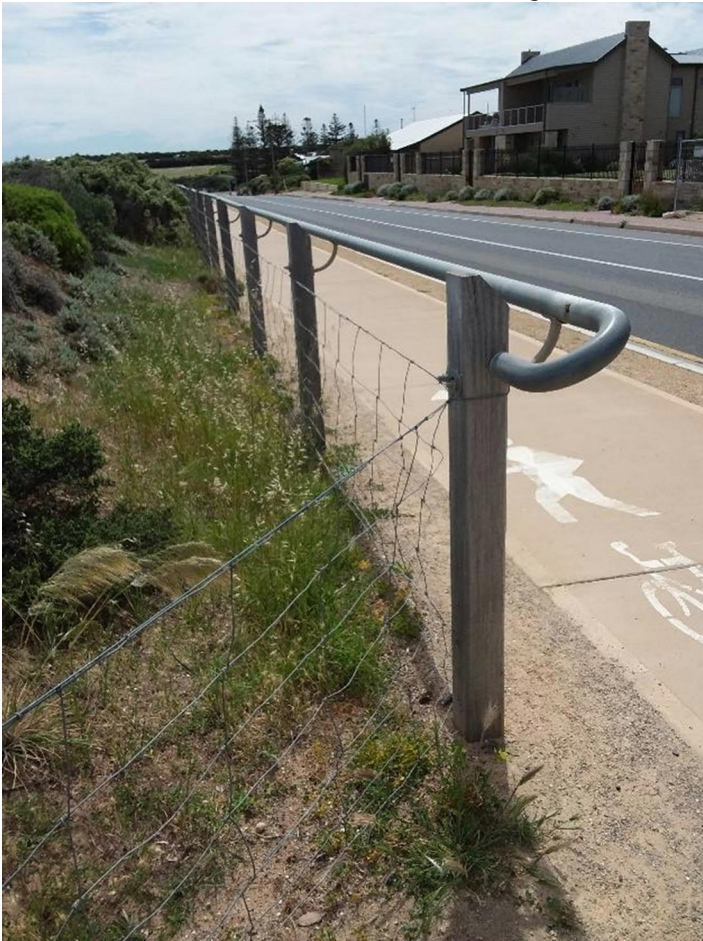
City Of Onkaparinga Port Willunga Examples 21/10/20

Modern fence systems
installed as part of the
footpath upgrade

Advantages:
Simple to build and fix
Durable
Allow vegetation to
grow through
Unsightly
Large openings
Can have more than 1
high strength strand
Bicycle standard
compliant

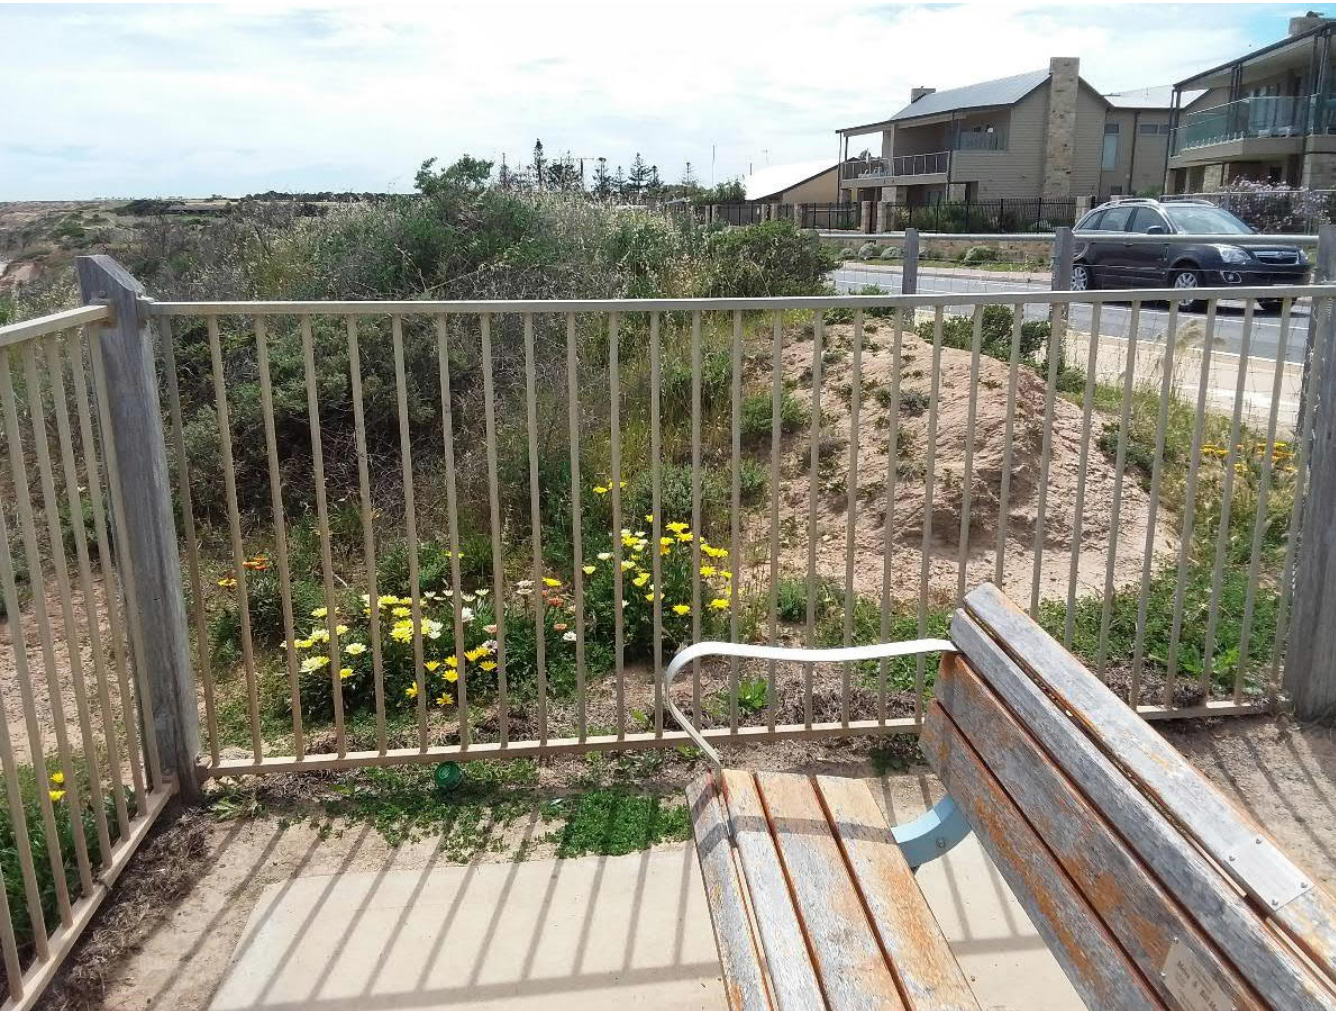
City Of Onkaparinga Port Willunga Examples 21/10/20

Modern barrier fence systems installed as part of the footpath upgrade at lookouts. Stops kids climbing.

If hit by a soil mass will detach and the panels becomes a hazard.

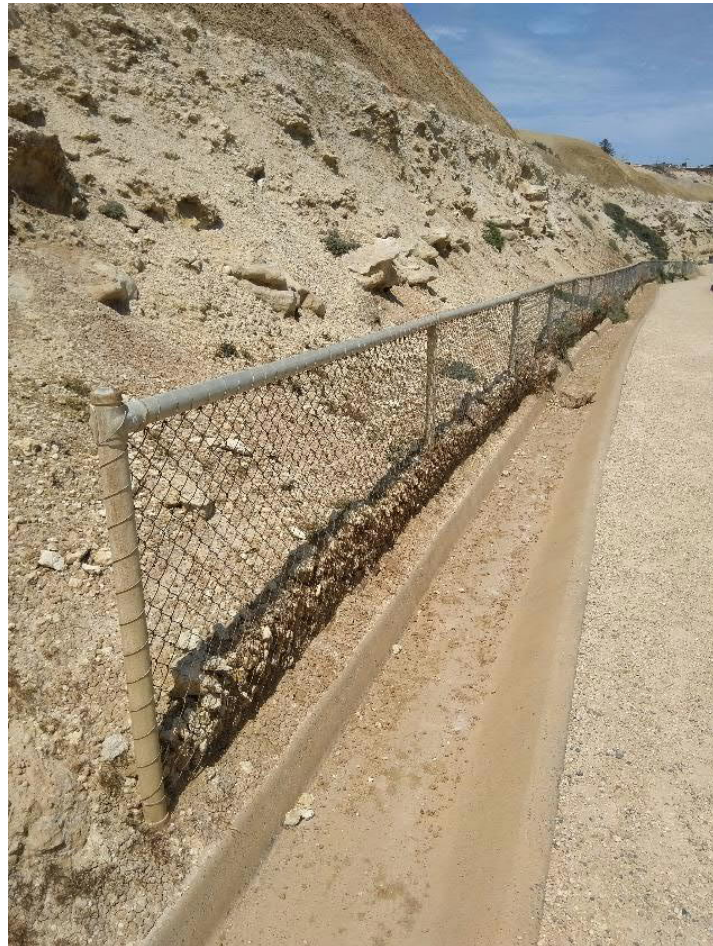
City Of Onkaparinga Port Willunga Examples 21/10/20

Old mesh fence systems installed as part of the original footpath

- Visually not so pleasant
- Narrow openings will not allow soil or rock material through.
- Not to bicycle standard
