# Wearing Street Aquatic and Arts Precinct

City of Onkaparinga

December 2020

| <b>Project Name</b> | Hydraulic Modelling and Geomorphic Assessment |

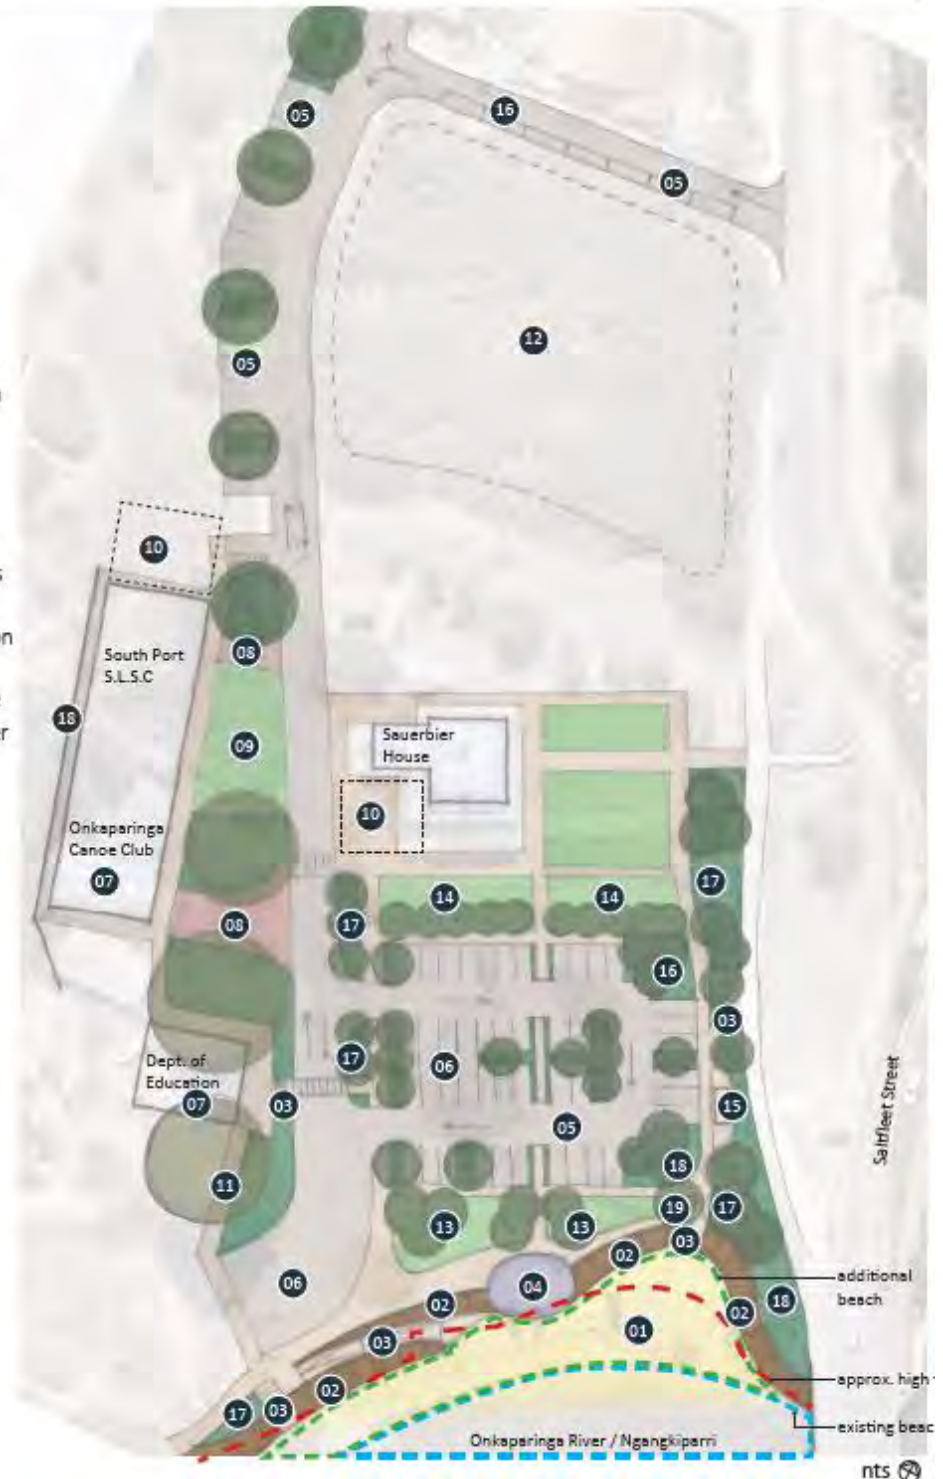
FIGURE 1-2 WEARING STREET AQUATIC AND ARTS PRECINCT – CONCEPT

1. Enlarged riverbank
2. Upgraded rock embankment
3. Access ramps and stairs
4. Large shelter with seating
5. Carparking
6. Trailer parking and short term drop-off zone
7. New aquatic facilities
8. Aquatic facilities access
9. Aquatic facilities breakout space
10. Potential commercial operation subject to EOI process
11. Access from aquatic facilities to riverfront. Possible boardwalk structure
12. Site with significant Aboriginal, natural and cultural heritage values
13. Recreation lawn; potential for food truck and/or aquatic recreation operators
14. Lawn adjacent Sauerbier House
15. Toilet block and outdoor shower
16. Upgrade Mann Street
17. Garden bed / buffer planting
18. Retaining wall
19. Bike station

The currently proposed concept design (Figure 1-2) will leave the beach face and access paths susceptible to erosion. Under base flow and tidal conditions, the beach face is likely to require regular nourishment to maintain its level to which the lower landing of the concrete path is aligned. However, during large events it is likely that substantial erosion will occur along the proposed rock wall. So long as the rock wall is keyed well into the bed this is unlikely to cause damage to the rock wall itself. Likewise, as long as the lower landing of the concrete access path is also keyed in, undermining of the path is unlikely; however, erosion may periodically leave a large step from the landing to the “beach” surface.

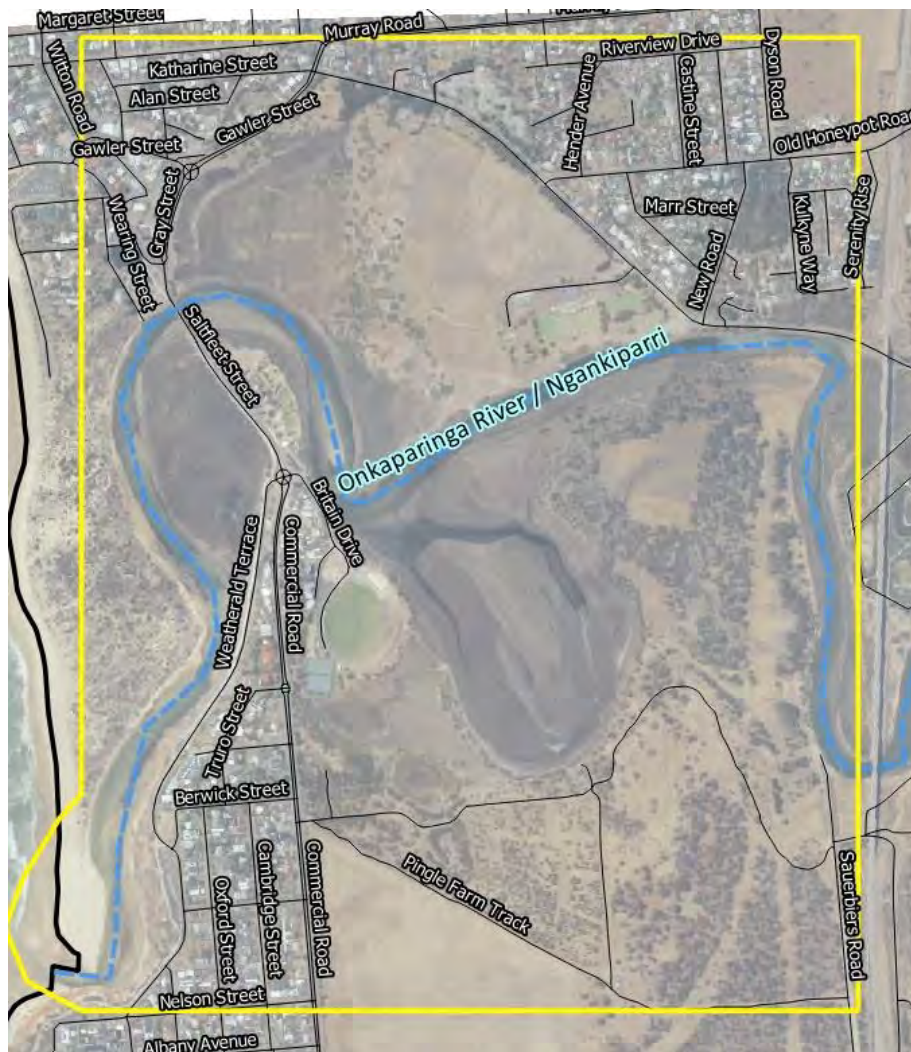
FIGURE 2-3 TUFLOW MODEL EXTENT

A TUFLOW hydraulic model (build 2018-03-AC) for the lower Onkaparinga River was developed employing the HPC (Heavily Parallelised Compute) solution scheme. TUFLOW is a 1D-2D linked hydraulic modelling software that solves depth-averaged shallow water equations to perform hydraulic simulations. The TUFLOW model developed for this study has been used to simulate the existing site conditions for a reach of the lower Onkaparinga River, the model extent is shown on Figure 2-3. The model boundary was situated a sufficient distance upstream to ensure any inaccuracies associated with boundary effects would not have any impact on the model results at the site. The downstream boundary as set approximately 150m downstream of the river outlet into the St Vincent Gulf. The hydraulic model has been used to estimate peak floodwater depth, velocity, water surface level, and other associated hydraulic outputs required for the geomorphic assessment. This section describes the development of the TUFLOW model.

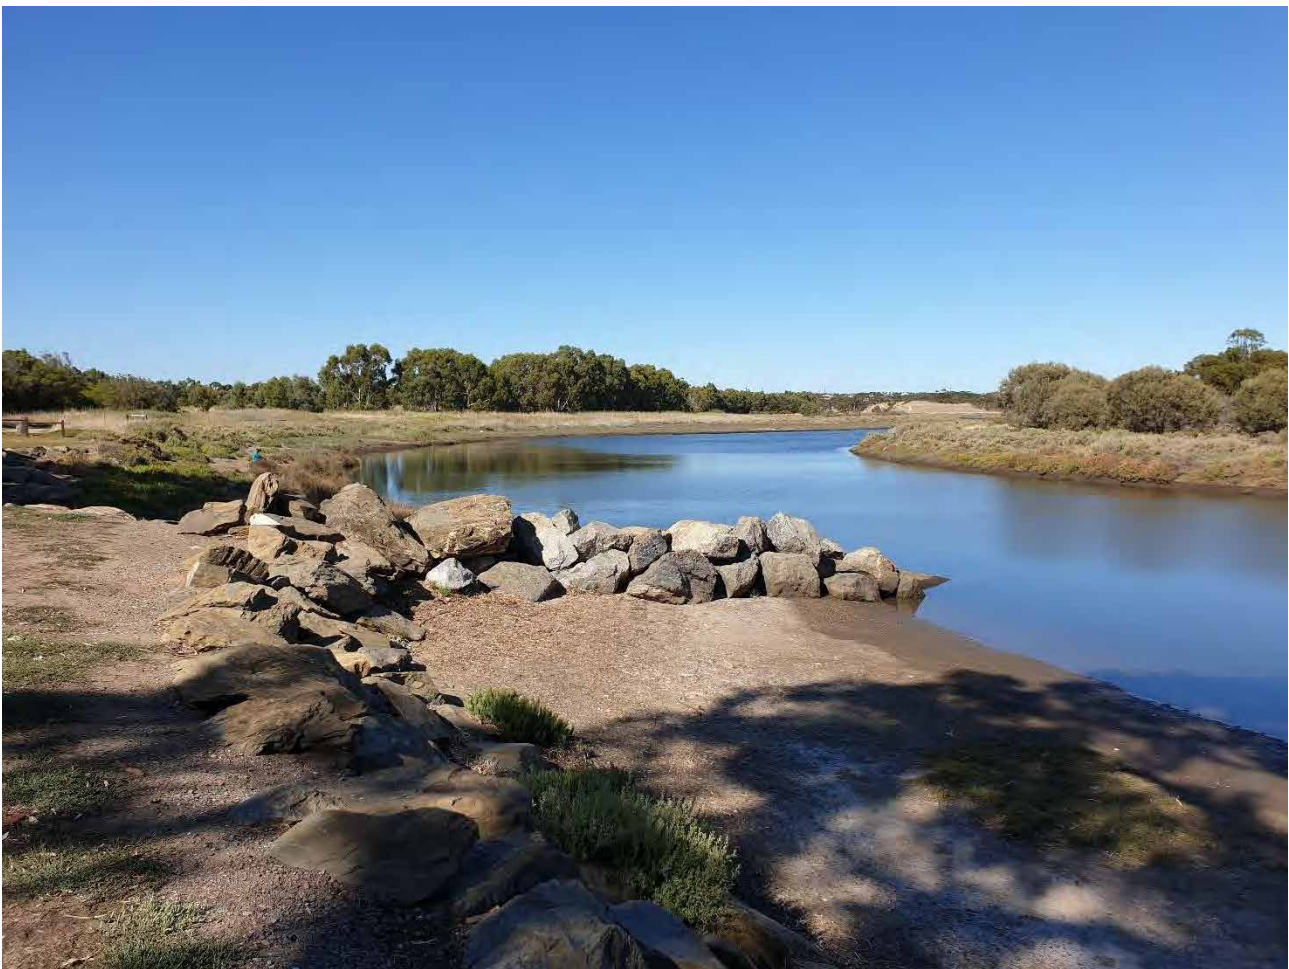
Within the vicinity of the study area, the Onkaparinga River is a wide and shallow, tidally influence system with a medium-grained sandy bed. Dense and continuous riparian vegetation is essentially absent once the river leaves the National Park. As stated above, this section of the river is laterally migrating meaning that the channel is moving across the floodplain. This occurs through meander extension where erosion occurs on the outside bank of meander bends due to increased hydraulic energy in that location and localised effects such as helical flow. Meander extension is evident on most meander bends, including at the study area, which is located on the apex of such a bend. Upstream of the site rock armouring has been placed to halt this process due to the proximity of Britain Drive and, again, further upstream on both meander bends that come close to River Road (Figure 3-1).

**FIGURE 3-1 ROCK ARMOURING AND GROIN PREVENTING EROSION OF OUTSIDE BEND NEAR RIVER ROAD.**

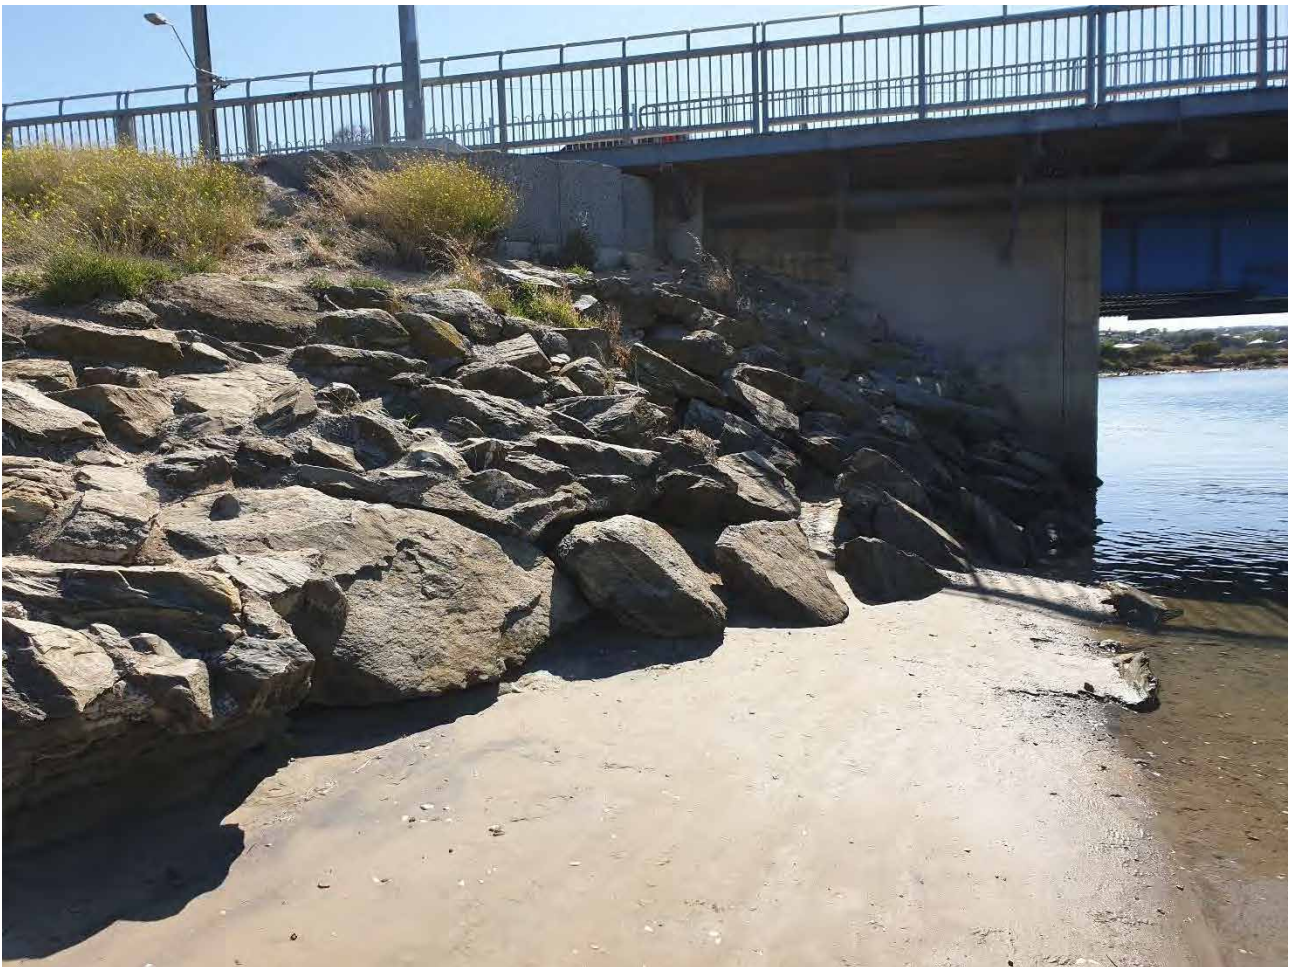
At the study site erosion is actively occurring, which is made evident by the undercutting and failure of previous rock and concrete erosion mitigation measures (Figure 3-2). This is also evident immediately adjacent to the study site upstream of the Saltfleet Street Bridge with failed rock armouring. At all locations, this erosion is occurring through fluvial scour as water flows against the outer bank of the bend. Flow is concentrated against the outer bank of the bend resulting in higher velocities and shear stresses (energy required to lift and entrain particles in flow). As such, where meanders are located in laterally unconfined areas (areas where movement

**FIGURE 3-2 UNDERMINED AND FAILING ROCK ARMOURING AT STUDY SITE.**

In this area erosion is occurring over the full length of the meander bend. It is gradual but observations certainly suggest that flows are capable of moving sand, particularly when no depositional features were observed. The hydraulic modelling results show velocities along the outer mender bend within the vicinity of the site ranging between 0.6 m/s for 50% AEP flows and 1 m/s for the 1% AEP flow. Velocities in the middle of the channel range between 0.8 m/s and 1.5 m/s. These velocities are not considered high; however, the resulting modelled bed shear stresses of between 6 and 10 N/m<sup>2</sup> are sufficient to move sandy particles. These results support the observations of active erosion and undermining of the previously installed erosion mitigation works.

Given the observed erosion and the hydraulic modelling results, erosion can be expected to continue along this site in the short medium and long term. As such, it is considered unlikely that turning the proposed area into an unprotected beach like area is sustainable without ongoing maintenance (sand nourishment). Rock armouring in this location is considered necessary to halt erosion and reduce the maintenance costs. Bed shear stress is a function of depth and water surface slope. Given that the water surface slope in this location is very low, depth is the critical factor at the study site. It is therefore likely that terracing may be an achievable sustainable method of incorporating boat launch facilities and “beach like” aesthetics in this location.

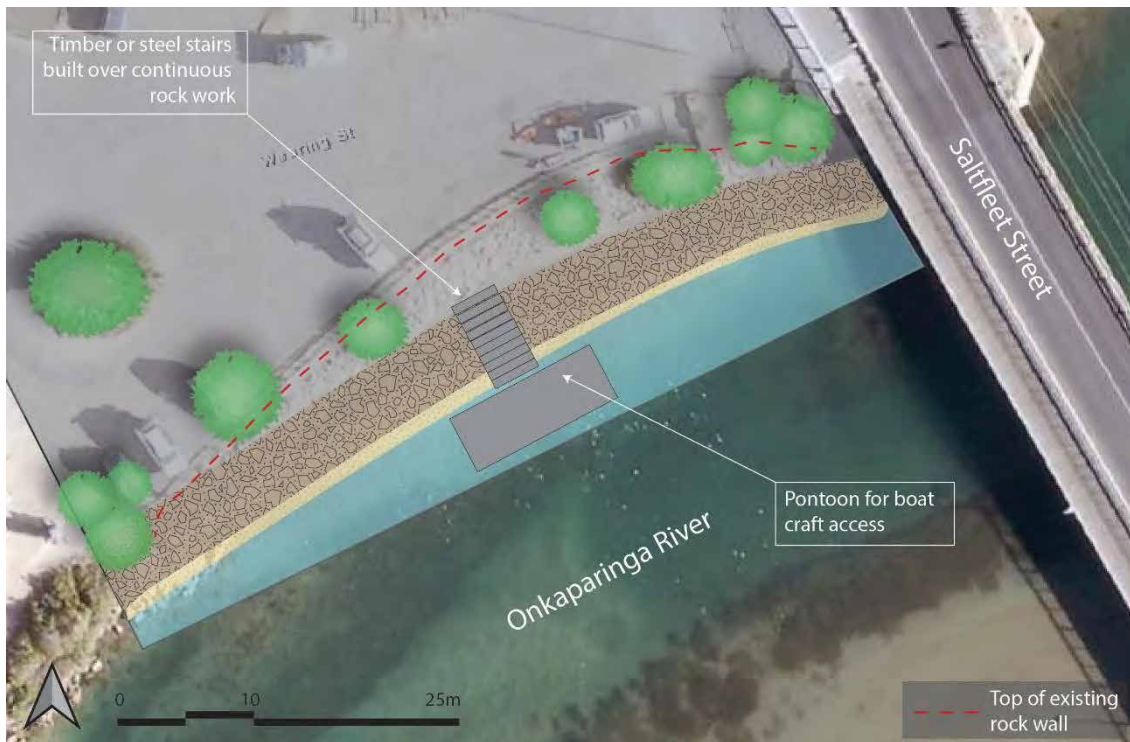
The requirement for a pontoon also would make the logistics for launching craft complicated, particularly given the very heavy usage of the site during the busy summer periods. Hence one of primary objectives for future use of the site would not be met (it would however stabilise the site and minimise ongoing maintenance requirements, and hence was initially included in the assessment process).

**FIGURE 3-4 CONTINUOUS ROCK WALL ALONG THE AFFECTED AREA.**

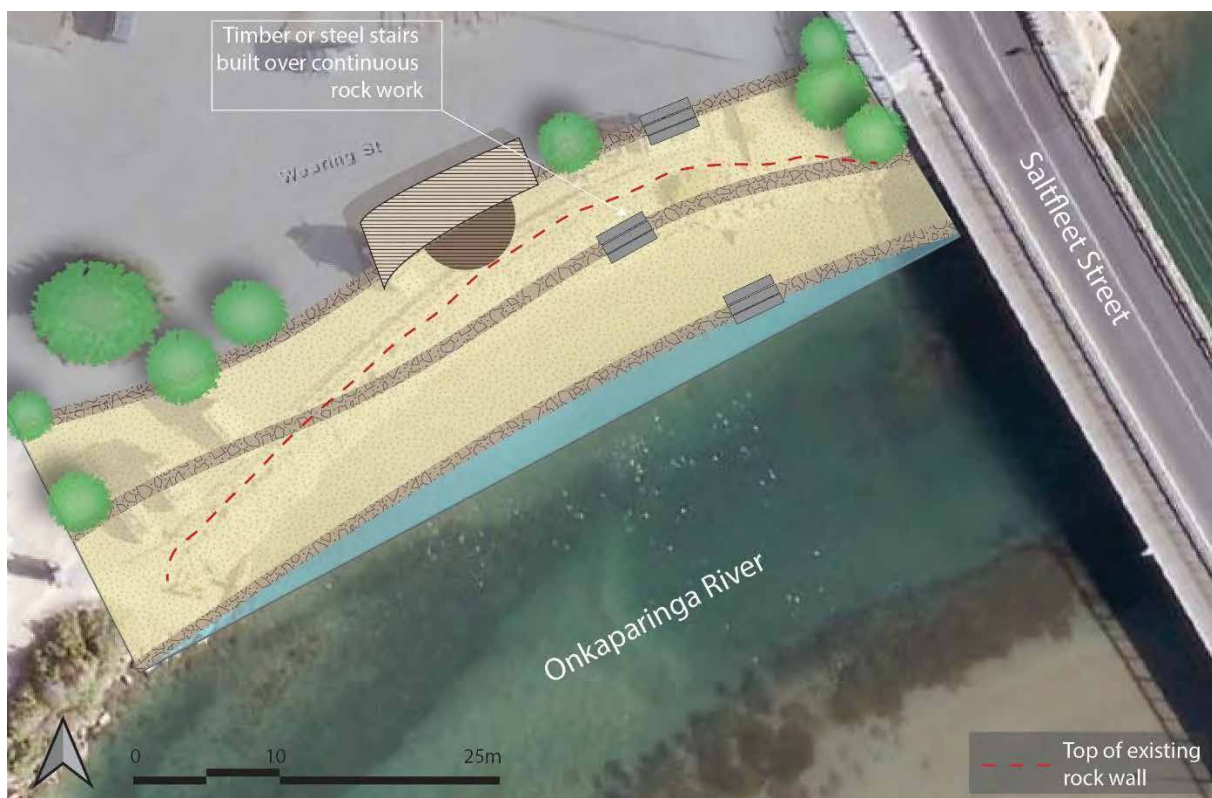
A terraced arrangement may be a balance between the two previous options with stepped beach flats between low lying rock walls (Figure 3-6 and Figure 3-7). If a terraced beach front is appealing to the community over a high rock wall, the following the following recommendations are made regarding the design:

- Each terraced wall behind the front wall should be keyed into at least 0.5 metres below the wall in front.
- Terraced surfaces should have a slight slope equal to approximately 1(h):10(v).
- Public safety should be considered with regards to the height of each terrace wall. This may result in a requirement for stairs to be added over the rock. These should be steel or timber, but not concrete.
- If fill is required behind each rock wall, the fill should be track compacted.
- It is highly likely that some sand will be removed from these surfaces during large events. This will necessitate nourishment efforts from to maintain a beach like aesthetic. This is expected to occur with events larger than 5% AEP.

**FIGURE 3-6 SMALLER STEPPED ROCK WALLS IN A TERRACED ARRANGEMENT.**
