***Witton Bluff Base Trail
Environmental Feasibility and Design
Concept Study***

*July 2005
Reference: J015.01/Rep
FINAL Rev 1*

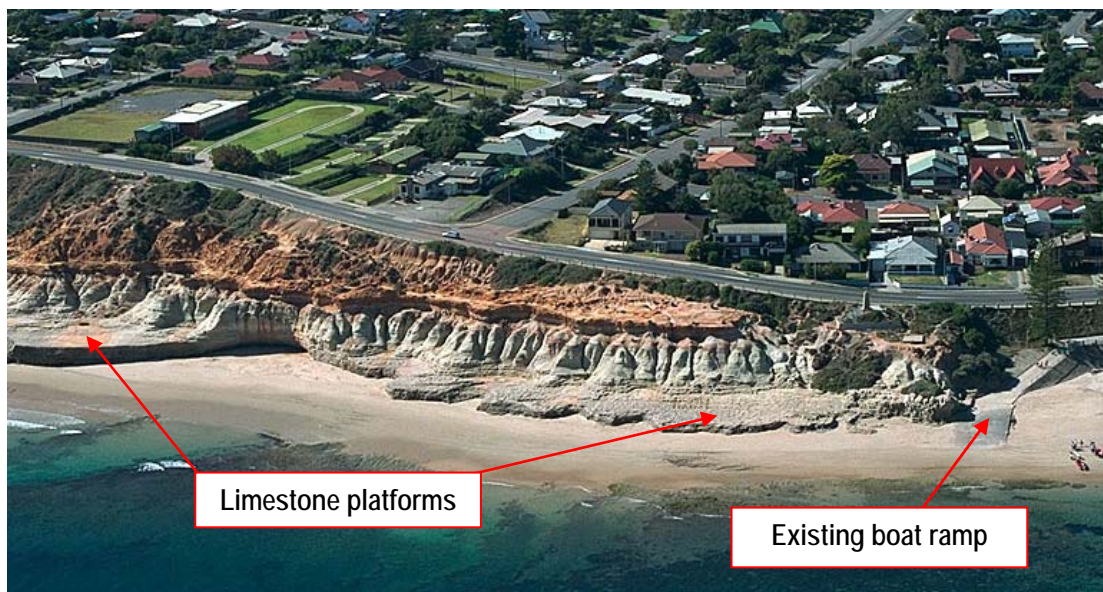
Figure 2 Aerial view of the location of the proposed base trail

Figure 2 illustrates the location of the proposed trail, at the base of the cliffs. The preferred option is to locate the trail on the limestone platform at the base of the cliffs, however it must be noted that this limestone platform is discontinuous; therefore a combination of engineering, planning and environmental factors should be assessed to determine the most practicable trail location.

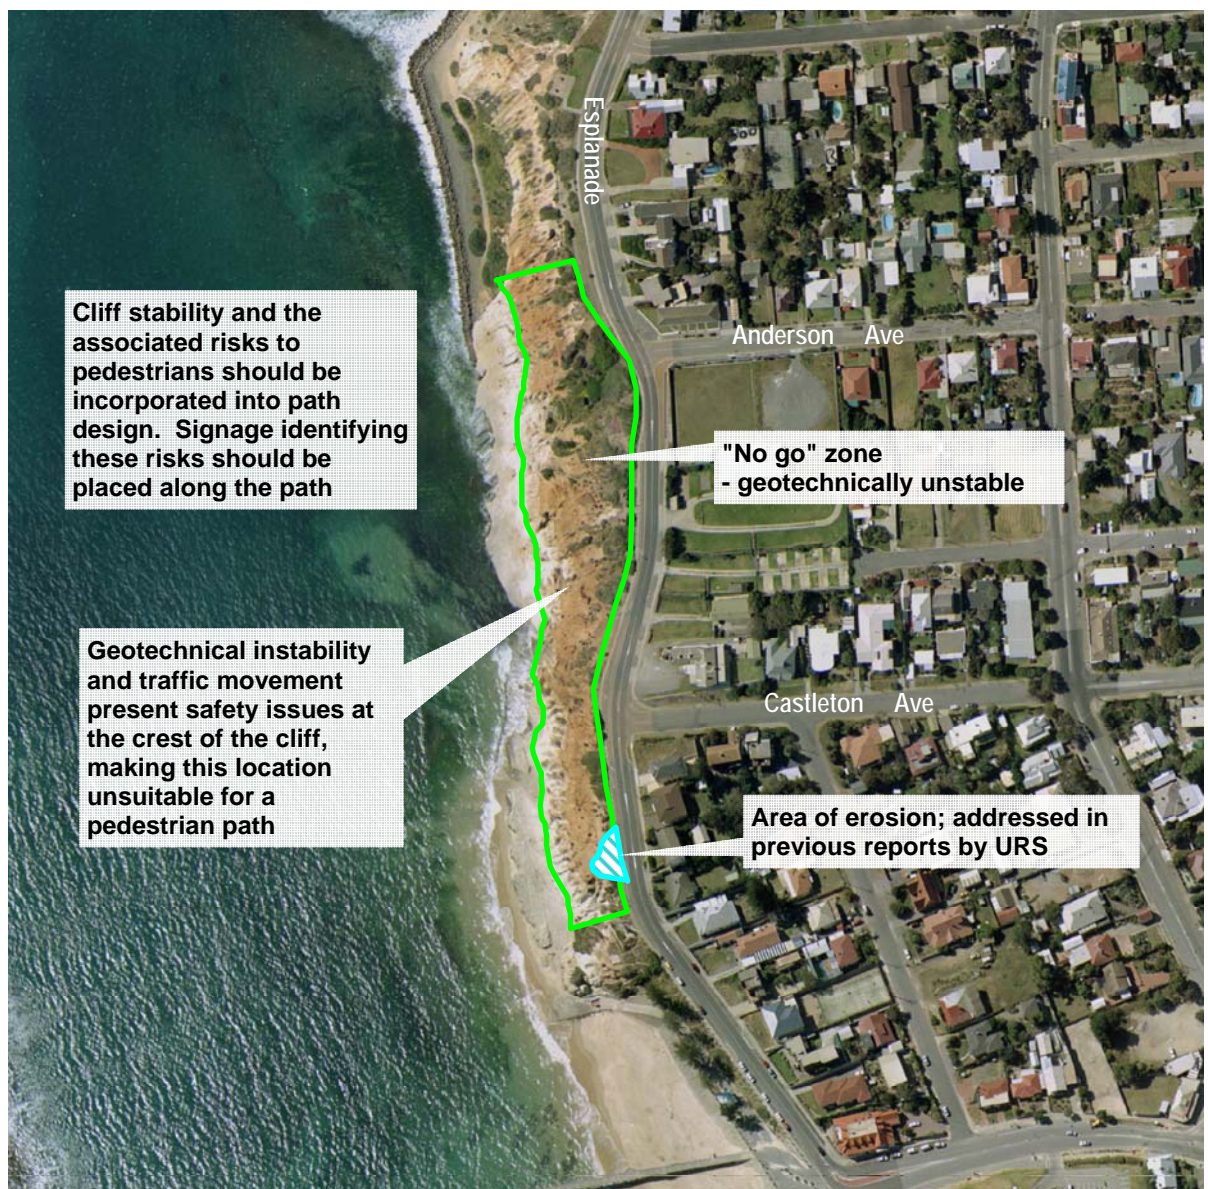
Figure 4 – Geotechnical considerations

- The Witton Bluff Base Trail should run along the top of the limestone base platform, and be aligned with the approximate middle of the limestone base platform width.
- A boardwalk form of path should be adopted rather than a pavement form of path.
- The foregoing outline concept for the Witton Bluff Base Trail should be taken to the next stage of design development and environmental assessment, given the geotechnical feasibility of the path concept that has been demonstrated in the current report.

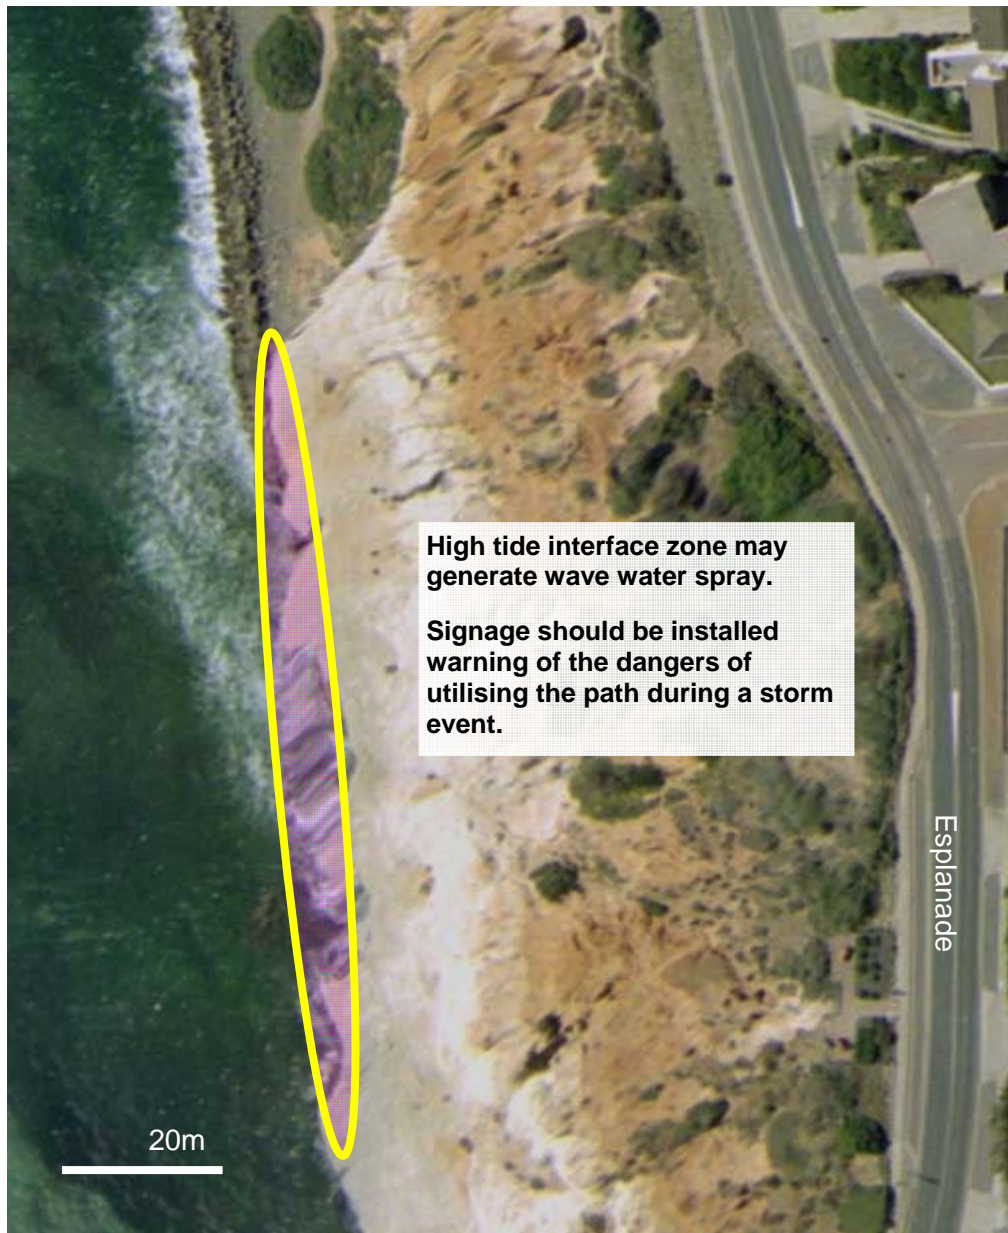
Figure 5 – Marine Interface

Immediately to the north of the site a rock revetment has been constructed to RL 5.0 AHD. This is the level that has been determined by the Coast Protection Board as being the appropriate height for coastal protection works in this location. It was determined following wave run-up damage to some sections of the seawall that had been previously constructed. The damage has since been repaired. Any path constructed on the limestone platforms would need to be at least at RL 5.5 AHD or designed to withstand wave forces.

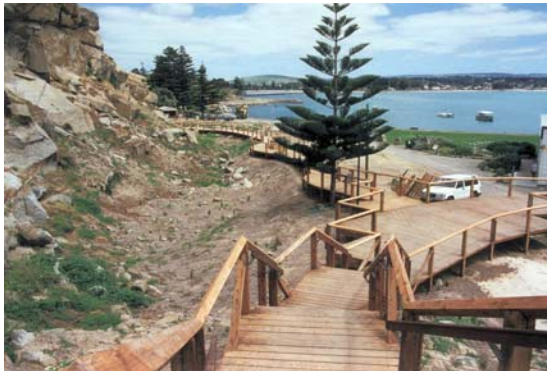
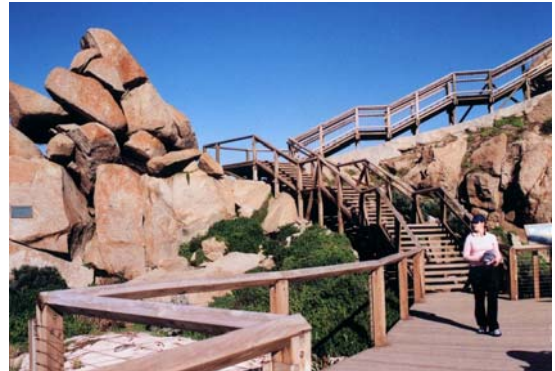
Photos 1 and 2: This type of boardwalk could be adapted to the coastal environment at Witton Bluff.

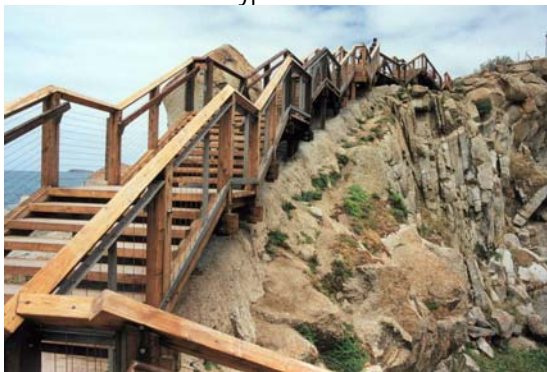
Photos 3 and 4: Stairs can be shaped to the existing environment. The timber compliments the colours and the general surroundings, which is similar to the Witton Bluff environment.

Photos 1, 2, 3 and 4 shows that the colour of the rock at Granite Island is similar in colour to the lower cliffs and rock platform at Witton Bluff.

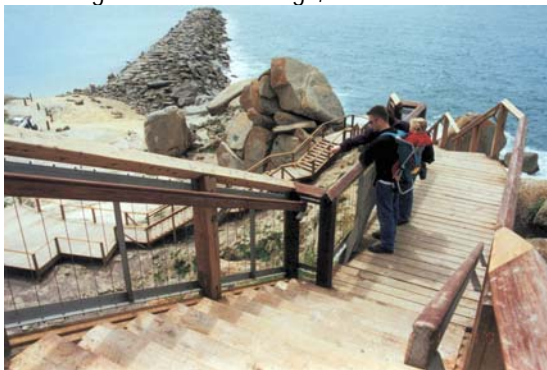
Photos 5 and 6: Added safety measures include steel vertical railings, which should be used in the construction of the Witton Bluff boardwalk for safety purposes.

Vertical railing should be used as opposed to horizontal railing so that children cannot climb over the railing, causing injury. This feature was a key component of the Granite Island boardwalk (refer **Photo 6**). The location of the boardwalk makes this a critical issue. The cost of vertical railing is higher than using horizontal railing; however the safety benefits override the extra project expense.

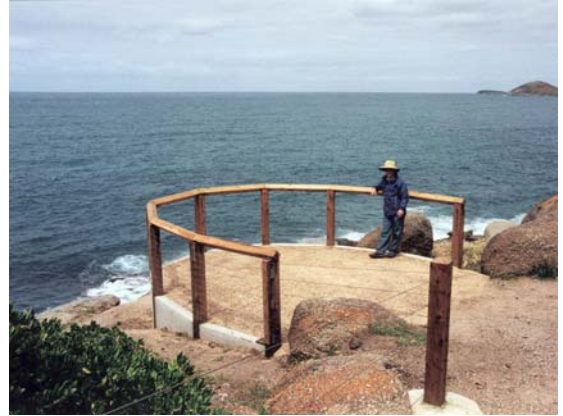
Photo 7: This image was not taken at Granite Island, however seating and viewing areas could be adapted at Witton Bluff similar to as depicted example.

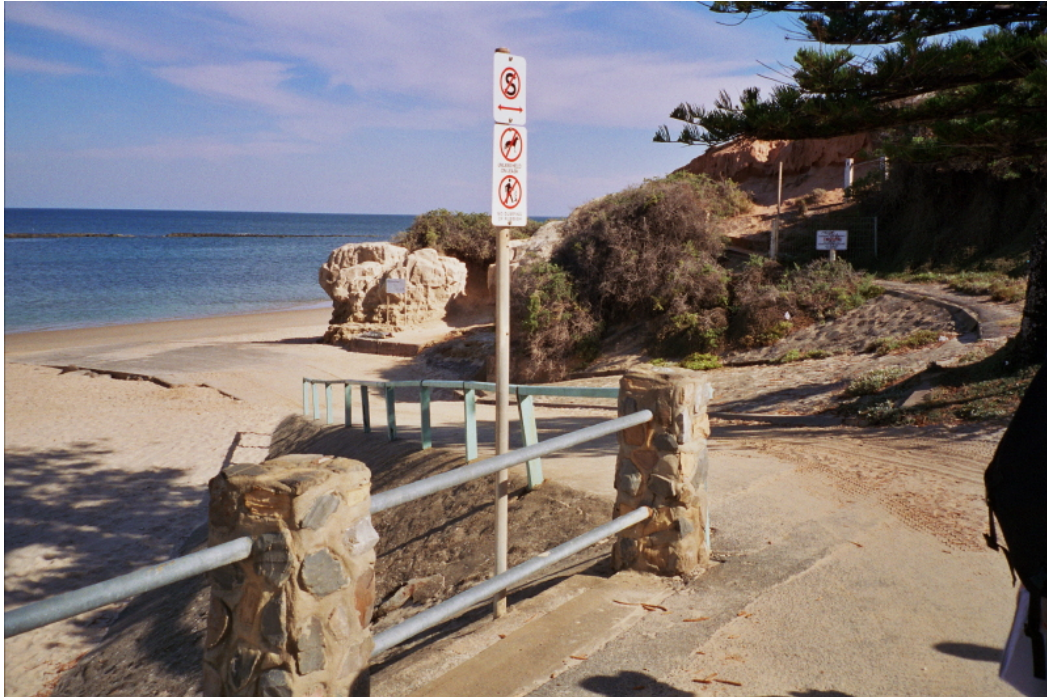
Plate 1 **View of southern end of proposed base trail**

The limestone beds dip to the south at an angle of 2 to 3 degrees. The lower beds form a strong base platform to the weaker rock beds and soil layers above (Plates 3, 22, 24). Wave action creates vertical faces in the lower, stronger limestone beds up to several metres high at beach level (Plates 16, 18, 20) and also erodes caves. In one of the caves located at the northern end of the Witton Bluff Base Trail site (Plates 11-13), a continuous vertical defect with strike 350 degrees outcrops over at least 20 metres (Plate 12). In places it is open up to 50 mm and clean. In other places calcrete fills the defect. In that cave the defect provides a release surface in the roof that could potentially lead to collapse of the cave. Another release surface is provided by the horizontal gap near the top of this cave that extends up to 6 m inward from the seaward edge of the limestone platform (Plate 13). Other overhangs in the limestone are forming and may collapse, including one that forms a small limestone point near the boat ramp (Plates 1 and 2) and another a little south of the cave shown in Plates 11-13 (Plates 14 and 15).

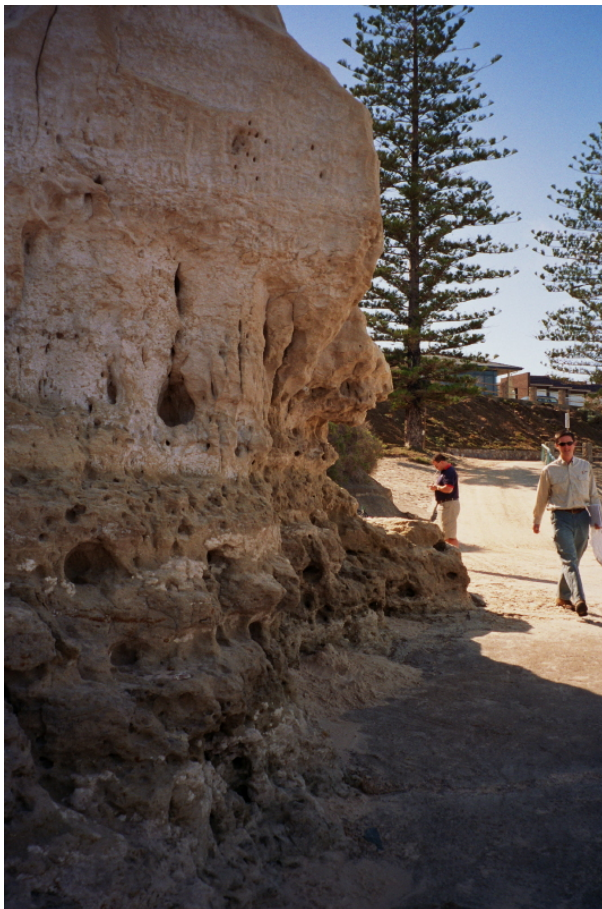
Plate 2 **View of overhang at the point near southern end of proposed base trail**

1. Rock falls from the limestone platform at the beach. Three areas (one cave and two blocks) were observed that will fall at some time in the future. The falls will be up to 5 m³ in size. Currently, people sit under these caves and overhangs. The hazard impact is on public safety only. If these overhangs are removed then this hazard can be downgraded.

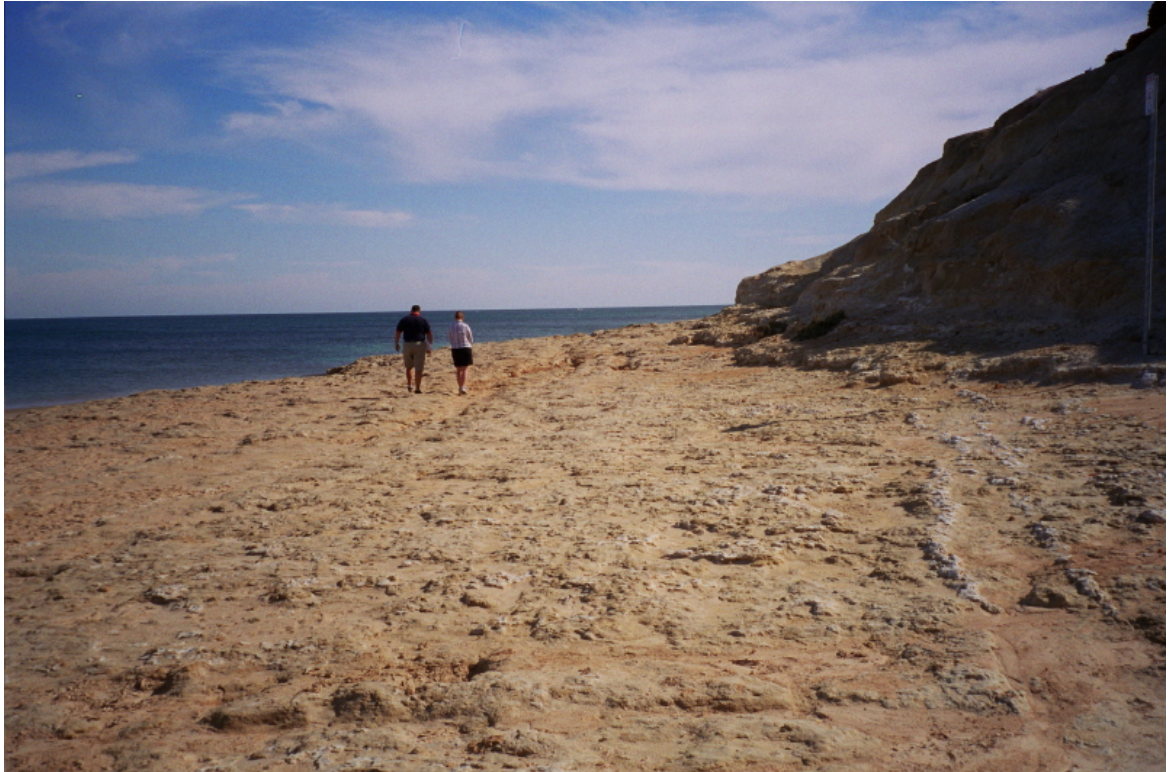
Plate 3 **Looking north along southern limestone base platform that is present over southern third of project site**

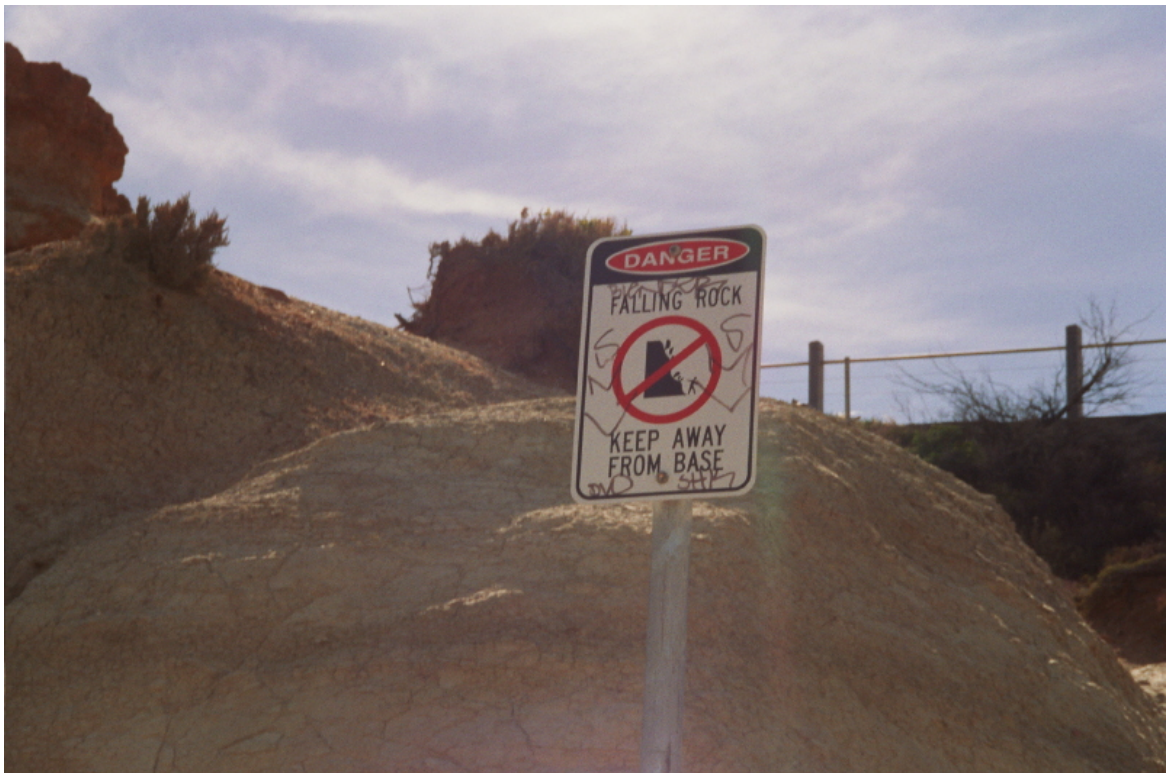
Plate 4 **Geotechnical hazard warning for weak soil and limestone above southern limestone base platform near monument**

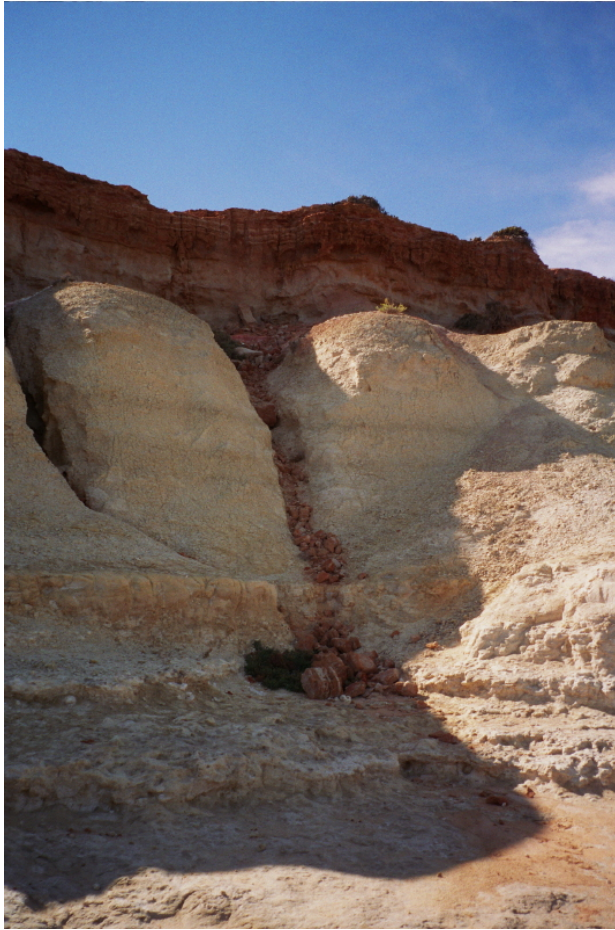
Plate 5 Gully erosion and minor rock falls in weaker limestone above southern limestone base platform

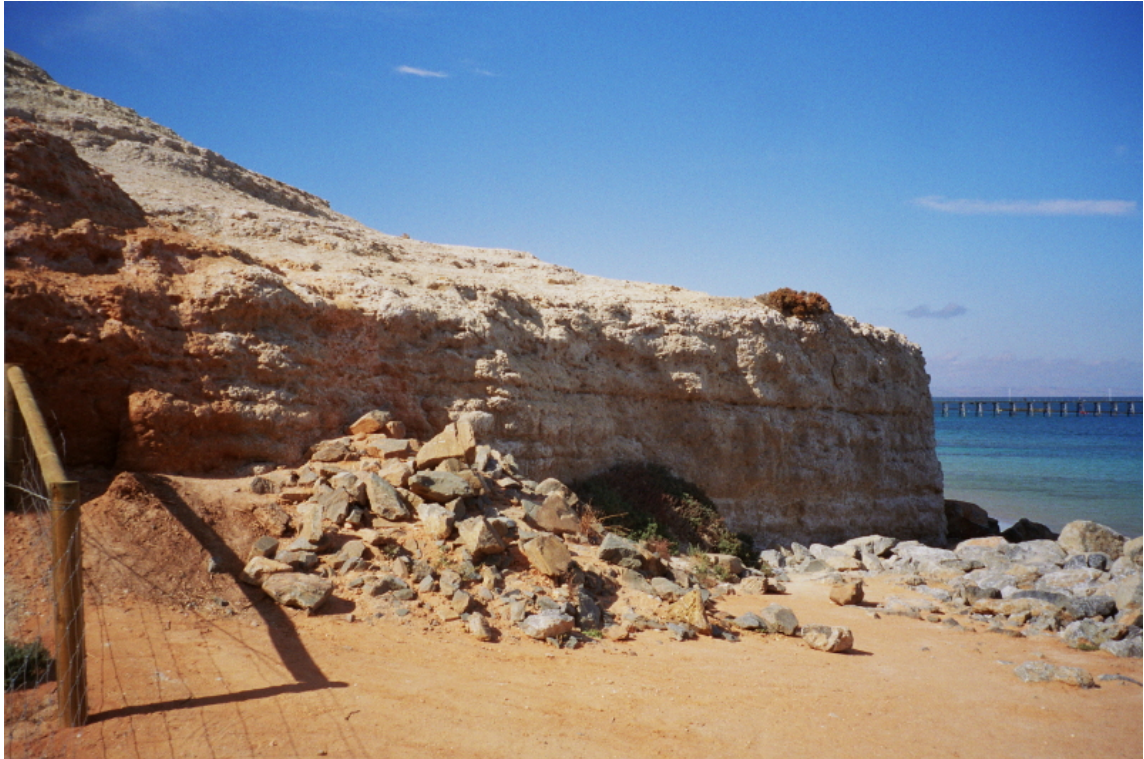
Plate 7 **Looking south at end of existing base trail at Witton Bluff and northern end of proposed continuation of base trail**

In the northern quarter of Area A (that part of Area A beyond the northern limit of the Witton Bluff Base Trail project site), a rock revetment has been placed where it appears the slope had been undercut to form a small bay (Plates 7 and 8). Rock fill was also placed behind the revetment to fill in this small bay

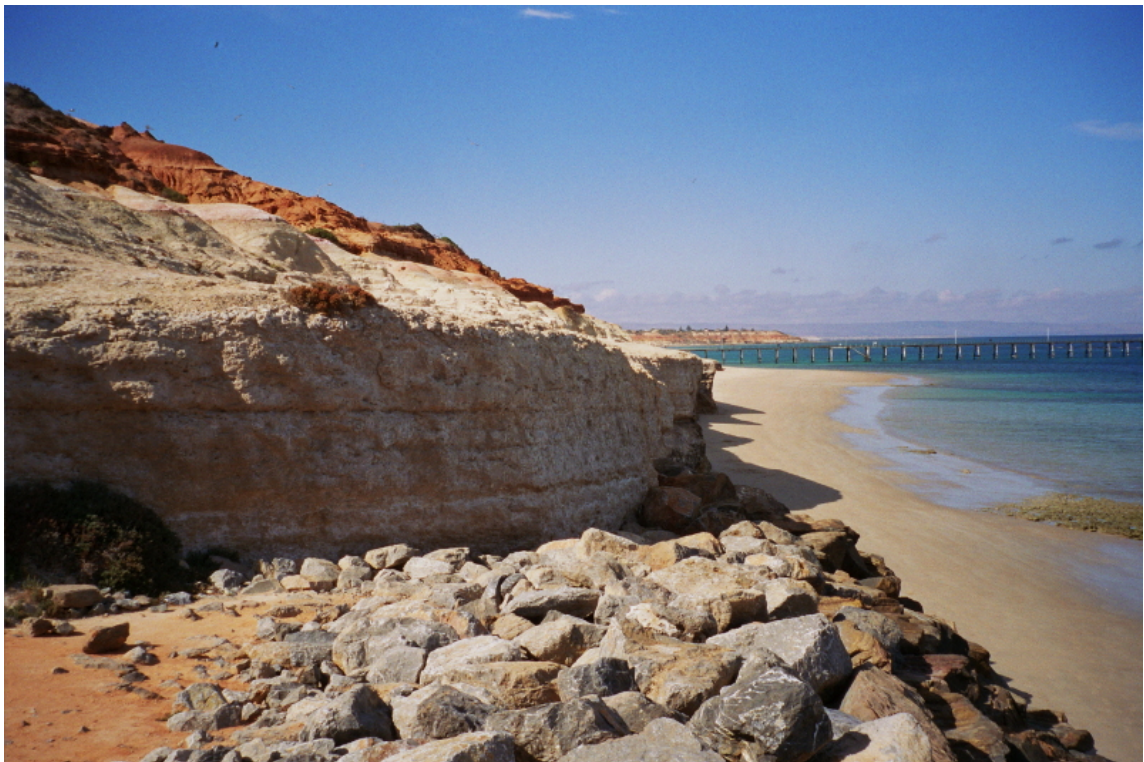
Plate 8 **Southern end of rock armoured slope protecting existing base trail at Witton Bluff, and commencement of limestone base platform beyond, that is present over northern half of project site**

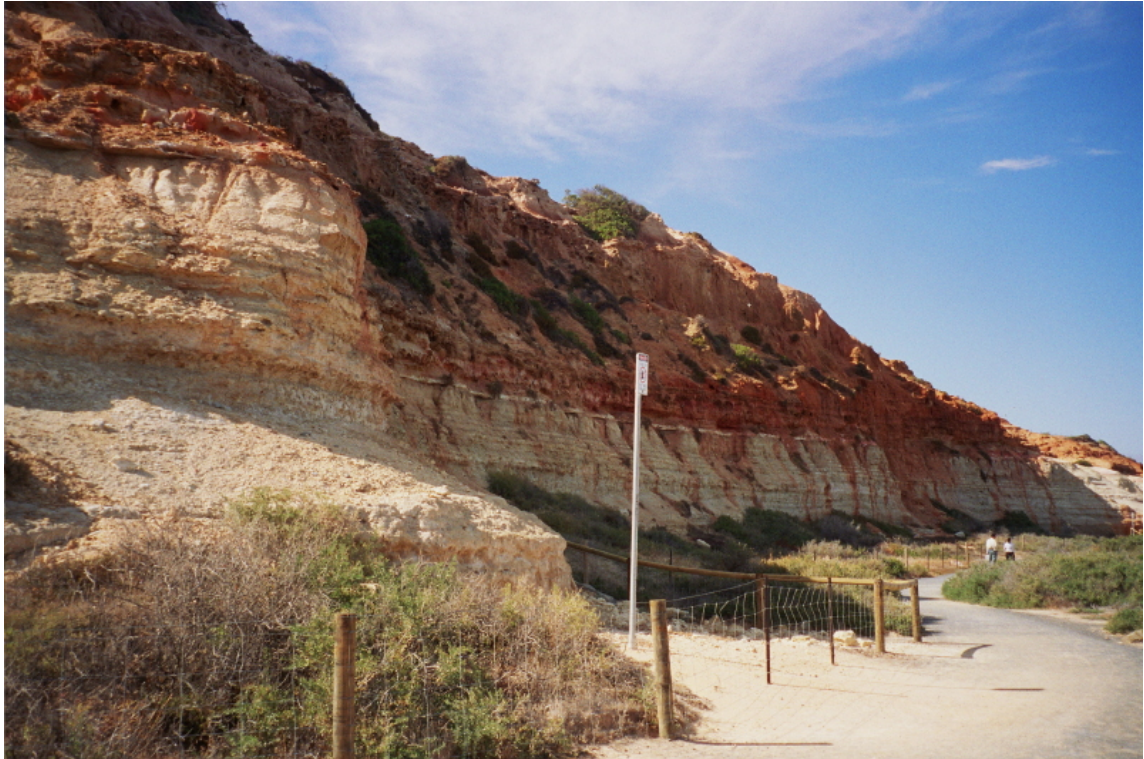
Plate 9 **Looking south from the point at Witton Bluff, along existing base trail north of project site**

(Plates 6 and 9). There is a near vertical cliff behind the revetment up to approximately 20 metres high (Plates 6, 9 and 10). Minor rock falls are noted from this cliff (Plates 6, 9 and 10).

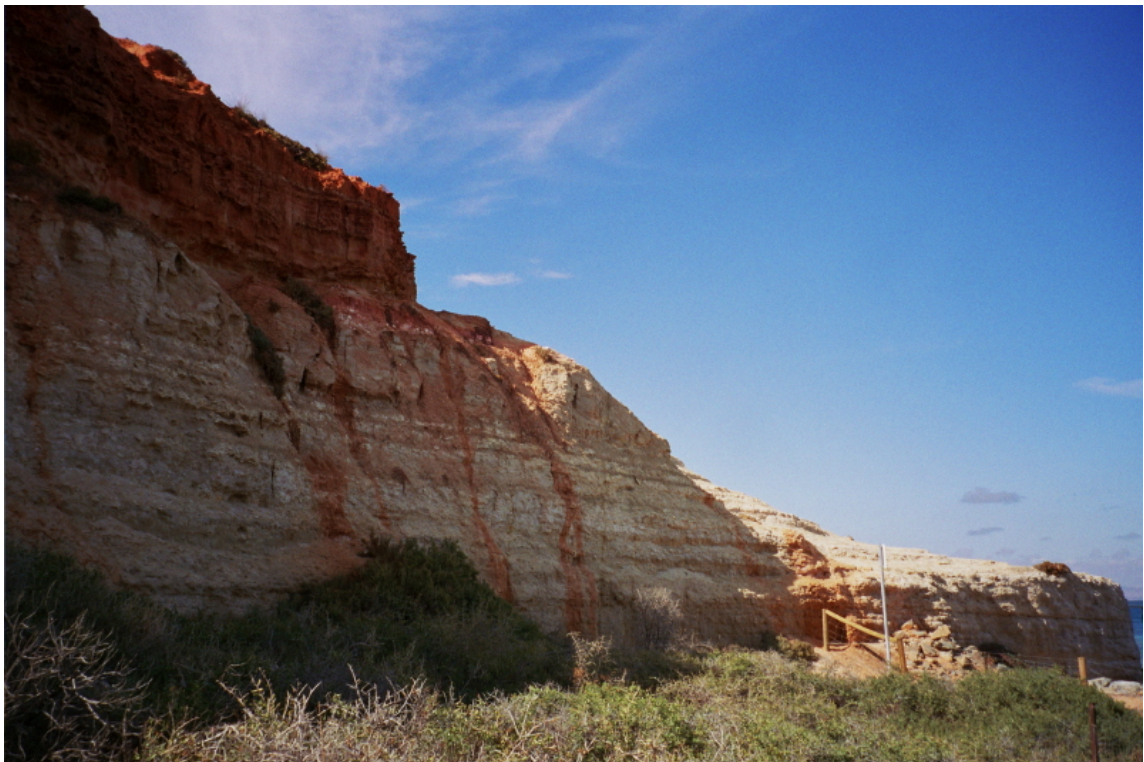
Plate 10 **Erosion gullying and minor rock falls in cliff face above existing base trail at Witton Bluff, north of project site**

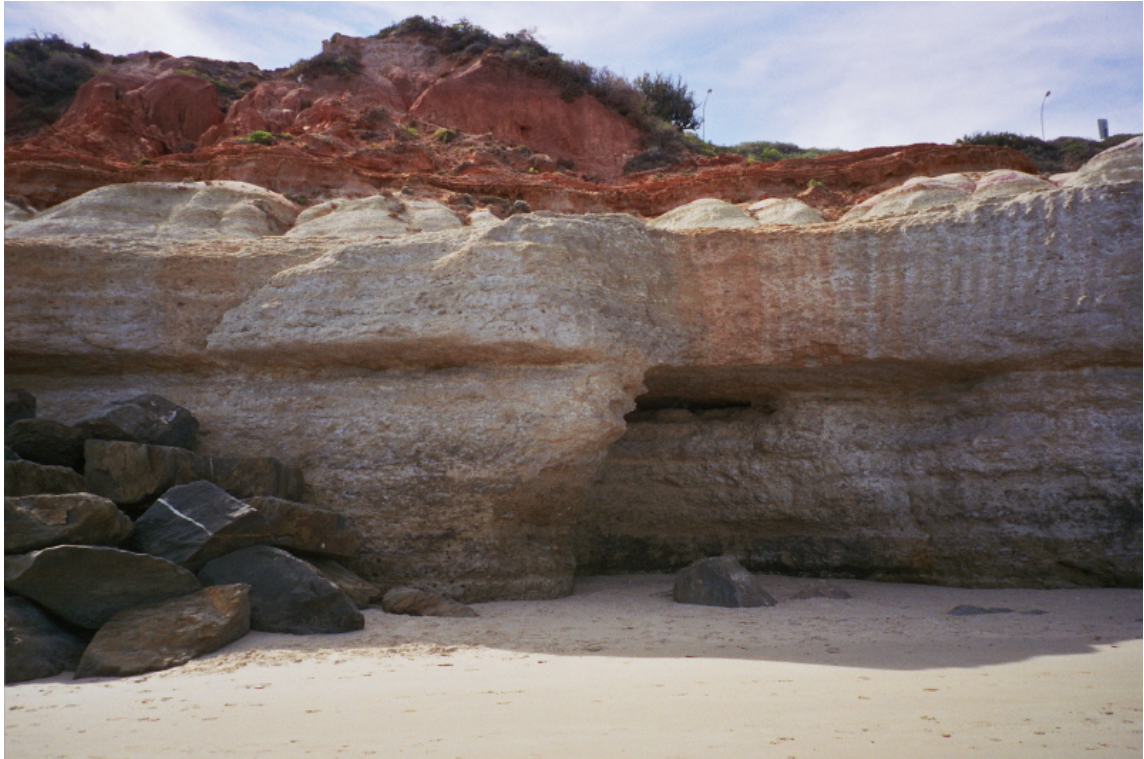
Plate 11 **Cave in northern limestone base platform at northern end of project site**

At the seaward edge of the platform, there is a risk of collapse of the limestone at a number of locations where caves and overhangs have developed. Although cave and overhang development is a slow process, when collapse does eventually occur failure is rapid and without prior warning. This poses a risk to the path infrastructure and path users.

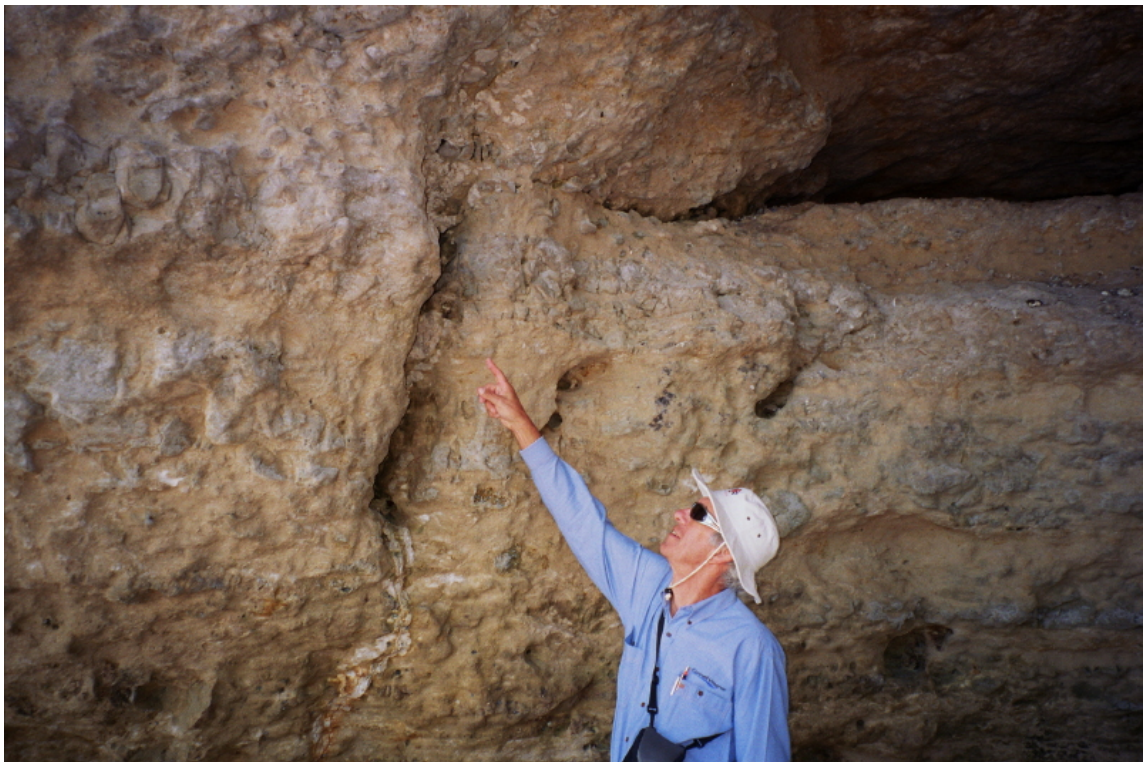
Plate 12 **Partly infilled vertical defect providing release surface in the cave from Plate 11**

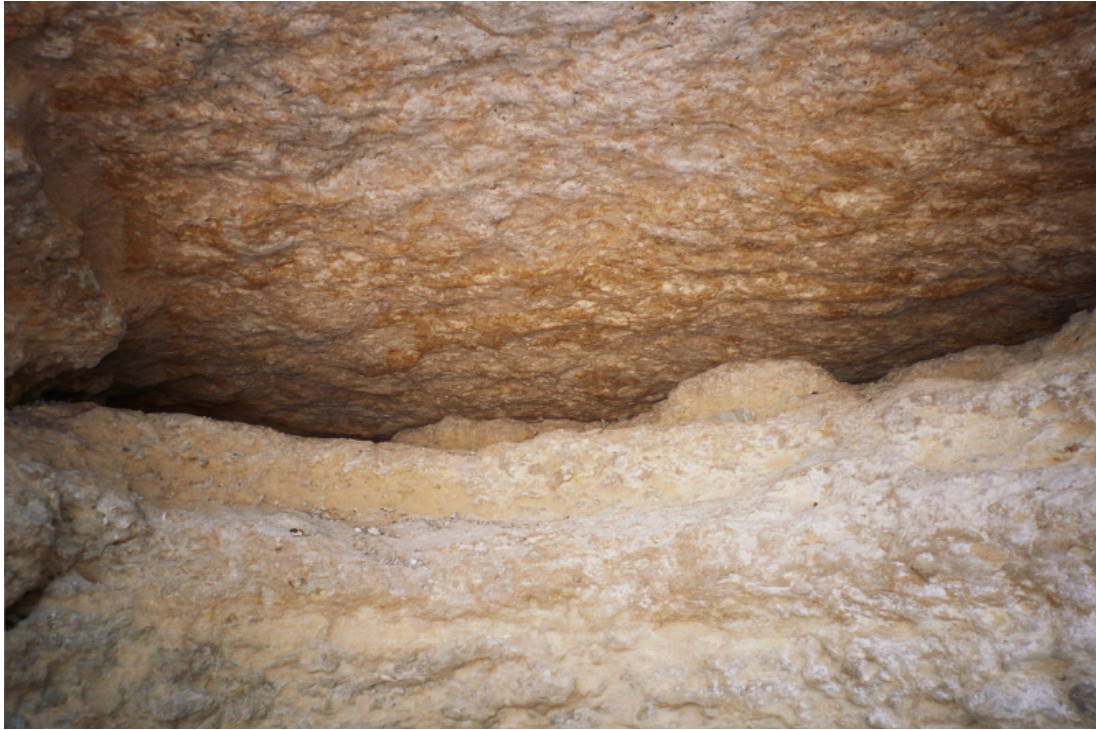
Plate 13 **Deep, thin, eroded horizontal space near top of cave from Plate 11**

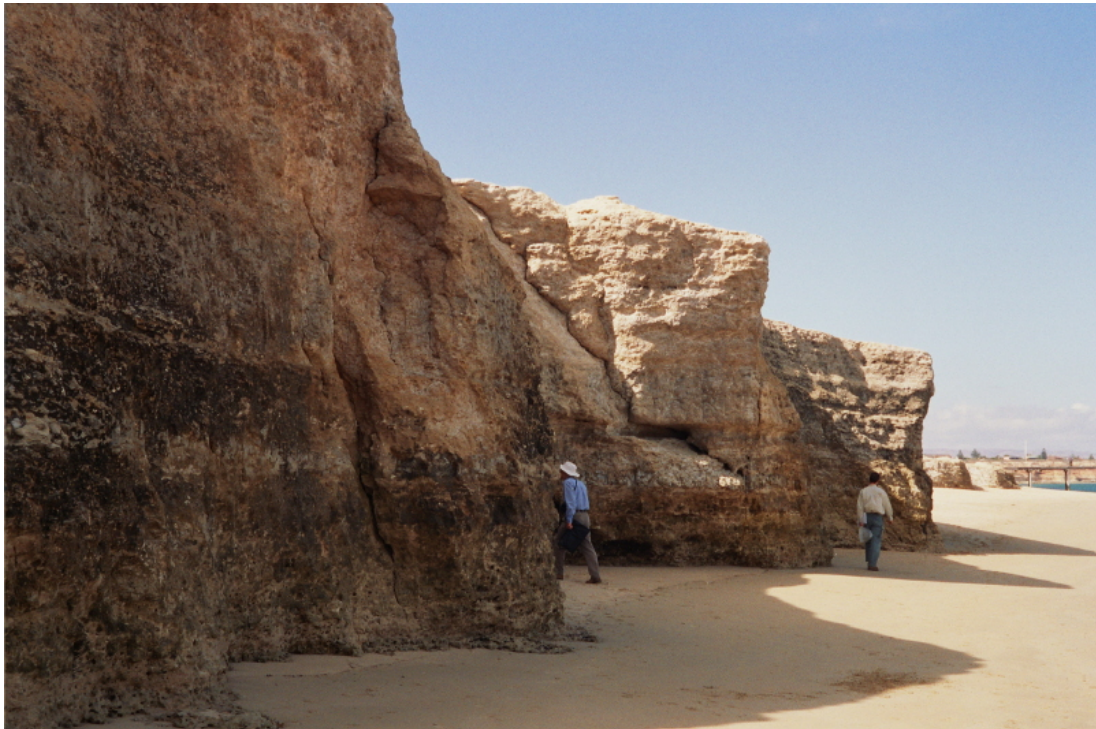
Plate 14 **View of limestone blocks in northern limestone base platform, with sub-vertical defects providing potential release surfaces**

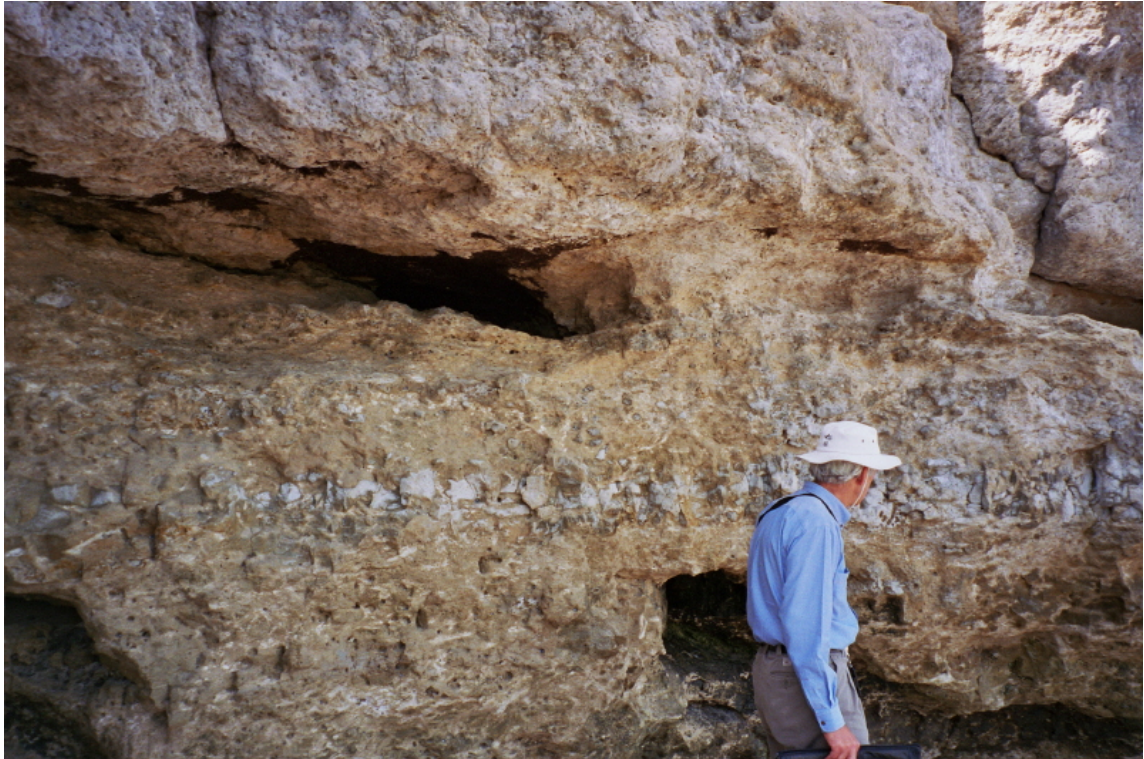
Plate 15 **Defects and voids in limestone blocks from Plate 14**

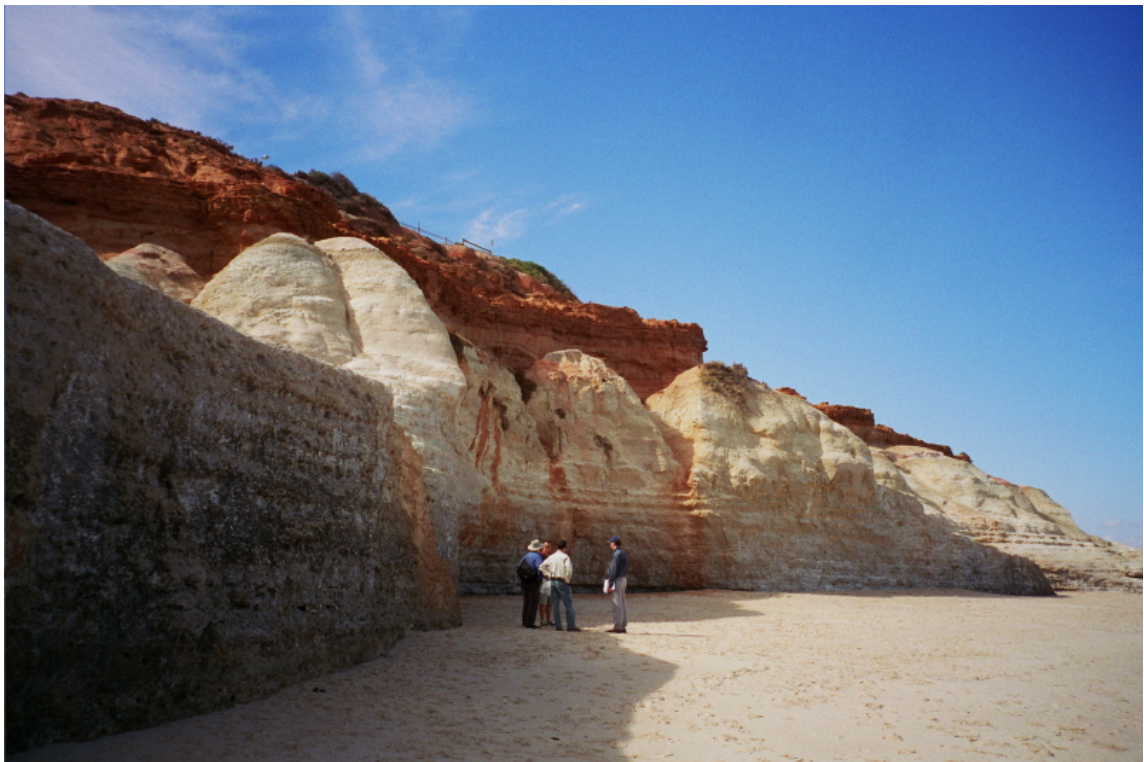
Plate 16 **Looking south at local embayment where limestone base platform has been eroded away by wave action**

There are several locations along the length of the site where appropriate buffer distances will not be able to be met. The most obvious example of this is over the width of the embayment feature north of Castleton Avenue, where the limestone platform has been completely eroded by wave action. In order to provide a link between the northern limestone platform and the southern limestone platform, a boardwalk form of path acting as a bridge will be necessary over the width of the embayment, supported by piles driven into the beach below. Alternatively, a fill embankment founded on the beach and protected by a rock revetment could provide the link between the northern and southern platforms. Another location where the buffer distances cannot be achieved is at the large gully feature in the limestone platform south of Castleton Avenue. This would require infilling with rock to support a pavement path, or suspension of a boardwalk path over the width of the gully, with the boardwalk supported by driven piles founded on the rock underlying the beach sand.

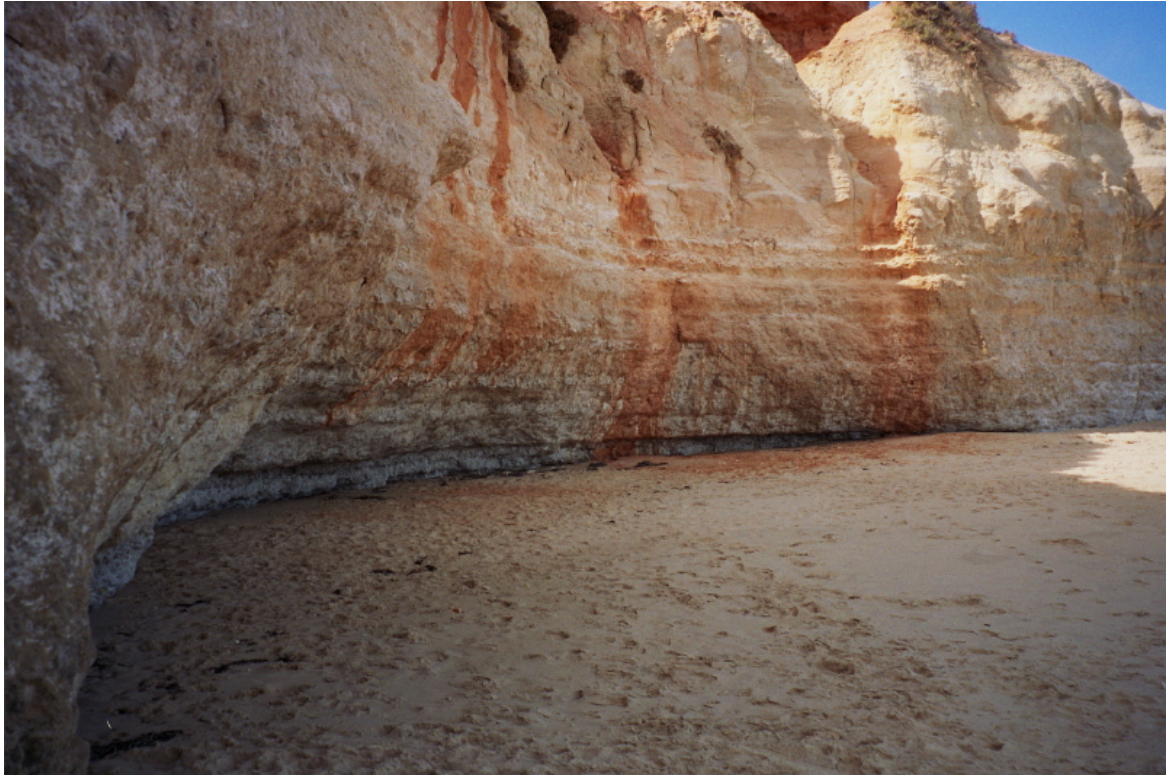
Plate 17 **Cave/overhang formation in limestone at base of embayment**

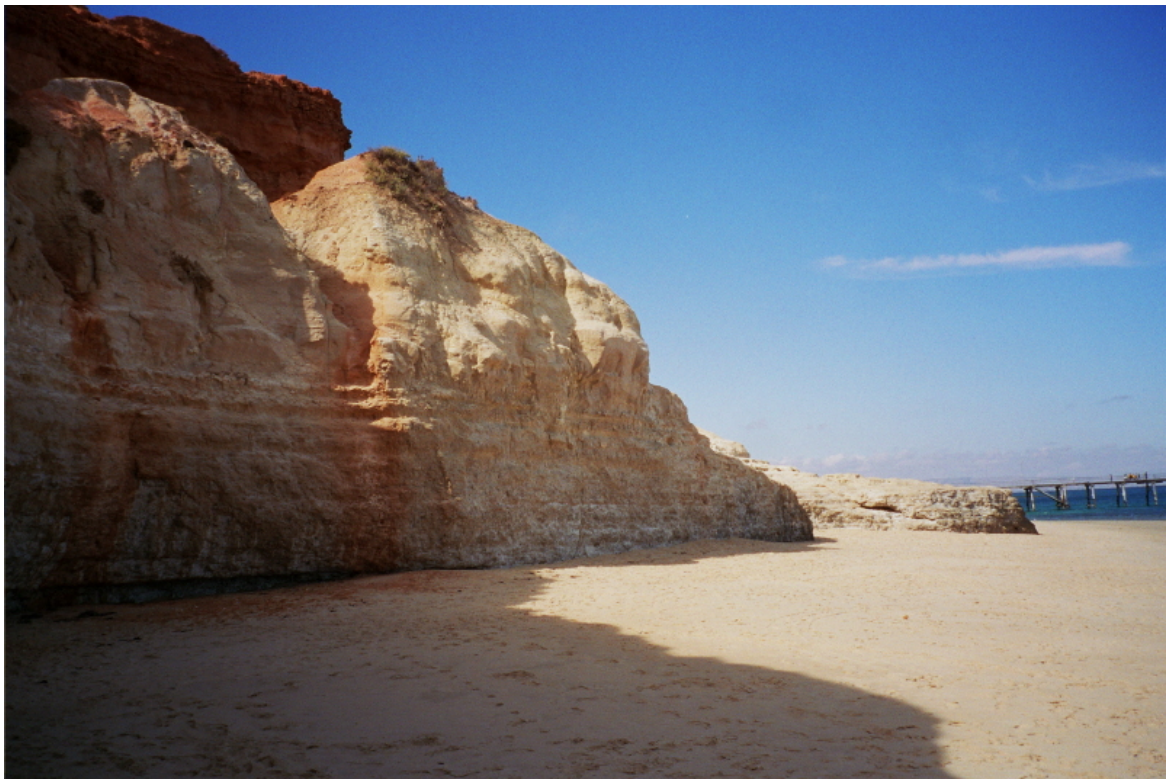
Plate 18 **Looking towards start of southern limestone base platform beyond southern extent of embayment**

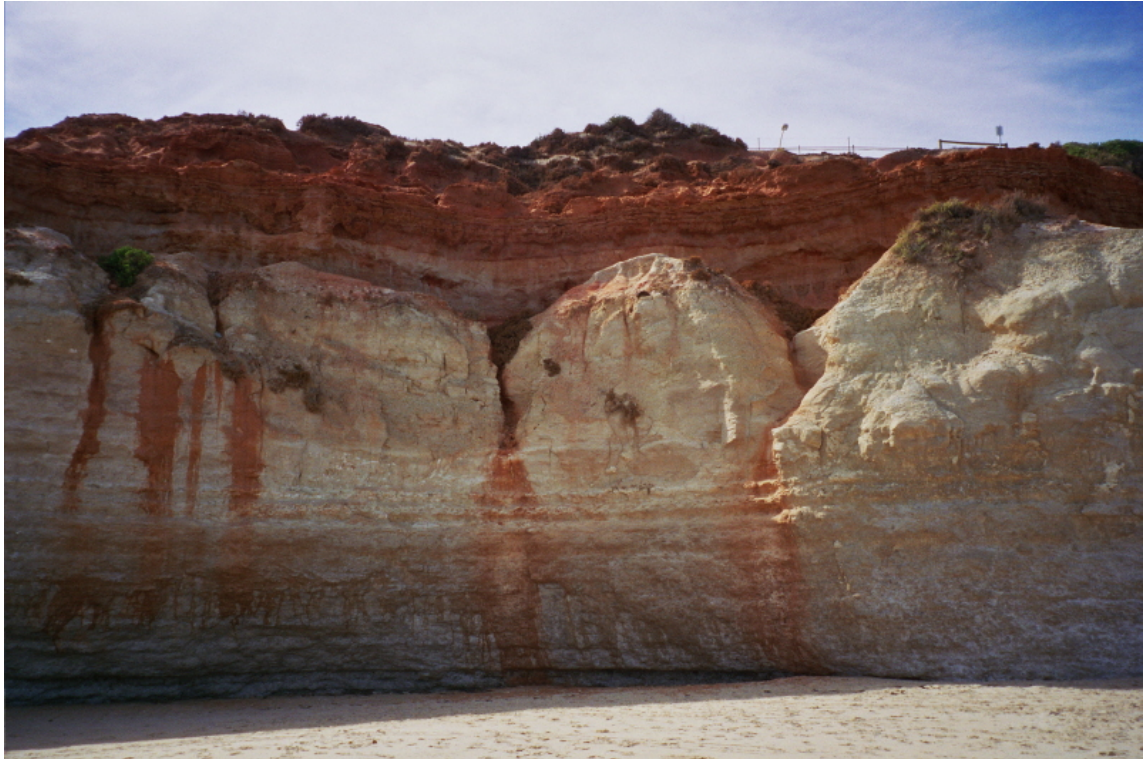
Plate 19 Erosion gullying in softer limestone above base of embayment

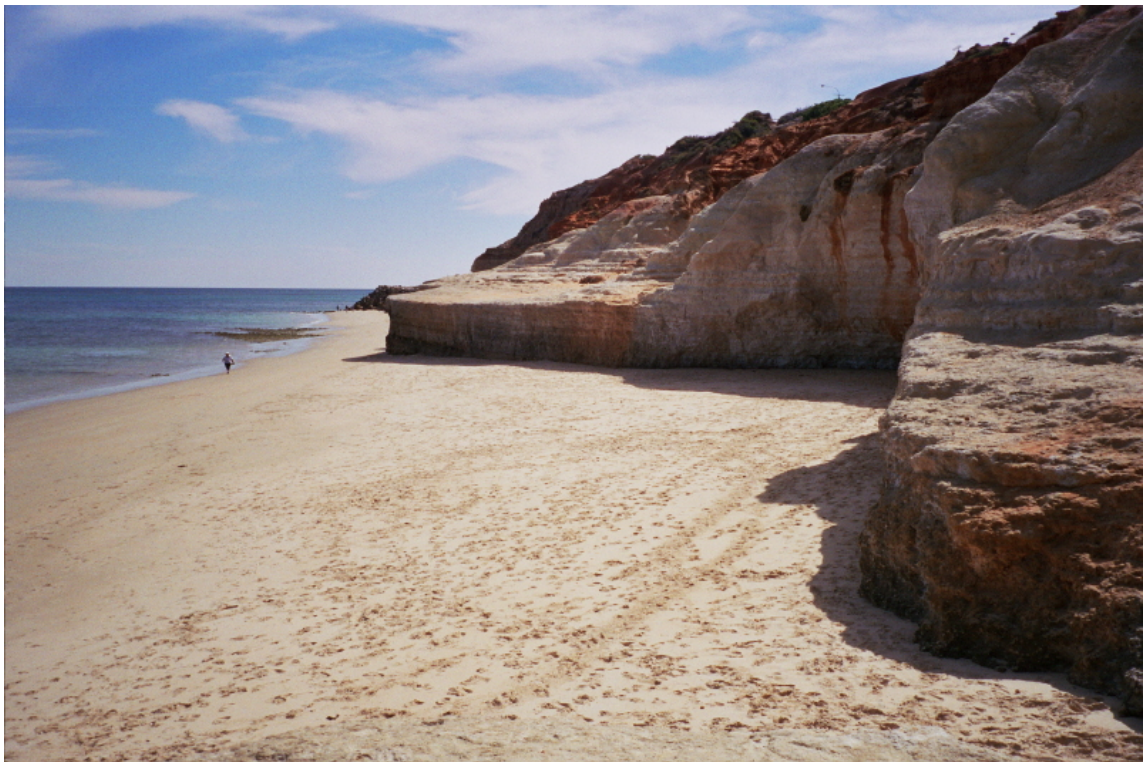
Plate 20 Looking from end of southern limestone base platform at southern edge of embayment, to start of northern limestone base platform beyond northern extent of embayment
