***Witton Bluff Base Trail
Environmental Feasibility and Design
Concept Study***

*July 2005
Reference: J015.01/Rep
FINAL Rev 1*

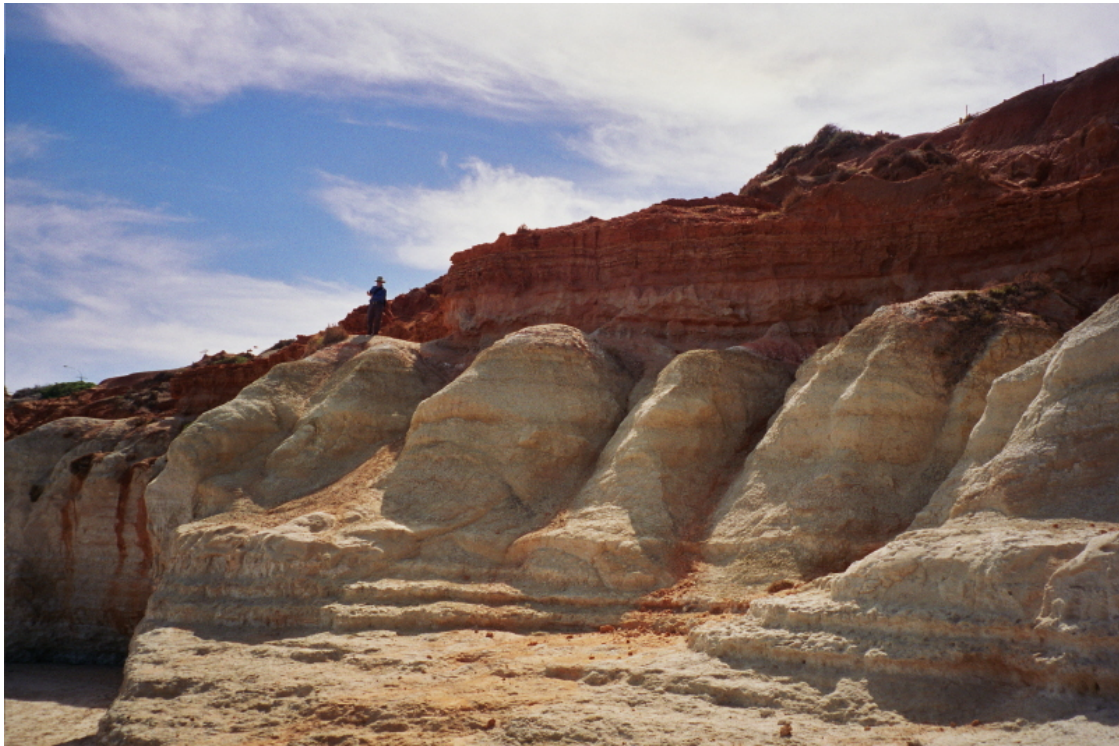
Plate 21 **Gully erosion in softer limestone above southern limestone base platform south of embayment**

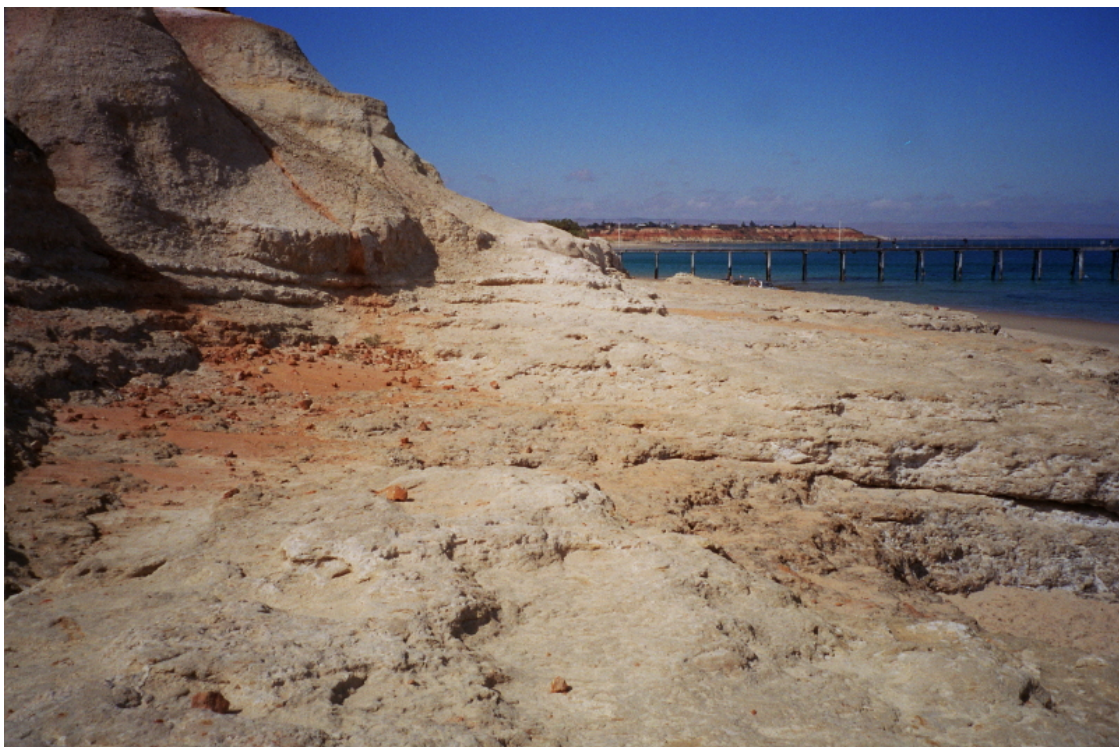
Plate 22 **Looking south along southern limestone base platform to south of embayment**

The limestone beds dip to the south at an angle of 2 to 3 degrees. The lower beds form a strong base platform to the weaker rock beds and soil layers above (Plates 3, 22, 24). Wave action creates vertical faces in the lower, stronger limestone beds up to several metres high at beach level (Plates 16, 18, 20) and also erodes caves. In one of the caves located at the northern end of the Witton Bluff Base Trail site (Plates 11-13), a continuous vertical defect with strike 350 degrees outcrops over at least 20 metres (Plate 12). In places it is open up to 50 mm and clean. In other places calcrete fills the defect. In that cave the defect provides a release surface in the roof that could potentially lead to collapse of the cave. Another release surface is provided by the horizontal gap near the top of this cave that extends up to 6 m inward from the seaward edge of the limestone platform (Plate 13). Other overhangs in the limestone are forming and may collapse, including one that forms a small limestone point near the boat ramp (Plates 1 and 2) and another a little south of the cave shown in Plates 11-13 (Plates 14 and 15).

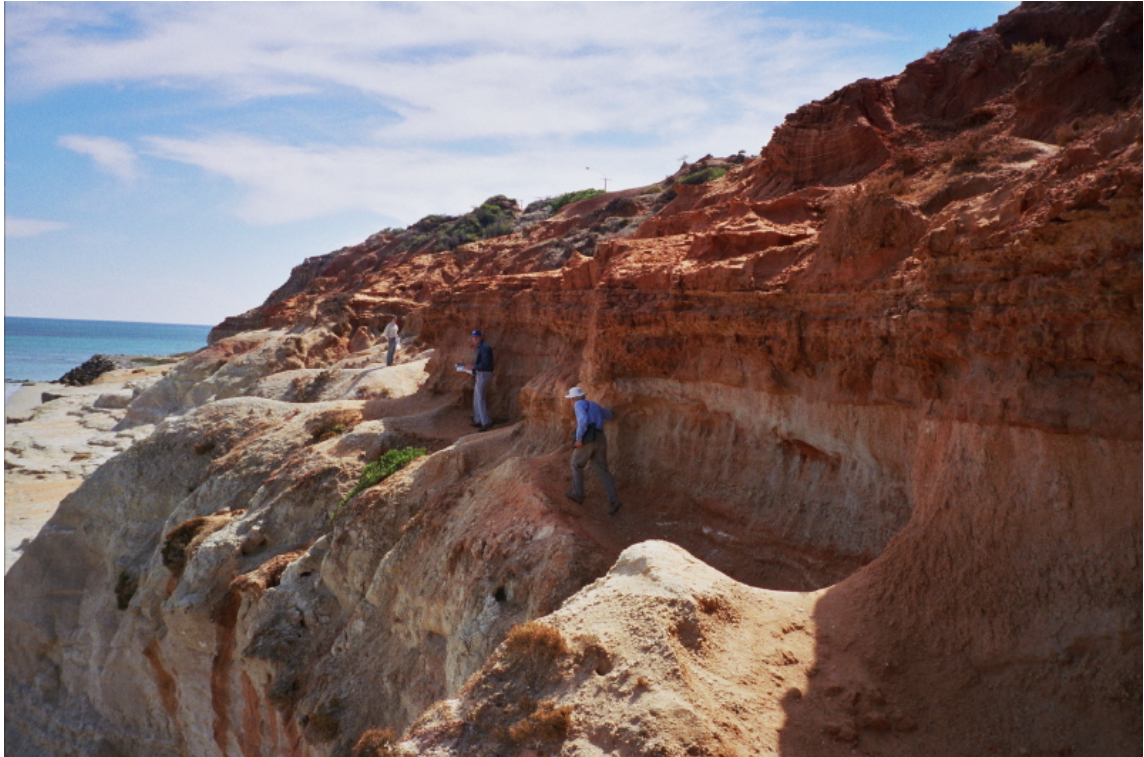
Plate 23 **Informal walking path along top of weak limestone above embayment**

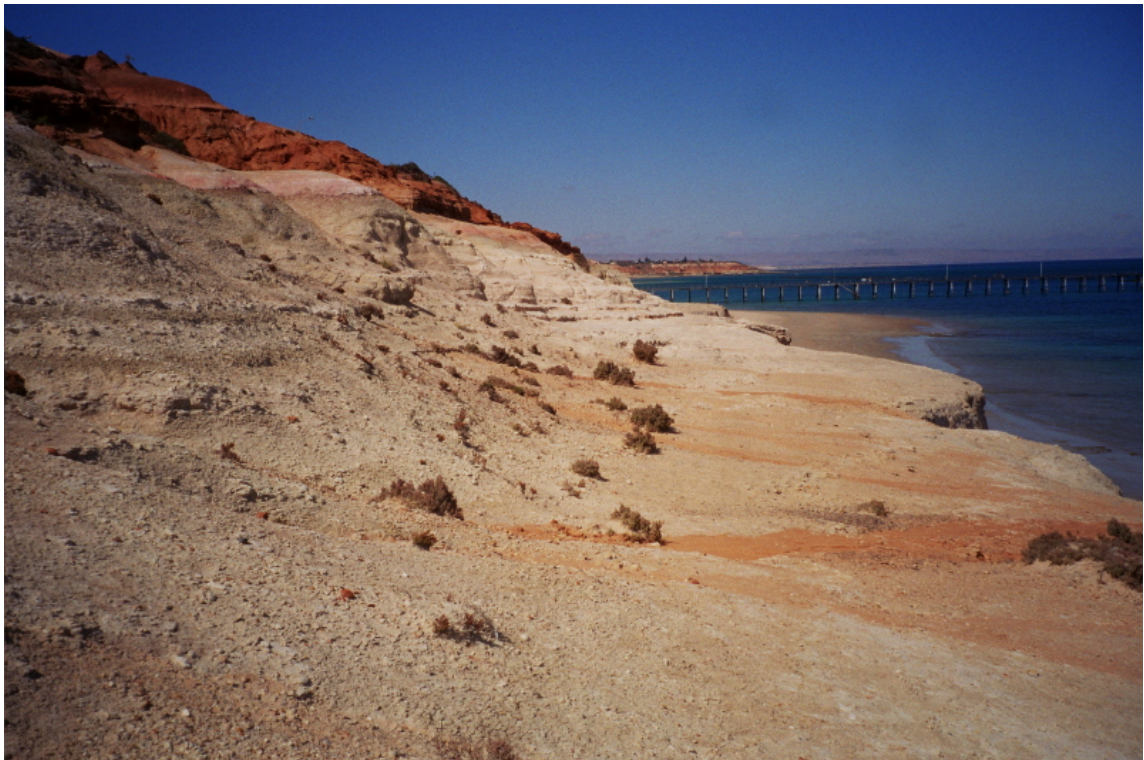
Plate 24 **View from near northern end of proposed base trail, looking south along top of northern limestone base platform that is present over northern half of site**

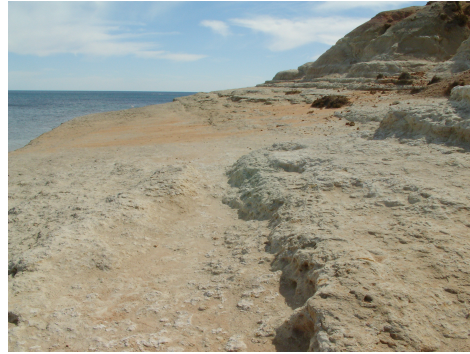
View looking north along the limestone platform, the location of the proposed trail

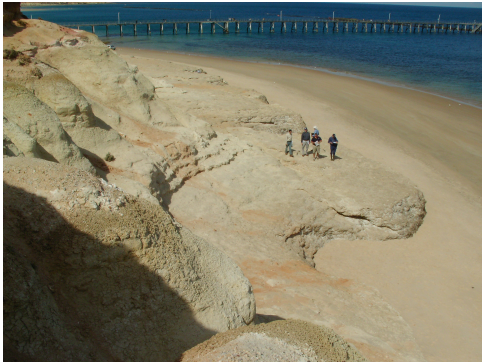
View looking south southwest. The path is proposed to be located along the platform in the foreground (where people are standing). Port Noarlunga jetty is visible in the background of the photograph.

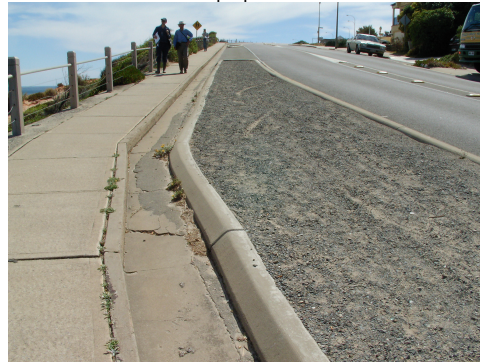
View looking north along the Esplanade. A footpath exists on the western edge of the road, however this path is considered unsafe for foot and bicycle traffic.

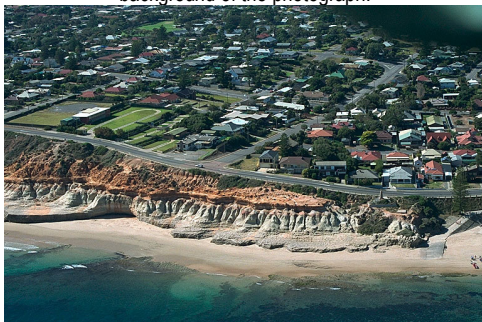
View looking west northwest. The location of the proposed trail is on the identified limestone platforms.

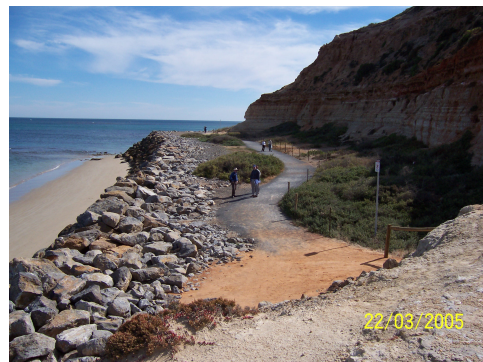
View looking north at the northern extent of the proposed path. Currently the existing dolomite path terminates where at its southern end at the location of a limestone platform.

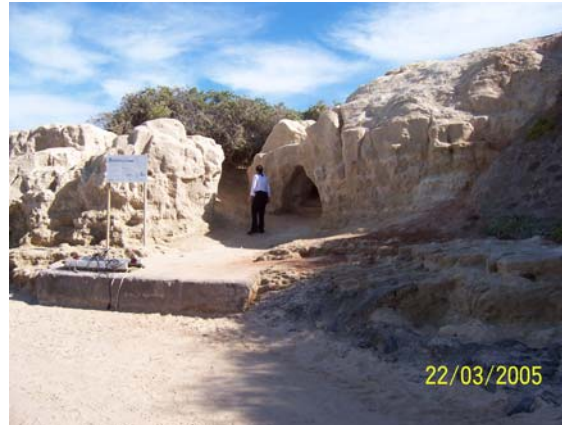
Man made cave underneath southern bluff

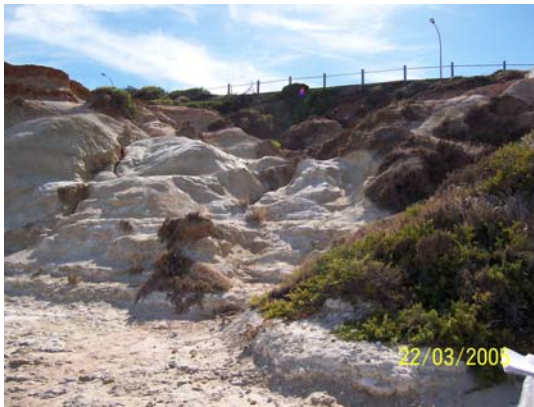
Site of cliff slump under investigation by URS

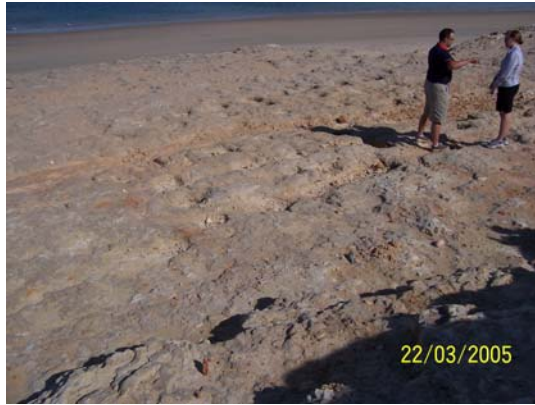
Site of former platform shelter (note hole pattern)

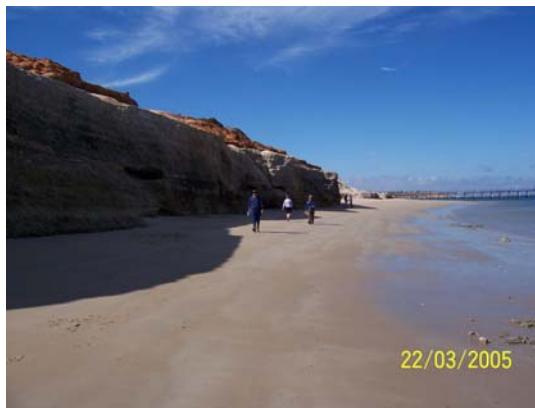
Northern Platform face (low tide)

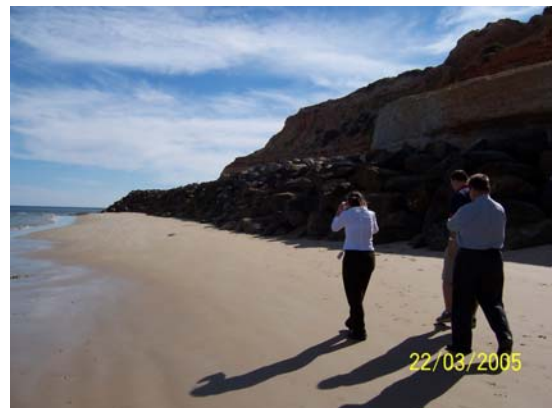
End of northern platform above revetment

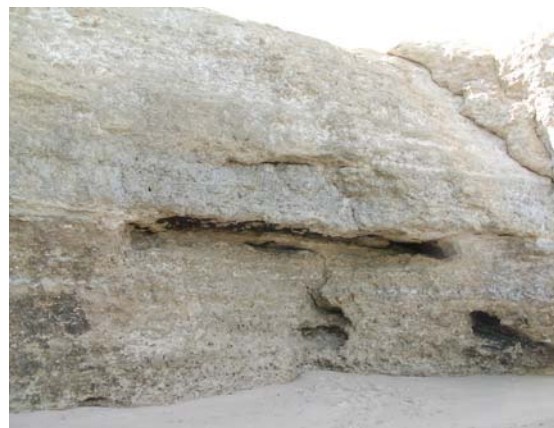
Cliff overhang (Face in the cliff)
