WALLBRIDGE GILBERT  
AZTEC

Project No. WGA201245

## WITTON BLUFF BASE TRAIL – PORT NOARLUNGA BEACH GEOTECHNICAL INVESTIGATION FOR PROPOSED BOARDWALK

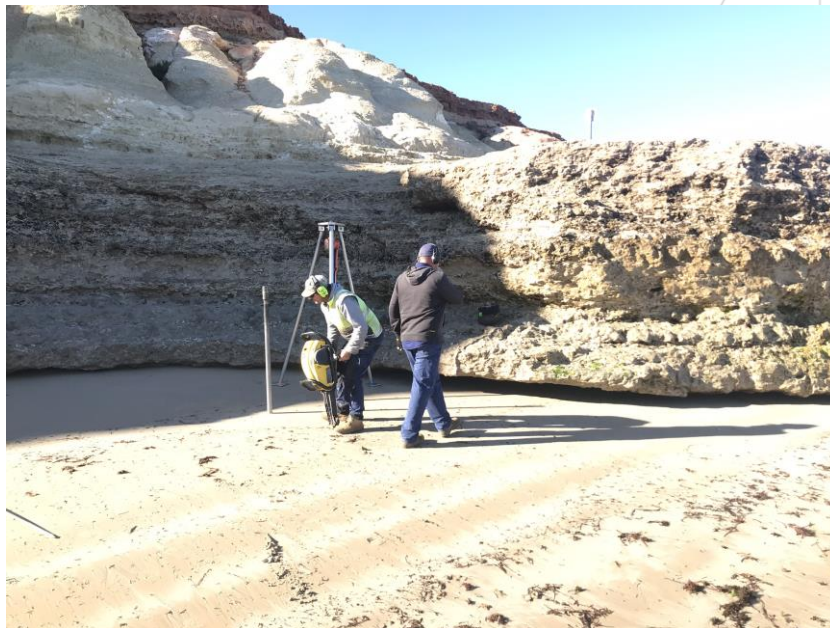
**Figure 1: Borehole Drilling, Note Limestone Shelf in The Background**

The field work was carried out on the 23rd July 2020 and comprised drilling three boreholes (referred to as BH1, BH2 and BH3) to depths of 0.9 m to 1.6 m within the embayment (refer to Figure 1).

The boreholes were drilled with a portable drilling equipment, using continuous push tube sampling methods. Push tube refusal was met in each borehole on weathered limestone.

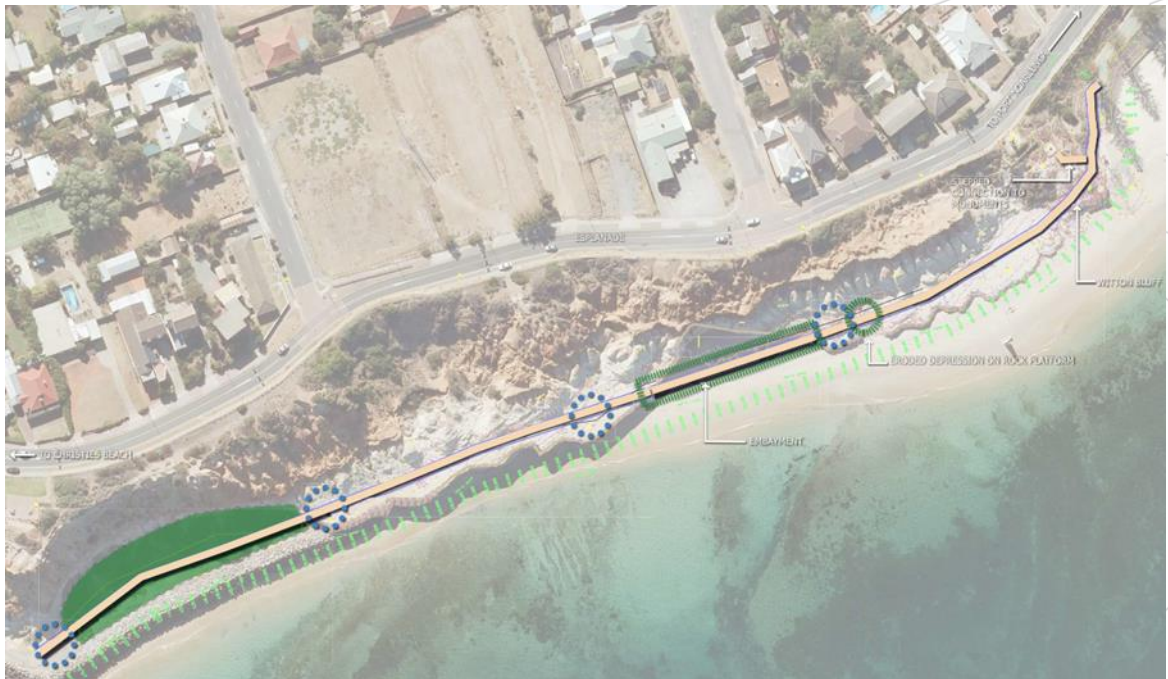
**Figure 2: Site and Proposed Boardwalk Layout**

An excerpt from the architectural landscape concept of the proposed boardwalk (08146SK02B Swanbury Penglase Architects) is reproduced as Figure 3.1.

The boardwalk will be predominantly located along an erosional limestone shelf, up to 4 m in height, that lies in front of the coastal cliffs. The Quaternary aged sediments overlying the limestone have been eroded in the past.

Wave and tidal erosion have created the 'stepped' geomorphology of the unit, with the formation of a sandy embayment between 2 distinct limestone shelves. An elevated structure is proposed for the boardwalk over the sandy embayment, between the limestone shelves.

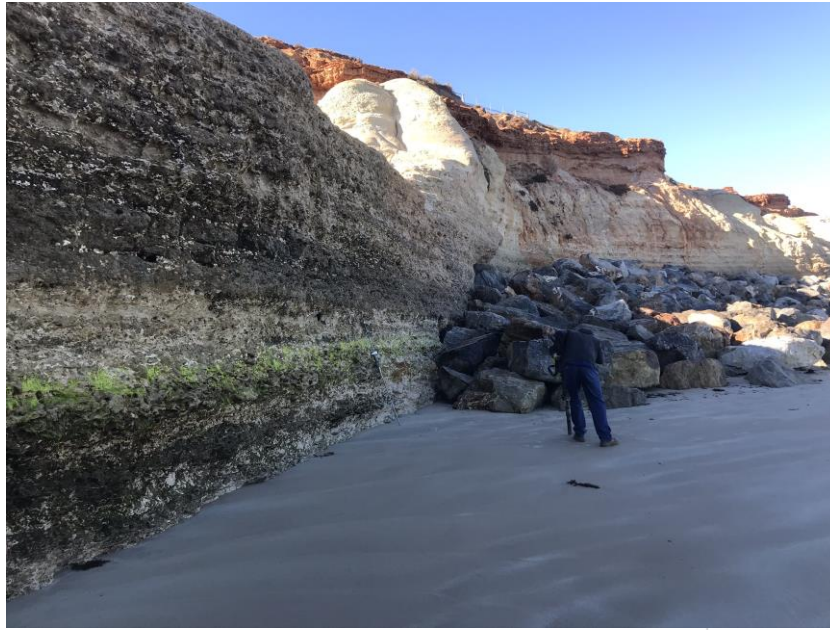
**Figure 3: Rip-rap Protection Abutting the Limestone Shelf**

The embayment contains rip-rap rock protection (refer to Figure 2) to prevent further erosion of the limestone at the toe of the cliff. Historical information indicates that the rip-rap was placed in 2013 at the location of previous cliff instability and a cave.

The limestone shelf is undercut at the base in places due to erosion.

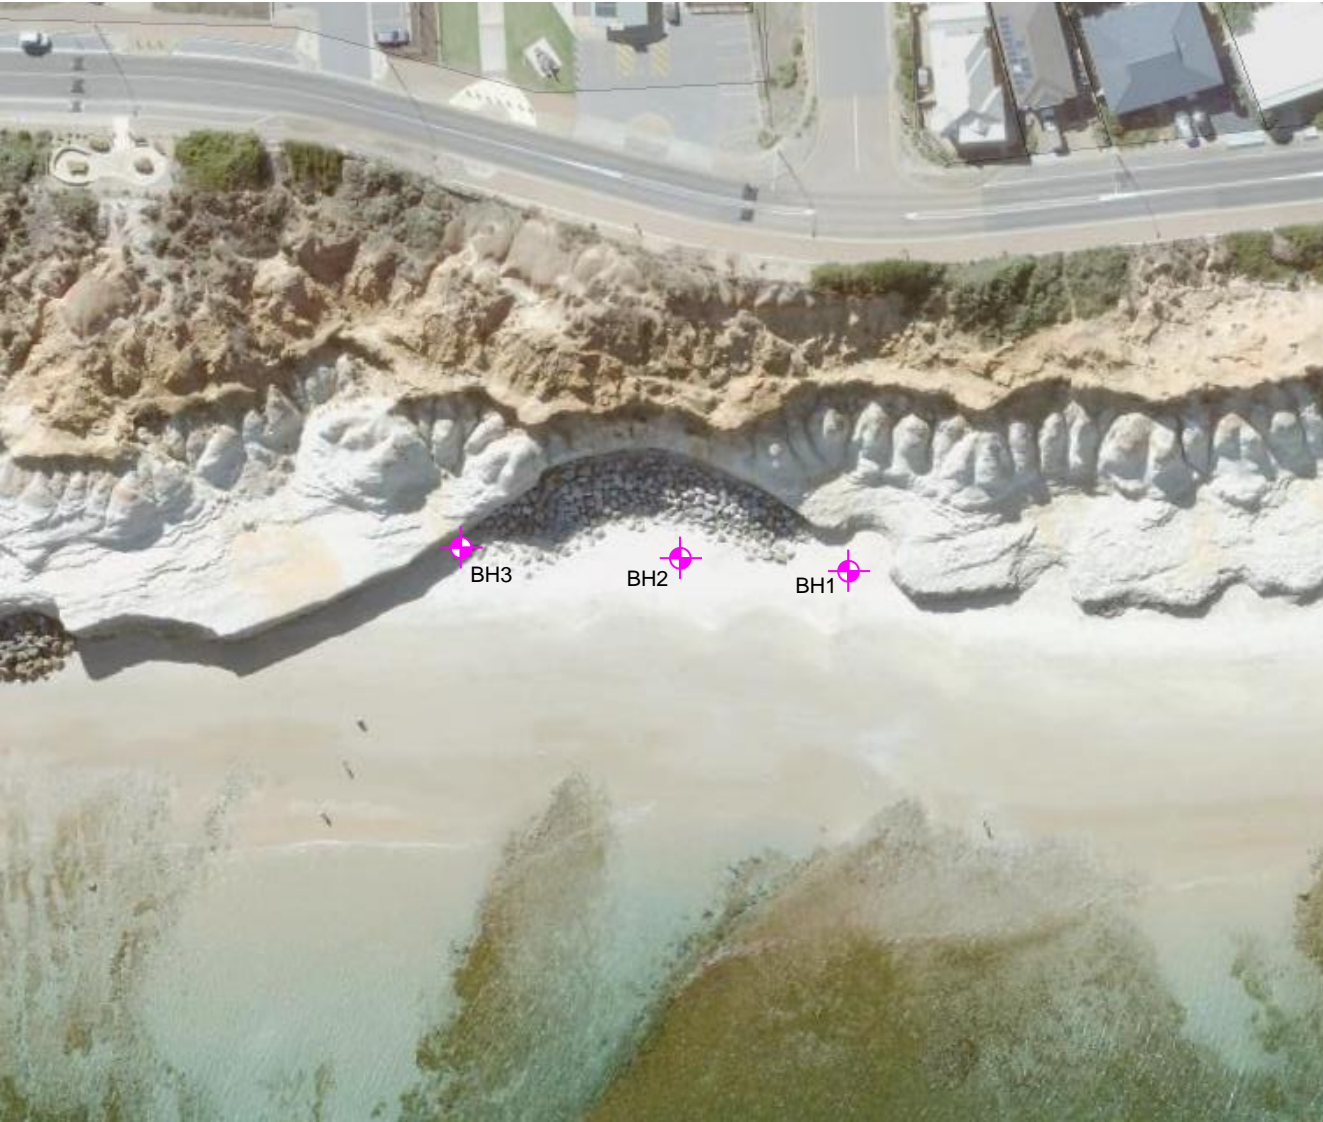
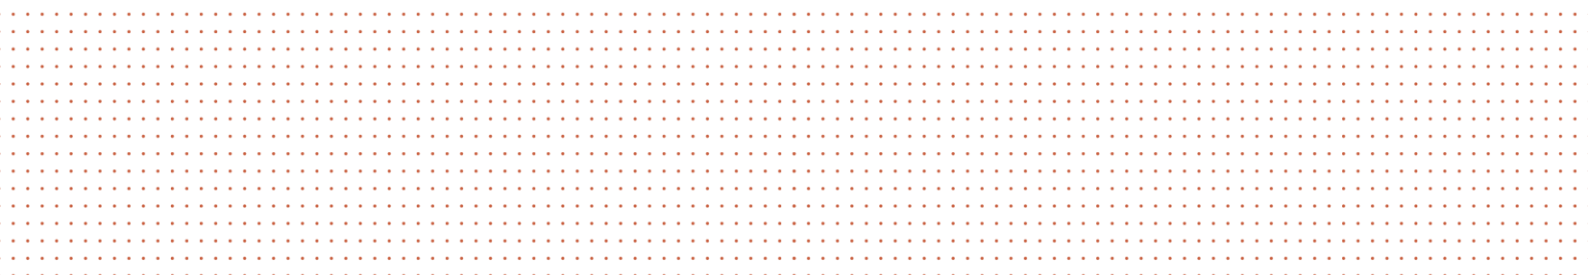
Client:	CITY OF ONKAPARINGA		
Project:	WITTON BLUFF BASE TRAIL		
Title:	BOREHOLE LOCATION PLAN		
Project No.:	WGA201245	Ref.	FIGURE 1

Appendix A - Figure 1: Borehole location plan

The locations of the boreholes are shown approximately on the attached Figure 1.
