Coastal Adaptation Study For City of Onkaparinga

Main Study Report

This document is the main report for the coastal adaptation study providing the methodology and key findings and should be cited as:

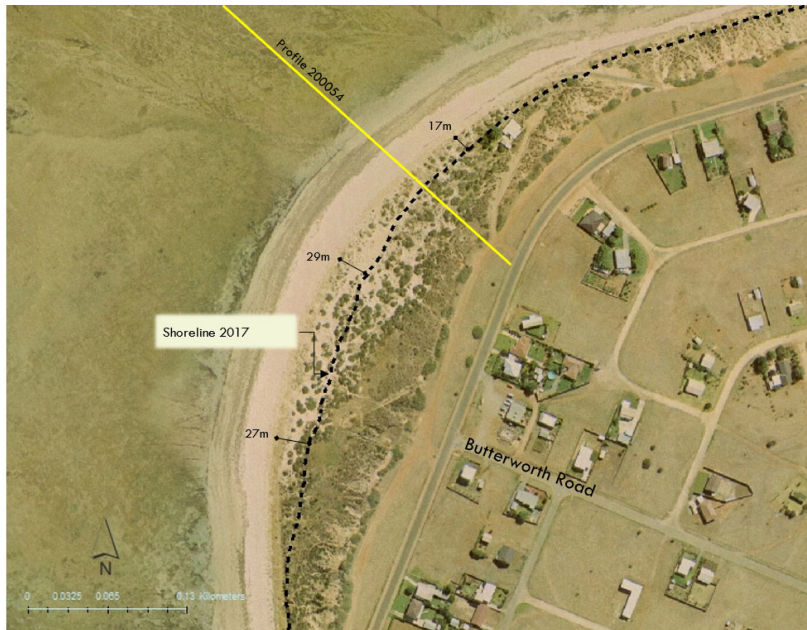
Figure 11. Comparison of shoreline position between 2017 and 1979 (M. Western, 2020)

Example 1: A comparison of shoreline position in 2017 with photography from 1979 reveals a major change to the shoreline which has receded in excess of 25m. Also note the position of the SA Coast Protection Board survey profile line 200054 which we will review in the next section.

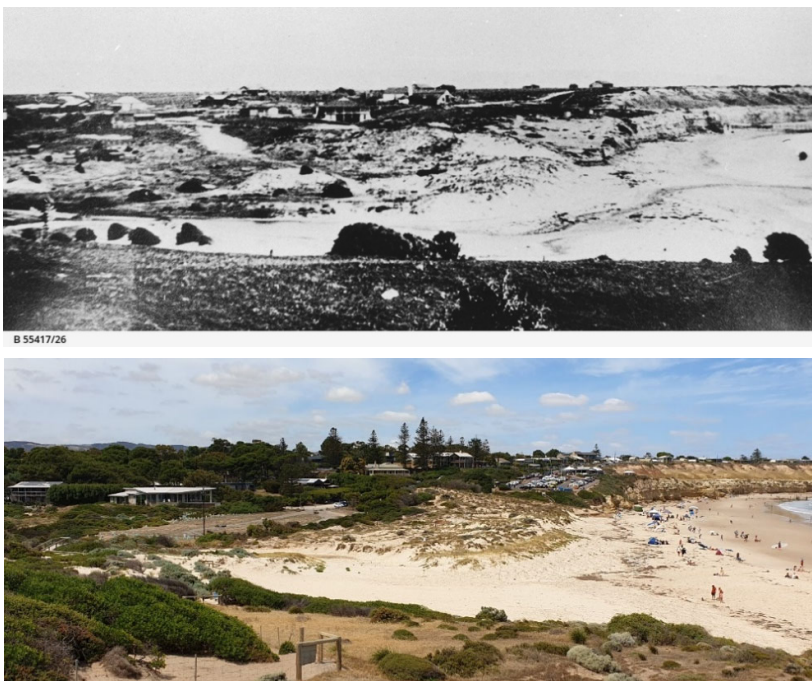
Figure 12. Comparison of shoreline characteristics between 1909 and 2020 (Source: SA State Library, M. Western)

Example 2: A comparison of land-based photography of Port Willunga from 1909 to 2020 provides the basis for qualitative analysis of changes over 110 years. In this instance, very little beach change is observed between the photographs.

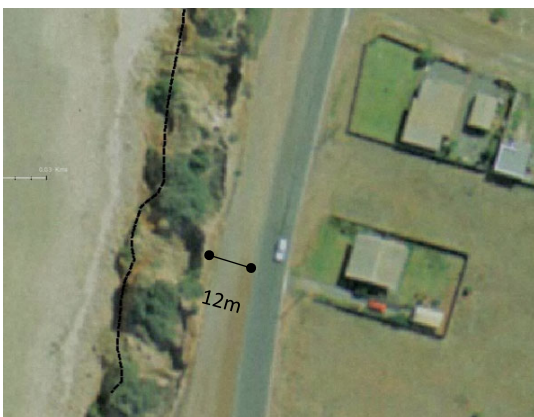
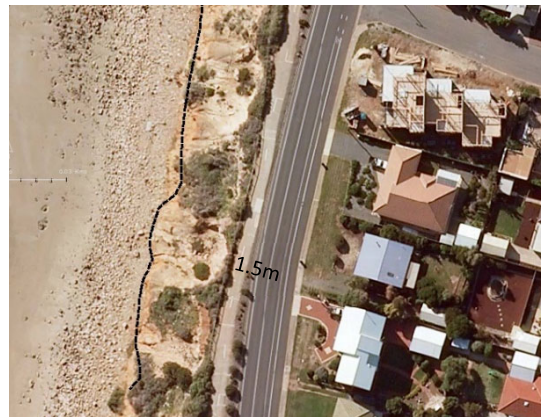
Figure 17. The Esplanade at Seaford in 1979 and 2007 (Aerial Photography, City of Onkaparinga).

Example 2: The esplanade road was widened in early 2000s to be within 1.5m of a backscar of a slump. A piled retaining wall has now been inserted under the footpath to ensure stability.

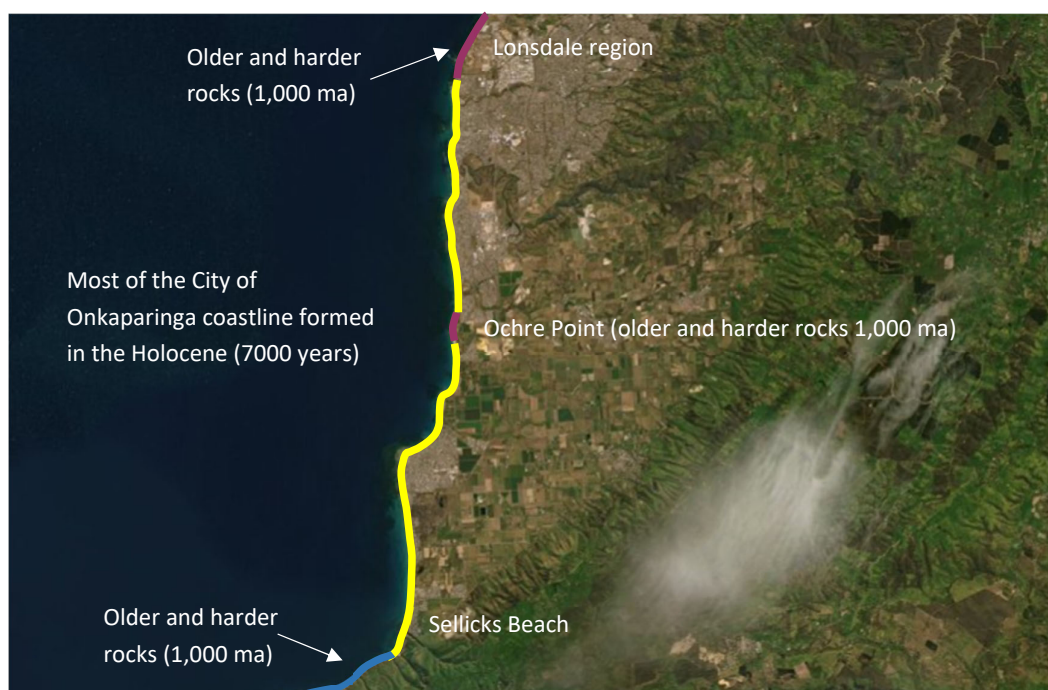
- A medium – fine sand beach is present in most locations,
- Offshore is generally dominated by sand but interspersed with low profile reefs and seagrass beds (varying from patchy to continuous),
- Backshores vary from soft rock sloping shores, soft rock cliffs or sedimentary plains.

Figure 18. The general layout of the coastline of City of Onkaparinga (Adapted from Nature Maps, Department of Environment and Water).

Each cell has been evaluated in regard to its form (topography), benthic characteristics (nature of the seafloor), and geology (nature of landforms). Understandably, there is great variation between cells in relation to these characteristics. However, in general the coastline of City of Onkaparinga is bordered by much older and harder rocks to the north at Lonsdale (and within Marion Council) and to the south (within Yankalilla Council) (ages ~1000 million years)³⁶. Most of the coastline as we know it today was formed recently in the Holocene (last 7000 years) as sediments interrelated with the softer and much younger rocks of the Eocene (~50 million years). The general layout of the Onkaparinga coastline is depicted by Nature Maps (Figure 18) and is characterised by:

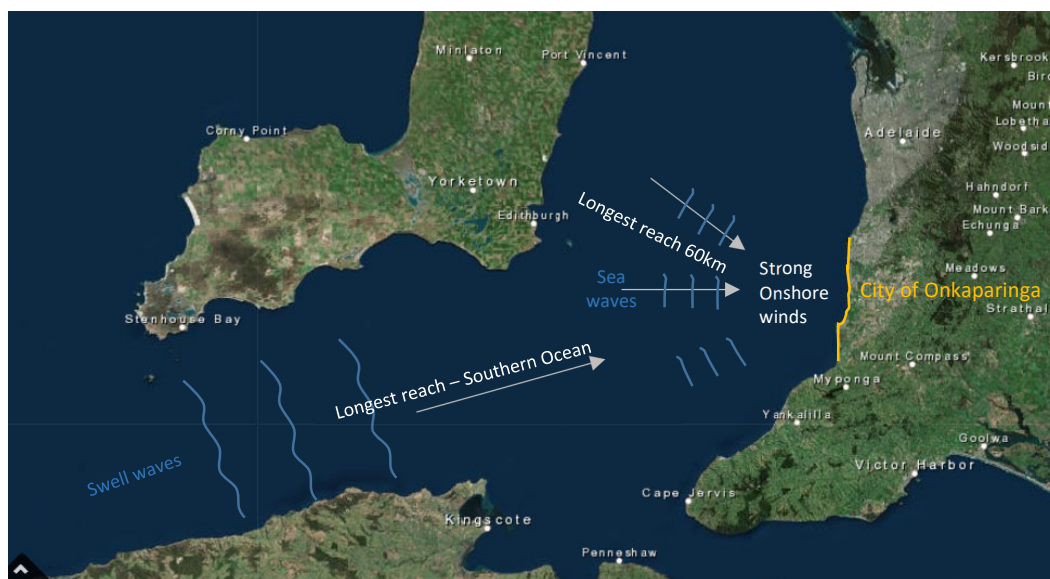
Figure 19. The orientation of the Onkaparinga coastline to wave energy (Adapted from map from location.sa.gov.au)

Orientation refers to the way a segment of land interrelates with the oceanic forces, and *fetch* relates to the distances that wind can blow across open waters. The alignment of the City of Onkaparinga shoreline is broadly orientated north-south, with transition sections at Witton Bluff, Ochre Point, Blanche Point and Aldinga Reef. Kangaroo Island provides significant protection from the Southern Ocean (Figure 19). Winds from the northwest and west travel over the shallower waters of the Gulf for fetch distances of less than 100 km. While winds from this direction do impact the shoreline with raised wave action, they are unable to generate the more elevated waters that are produced when waters are pushed up through Investigator Strait from the Southern Ocean when the winds are from the south-west (see also Storm Surge section below, p. 36).

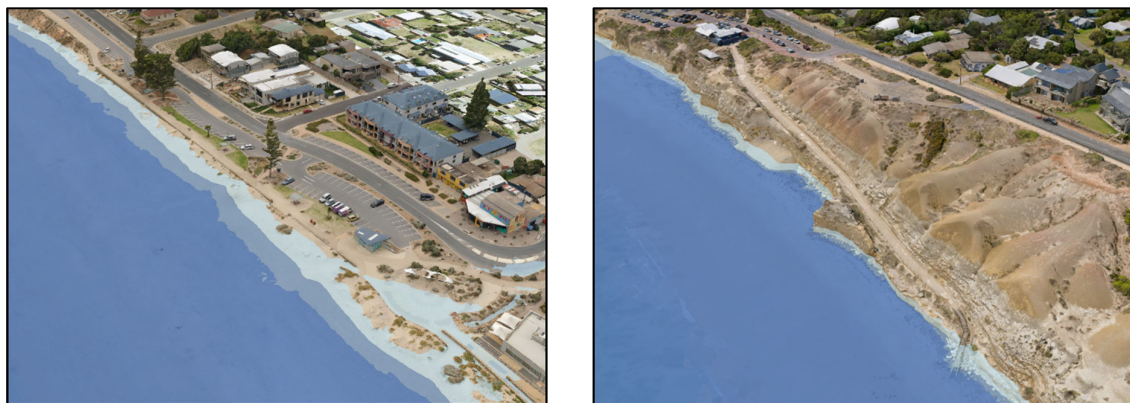
Figure 25: Current 1 in 100-year sea-flood scenario for Moana Beach and Port Willunga (M. Western).

To provide a more fine-grained basis for the modelling the *wave run-up* figures in Table 4 were not utilised but wave run-up figures were obtained by surveying the location and height of seaweed strands of the storm on 21 November 2018. This storm occurred when the tidal cycle was in the lower range and therefore had only moderate impact, but the wave effects were significant. The wave effects applied to each coastal cell are recorded in Appendix 3. See also report, *Extreme event analysis: Port Noarlunga to Sellicks Beach for 21 November 2018*, for full explanation of methodology and results. Sea-flood modelling for the current 1 in 100-year event was created within the 3D model for each cell using the inputs described in Appendix 3. Examples for Moana and Port Willunga are provided below (Figure 25).

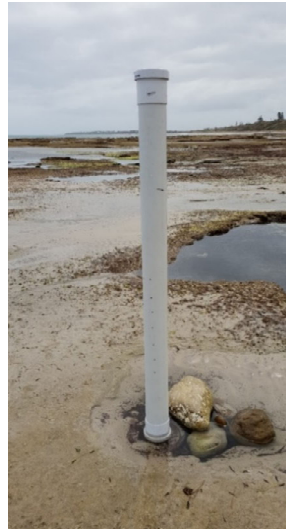
Figure 27: The float and tube manual tide gauge was installed prior to each tide data capture on the surveyed base.

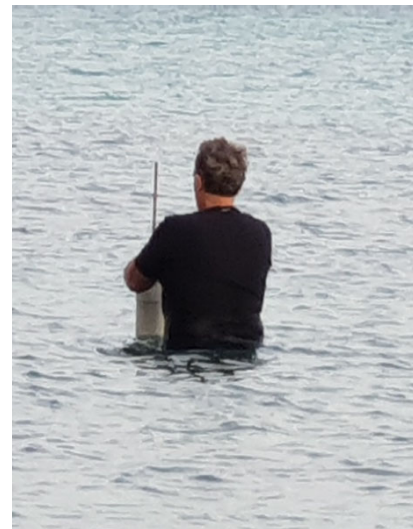
Figure 28: Five-minute observations were taken over ~1 hour period at projected high tide on calm days.

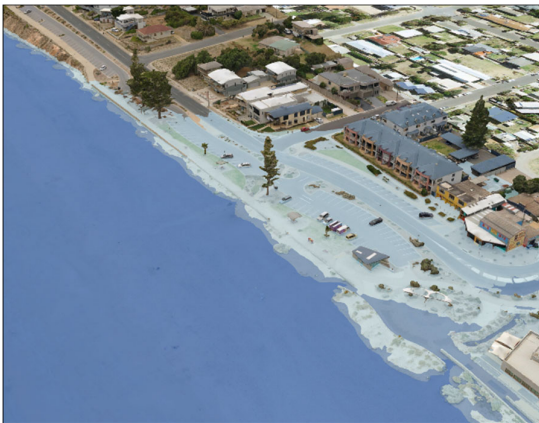
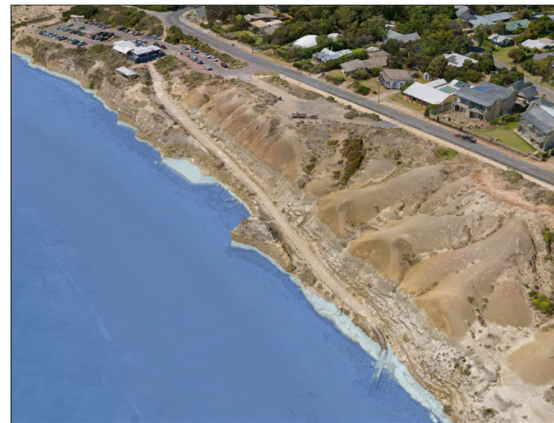
Figure 29: Modelling for 2100 scenario for 1 in 100-year sea-flood for Moana Beach and Port Willunga (M. Western).

Using the inputs as described in the previous section, 0.30m for scenario 2050 and 1.00m for scenario 2100 were added to the modelling for storm surge and routine high-water events. Scenario modelling of 1 in 100-year events for Moana and Port Willunga are depicted below as examples.

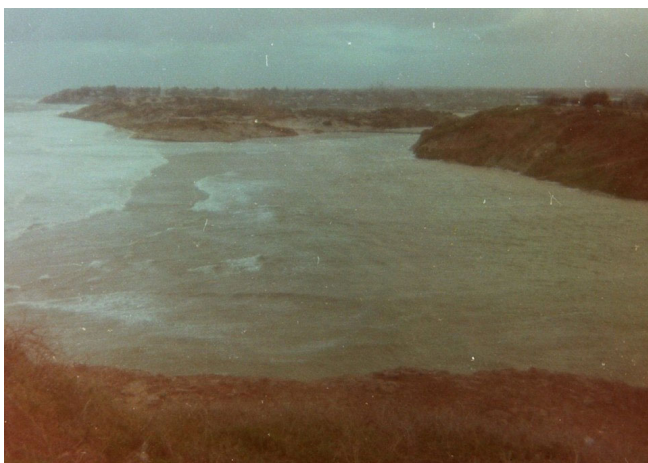
Figure 22. Photograph: Southport sand spit, Dave Manzdorf, 1981. It is unknown as to when this photograph was taken but presumably it is of the second event or after the second event as the sand spit has already been removed at the time of capture. (Photograph supplied by Sue Bennett, Midcoast Surfing Reserve).

One additional event was identified in 1981 which removed the sand spit at Southport. In reality there were two events that occurred within consecutive months – June and July. These events still stand as the fifth and sixth highest since records began in 1940 at Outer Harbor.

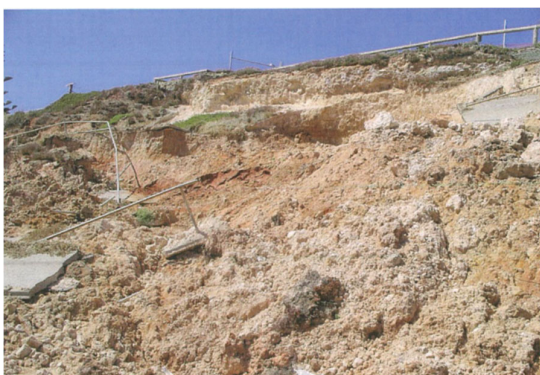
Figure 23. Increasing height of erosion scarp first noticed in event 4 July 2007 (Department of Environment and Water).

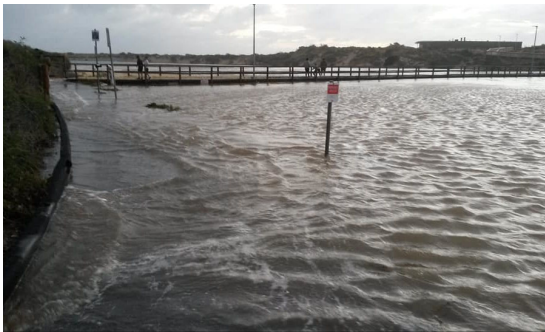
The height of the flood waters was accurately identified as 2.35m AHD between the footbridge and Saltfleet Street (Figures 25,26).

Figure 25. High tide, 17:30, 9 May 2016 Photograph: Sue Kenny (Mid Coast Surfing Reserve).

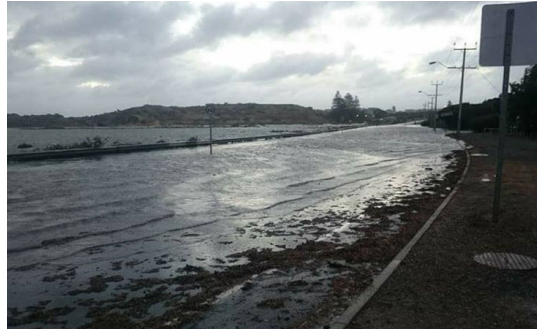
Figure 26. Tide receding but debris marks the high tide mark Photograph: Darren McPhail (Mid Coast Surfing Reserve).

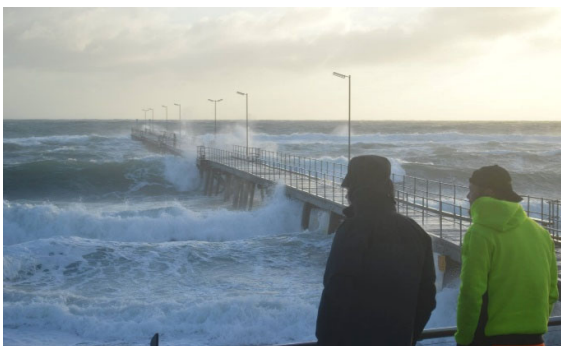
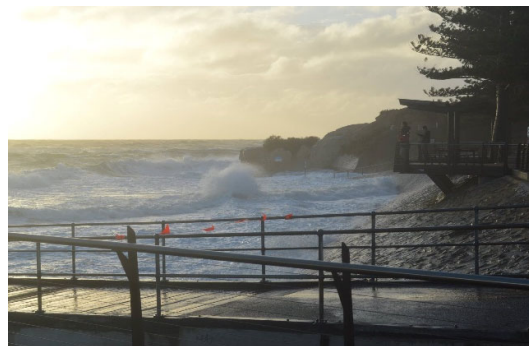
The characteristics of the storms general impact was observed at Port Noarlunga and the wave height identified as ~2m.

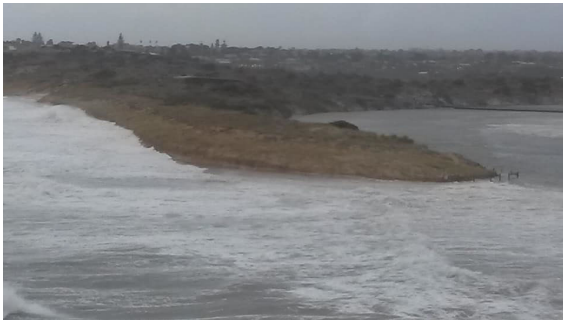
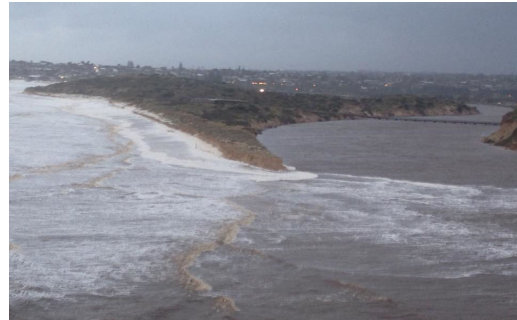
The impact on Southport spit. The photograph on the right is from the event of 28 September 2016. Anecdotes from Council report that follow-up events were just as damaging due to earlier erosion.

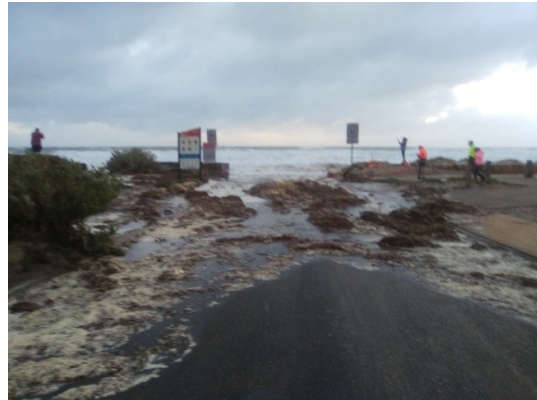
The height of the flood was accurately identified in Pedler Creek at 2.50m AHD but this is likely to include an increase height over storm surge level due to narrowing of creek banks. Sandbags were required at the front of the Surf Life Saving Club.

Figure 29. Storm event 9 May 2016, 1730. Photographs by M. Western. Survey height within Pedler Creek was 2.50m AHD

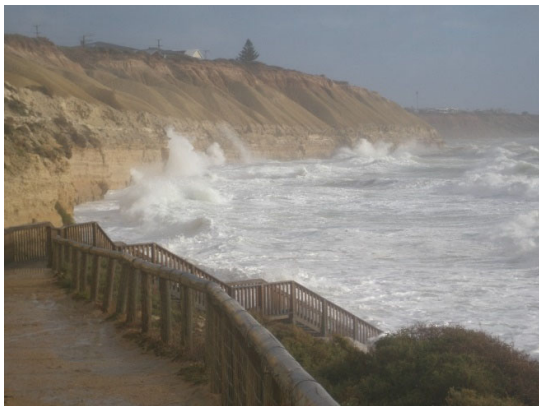
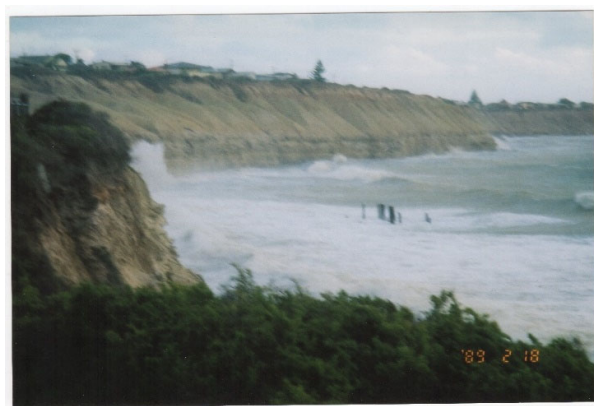
The impact on the cliffs at Port Willunga was significant. Photographs from the event 25 April 2009 appeared to have a similar impact.

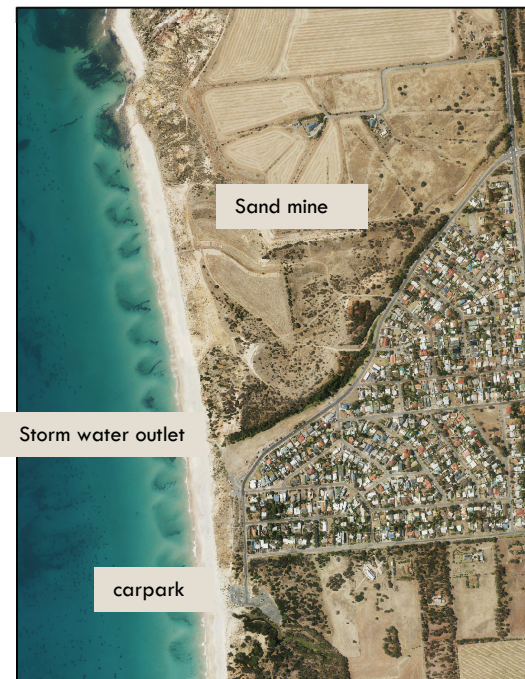
Maslin Beach is characterised as a sandy beach backed by soft coastal cliffs (harder rock at the base). The cell is dissected by Maslin Creek. Nearshore and surf-zone dominated by sand. Offshore scattered low-profile reef and seagrass.

Historical analysis indicates that the coastline undergoes periods of accretion and erosion. The beach and position of the toe of the embankment in the north have been largely stable but areas of dunes in front of the park at Maslin Beach have recede. A sand mine operated adjacent the coast in the earlier part of the twentieth century. Soft sediments have been deposited in the backshore when the mine was rehabilitated.

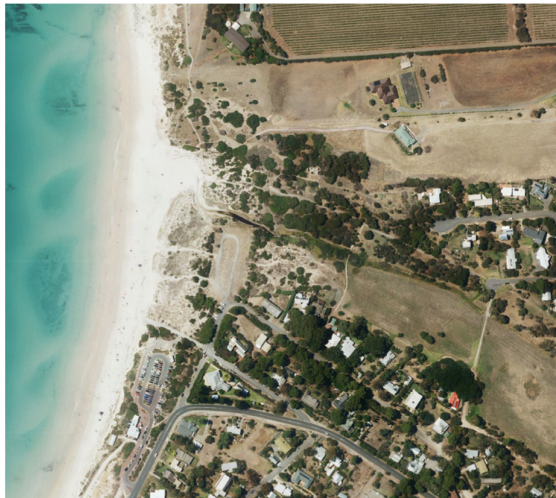
Port Willunga (9.2) is characterised as a sandy beach backed by coastal dunes.. Nearshore and surf-zone dominated by sand with low profile reef of varying consistency offshore.

Historical analysis indicates that the coastline undergoes periods of accretion and erosion. The beach and dune area near Willunga Creek appear largely unchanged since 1909, and the dunes have built up since 1975. Sea level rise does not appear to have had any major impact on this section of coast as yet.

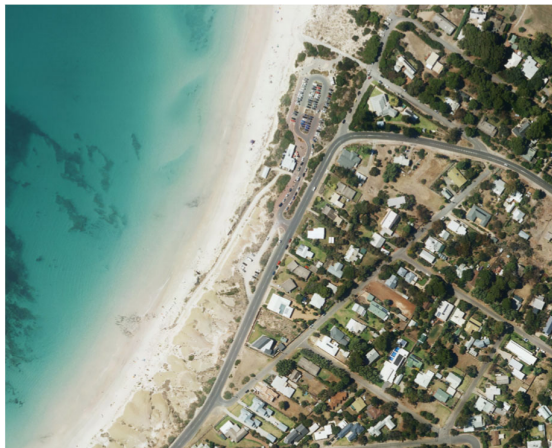
Port Willunga (9.3) is characterised as a sandy beach backed by limestone cliffs in the south overlain with softer sediments. Nearshore and surf-zone dominated by sand with low profile reef of varying consistency offshore.

Historical analysis indicates that the coastline undergoes periods of accretion and erosion. There appears to be less volume of sand adjacent the cliffs south of the creek than in 1909 which may relate to rises in sea level over a century. Some recession of the cliff has occurred in places as a result of rock falls (overall recession 1-2m). The cliff has become undermined in places, and rock has been placed in one location under the cliff to slow erosion.

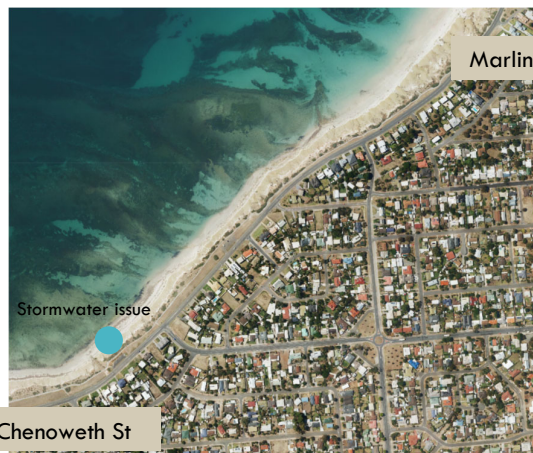
Rocky/sandy shore backed by soft coastal cliffs. Ngalinga formation on the top and Blanche Point formation at the base (which is resistant to erosion). Fronted by reef/rock platform close to the shoreline.

Historical analysis reveals that this coastline undergoes periods of accretion and erosion, the latter relating to larger storm events (2007, 2016). GHD noted evidence of block falls and tension cracks, some up to 10m from the cliff crest. A comparison of aerial photograph estimates recession of cliff top ~2m from 1979.

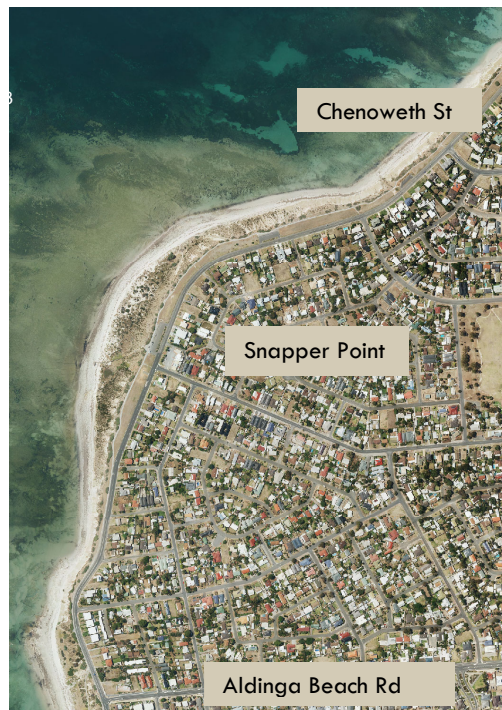
In the south, sandy shore backed by soft coastal cliffs (highly erodible Ngalinga formation). In the Snapper Point region, the sloping soft cliffs are set behind a dune system. Nearshore and surf-zone are dominated by a low-profile reef

A comparison of aerial photographs from 1949 to 2006 demonstrated that this coastline was stable. Substantial erosion has occurred since 2006. In the vicinity of Gordon Street, 8-10 metres recession of the cliff toe, but only minor erosion of the cliff crest is likely to have occurred. At Snapper Point, 24-34m recession of the shoreline has occurred between Butterworth Road and Hume Street. Analysis of the beach profile lines is congruent with these findings.

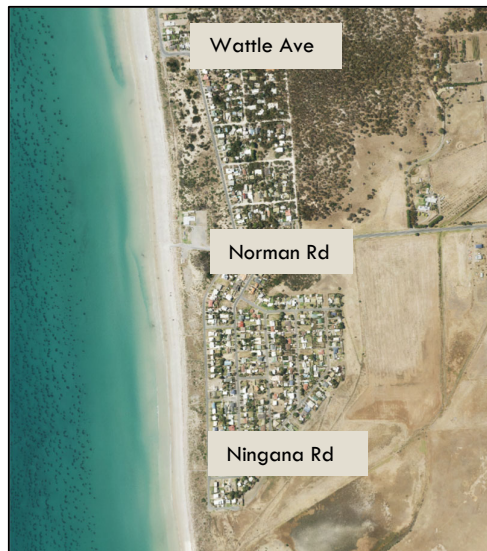
Sandy shore backed by dunes and soft sediments less than 8m AHD but rising to 15-20m AHD north of Norman Road. The nearshore and surf-zone dominated by unconsolidated sand, with patchy to medium density seagrass and a low-profile offshore reef. A pebble ridge is situated in the backshore, but the height of the pebble ridge declines toward the north. Moderately erodible.

A comparison of aerial photographs and profile lines indicate that the coastline undergoes periods of accretion and erosion, the latter relating to storm events (2007, 2016). In the vicinity of the Norman Road on ramp, there has been ~2m recession of the shoreline, but with little evident in the last decade. Further north toward Wattle Road, the impact of erosion increases to 2-4m, with some areas at 6m of erosion.

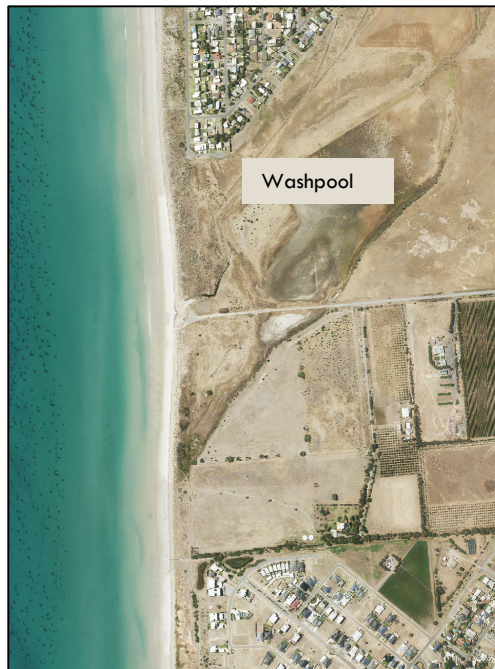
The coast in this region is characterised as a sandy beach, the nearshore and surf-zone dominated by unconsolidated sand, with patchy to medium density seagrass and a low-profile offshore reef. A pebble bank is situated in the backshore. Behind the ridge a low-lying plain basin called the Washpool Lagoon is located.

A comparison of aerial photographs and beach profile lines indicates that the beach undergoes cycles of accretion and erosion. The pebble bank is in a similar position to 1976. Analysis of beach width from 1976 to 2018 revealed no significant trend for the narrowing of the beach in this location. Levees have been installed in the Washpool Lagoon at height 3.00m AHD which will protect the lagoon from inundation from the sea.

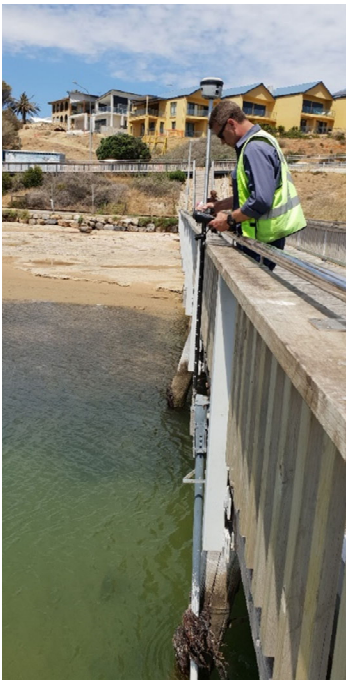
Figure: Levellogger tide gauge installed in tube on footbridge at Southport (Port Noarlunga). Data from a barometric reader was combined with the tidal data.

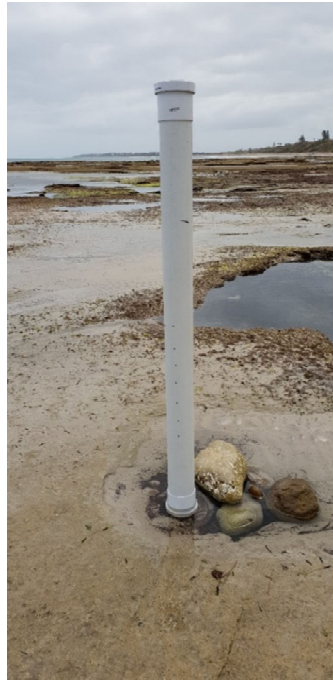
Figure: Dumbbell surveyed and left on the reef/rocks at Sellicks and Maslin Beaches. The float and tube manual tide gauge was installed prior to each tide data capture.

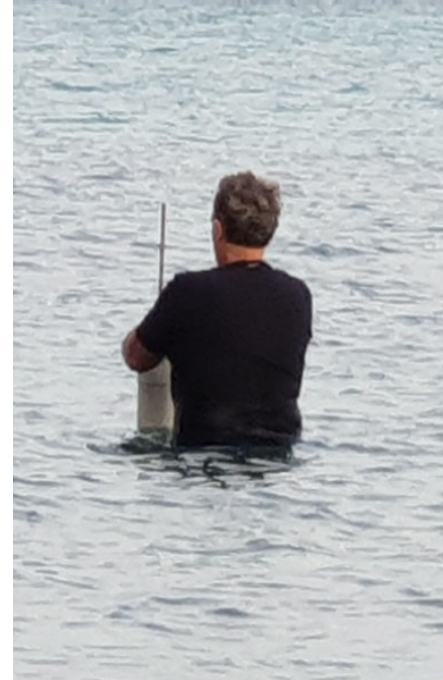
Figure: Five-minute observations were taken over ~1 hour period at projected high tide on calm days.

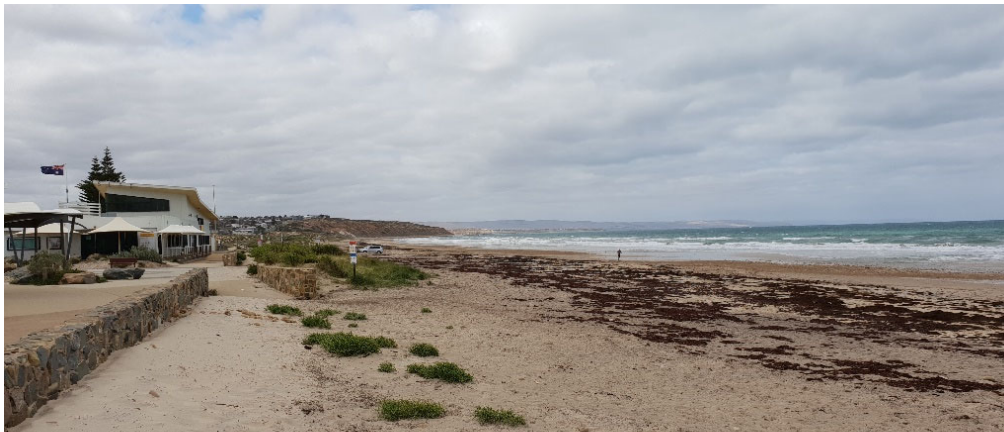
Modelling of the routine highwater tended to display high congruence with observed winter seaweed patterns throughout the coast.

Figure: Location of seaweed strands after routine highwater events (end of winter)
