Geotechnical Assessment (Cliff Stability)

Witton Bluff, South Australia

30 OCTOBER 2009

Prepared for
City of Onkaparinga

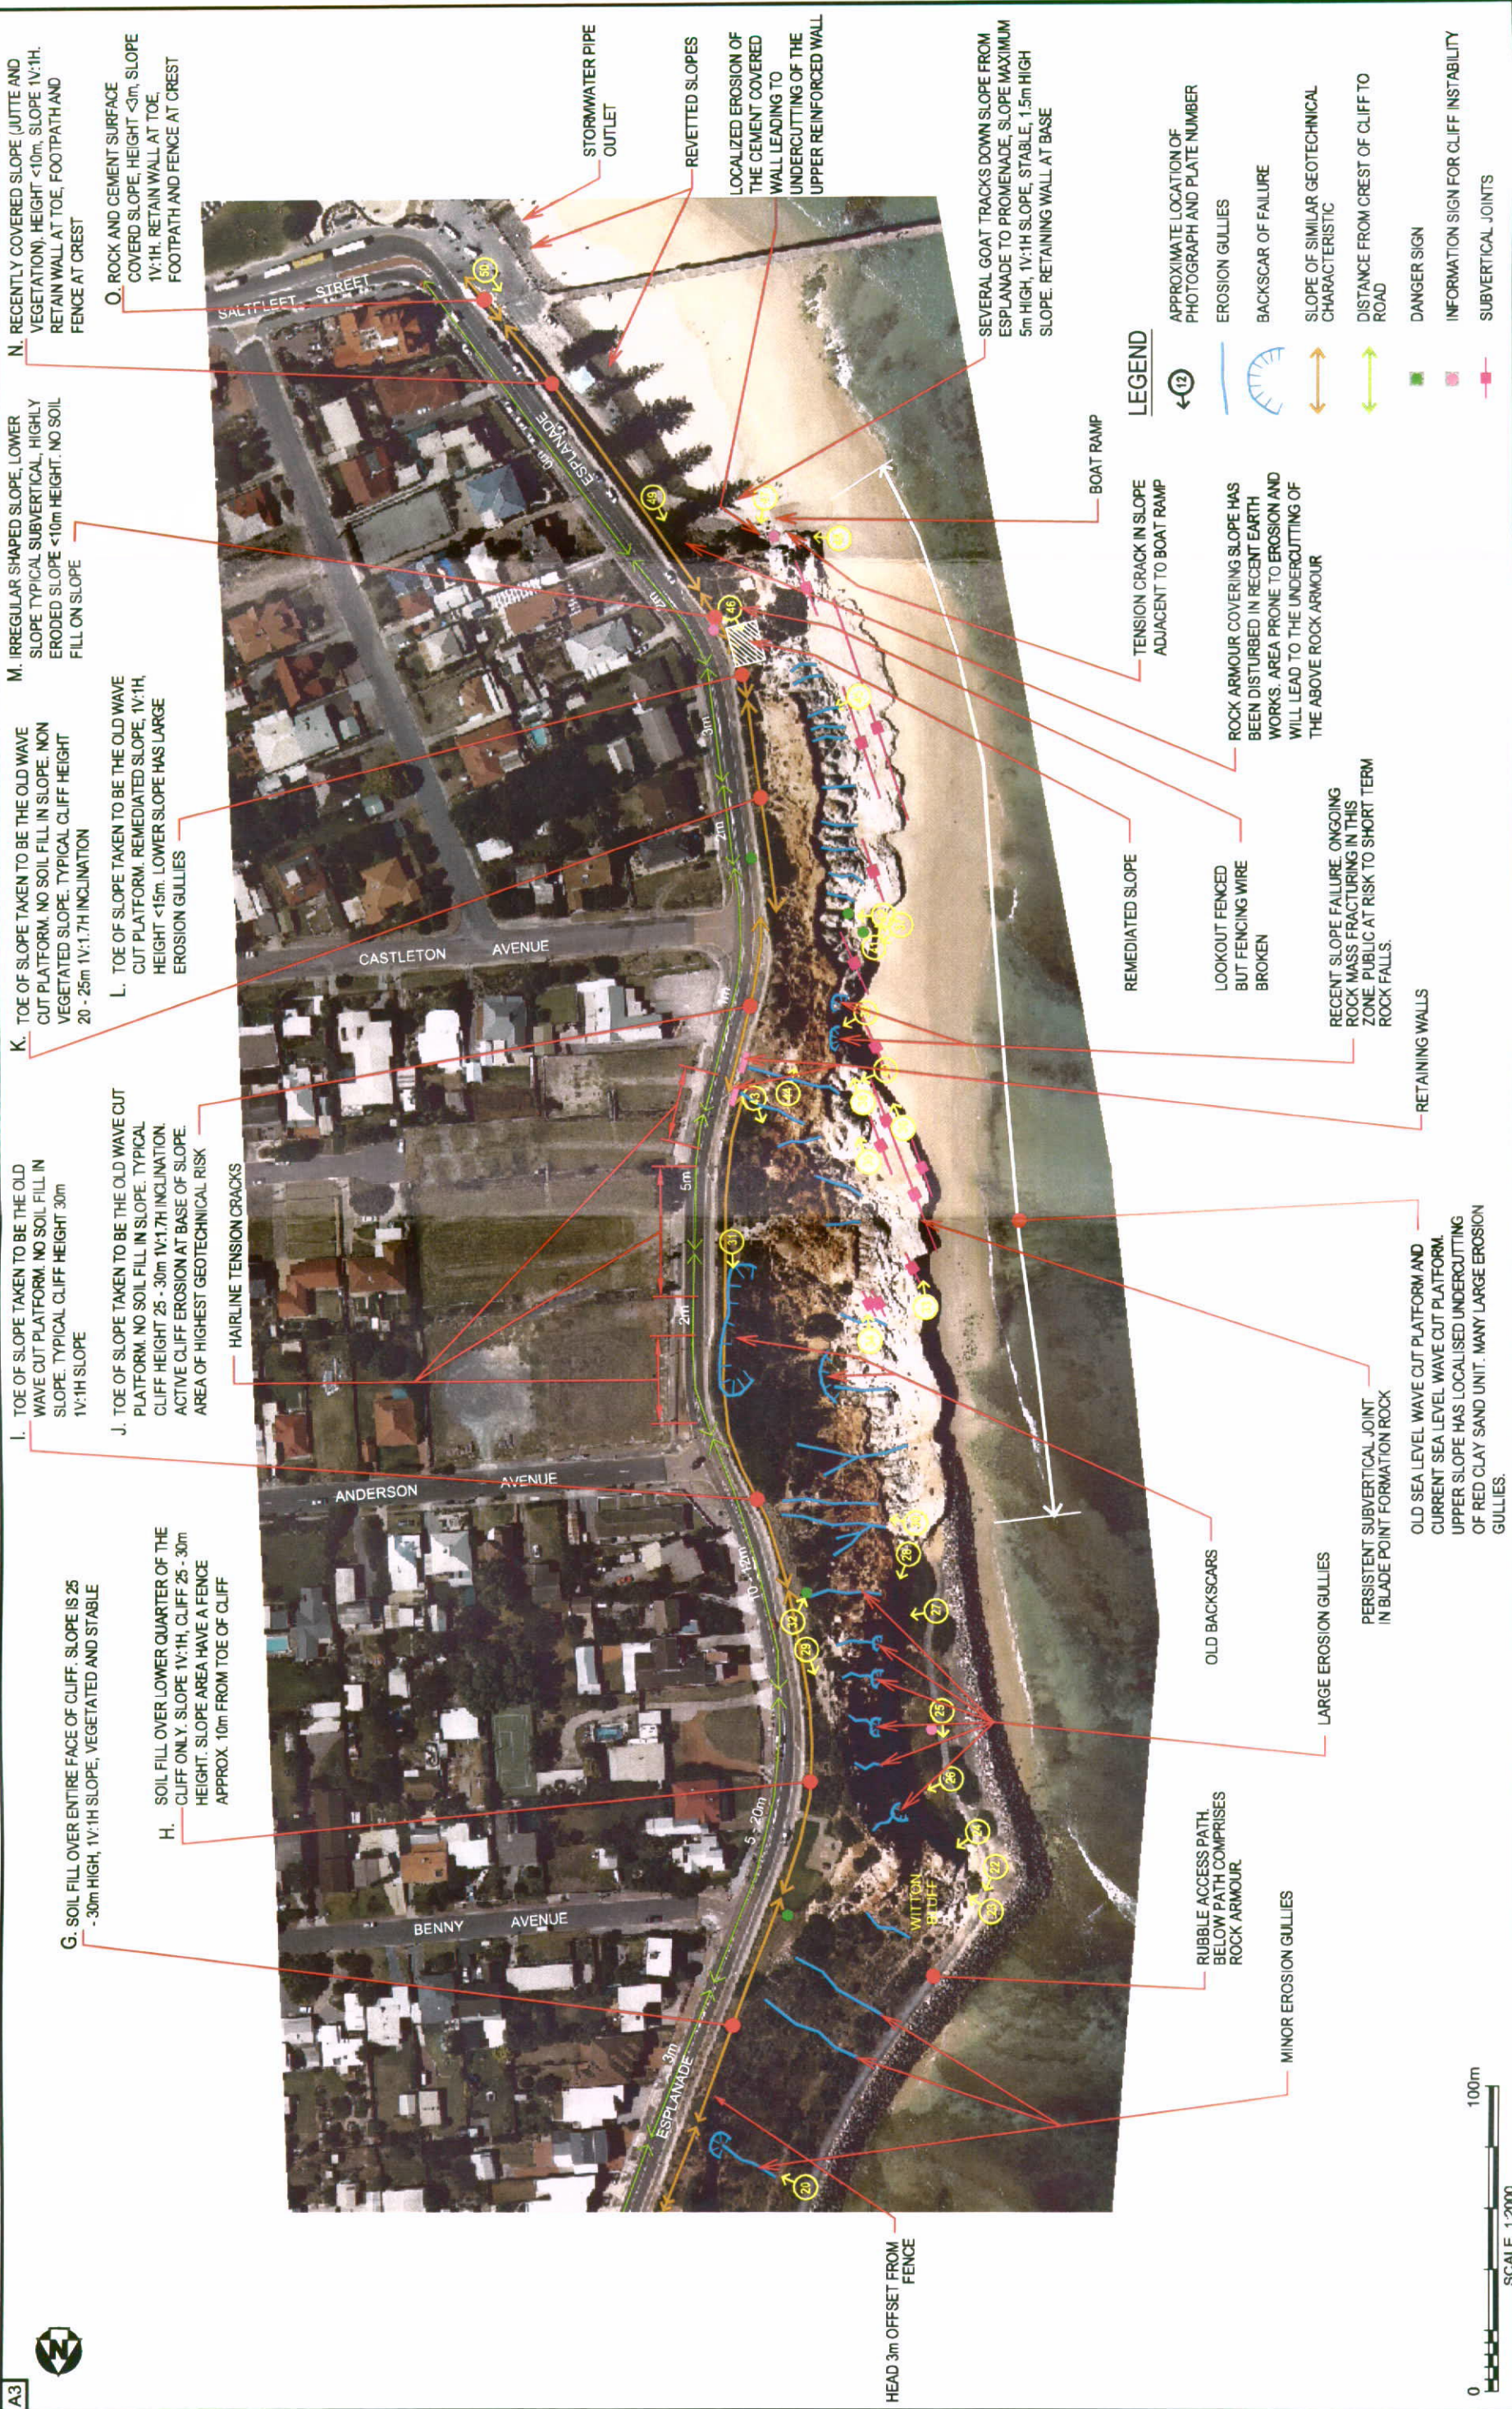
In March 2009, URS were commissioned to provide remedial advice for tension cracks observed at the crest of a cliff previously remediated in 2003 with a reinforced retaining wall (Refer to Zone C on Figure 2). Tension cracks were also observed in the crest of the cliff during the 2007 URS Cliff Top Audit. Recommended remediation measures included local reinstatement of engineered fill, establishing vegetation and the placement of a growing medium covered by erosion protection matting.

The main features recorded during the site inspection are noted on Figures 2 and 3 (Sheets 1 and 2 of the Site Observations). These features are referenced to a plate number; the plates are included in this report. Lengths of the cliff face with similar geotechnical features have been grouped into Zones (Zone A to Zone O). Refer to Figures 2 and 3 for the extent and description of features in each Zone. Refer to Table 3-1 for a listing of hazards observed in each cliff Zone. The description of each hazard is discussed in Section 4.1.

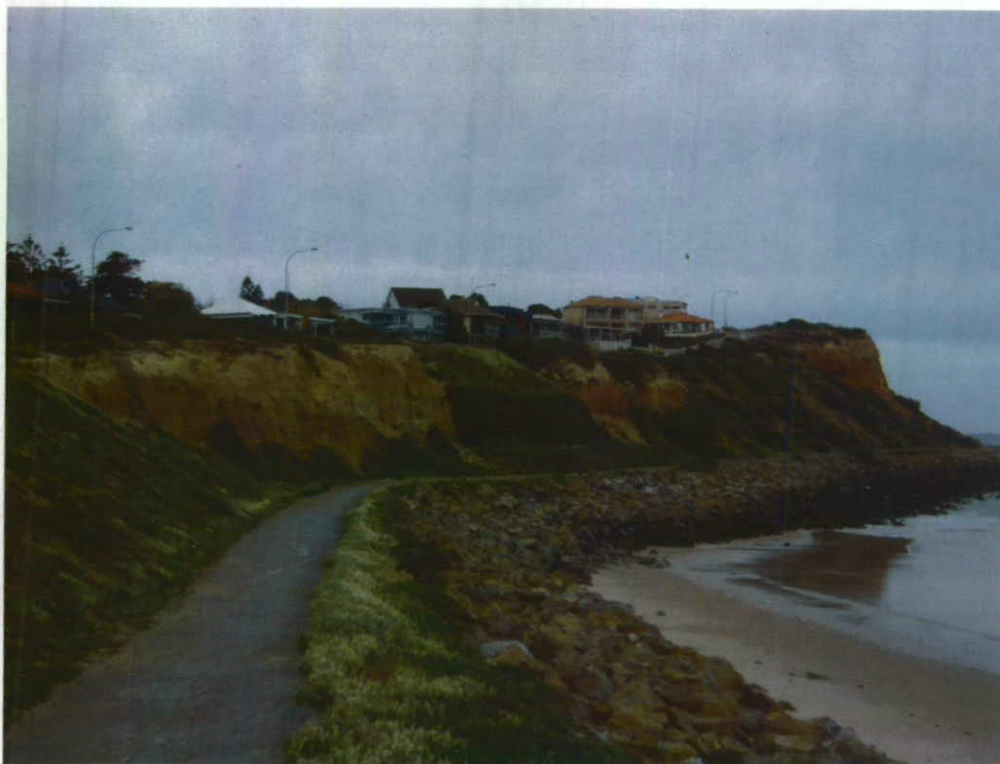
Access to the base of cliff in Zone A, west of the esplanade, was gained via a pedestrian access pathway. A view from the base of this path is shown in Plate B and Plate 2. This path extends from Beach Road to Anderson Avenue at the base of Zones A to I. Plate B is a general view of the typical 1V:1H slopes in Zone A to F, where slopes are either uniform in grade or are eroded into steep exposed soil upper slopes and shallow soil filled lower slopes. Typical geological profiles in Zones B to G are consistent with the regional geology described in Section 2.2 above. In these zones the cliffs are typically composed of thin aeolian (wind blown) brown sandy topsoil over a calcrete layer (Bakara Calcrete) of limited thickness (usually 1 m or less) that is often composed of hard rock at the top of the unit grading to calcrete rubble or calcareous soil at the base of the unit. This is underlain by the erodible mottled clays and sands of the Ngalinga Clay.

Plate B: General view to the south at Zone A to Zone F (Beach Road to Dale Avenue).

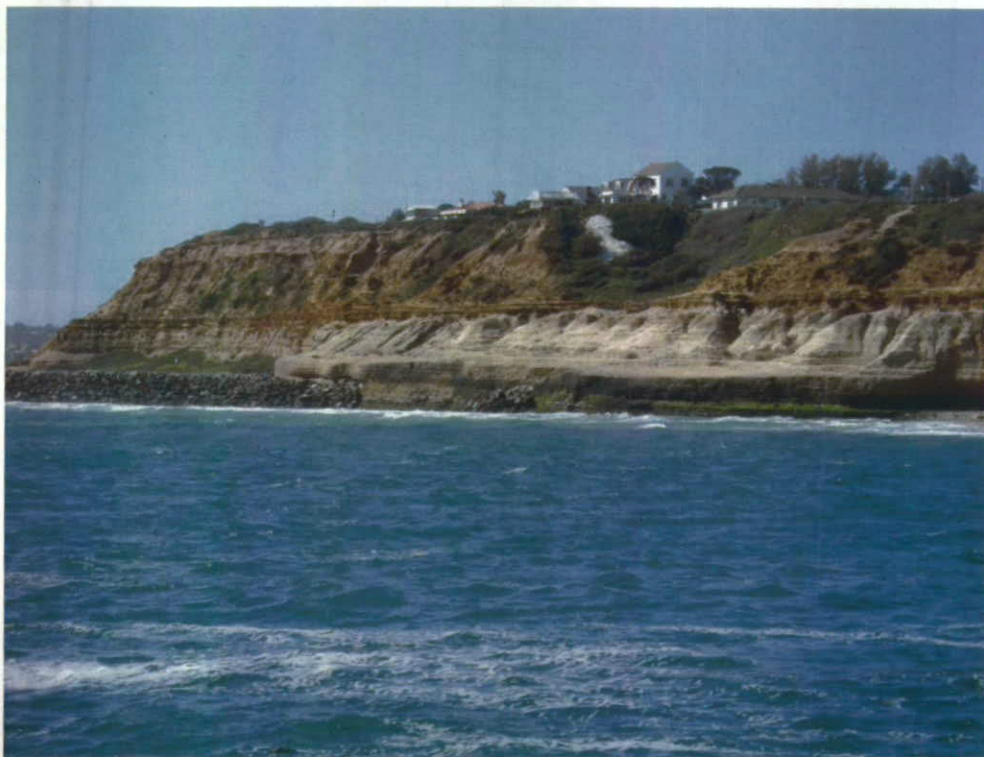
Plate C: General view to the east at Zone I to Zone K (Benny Road to Anderson Avenue).

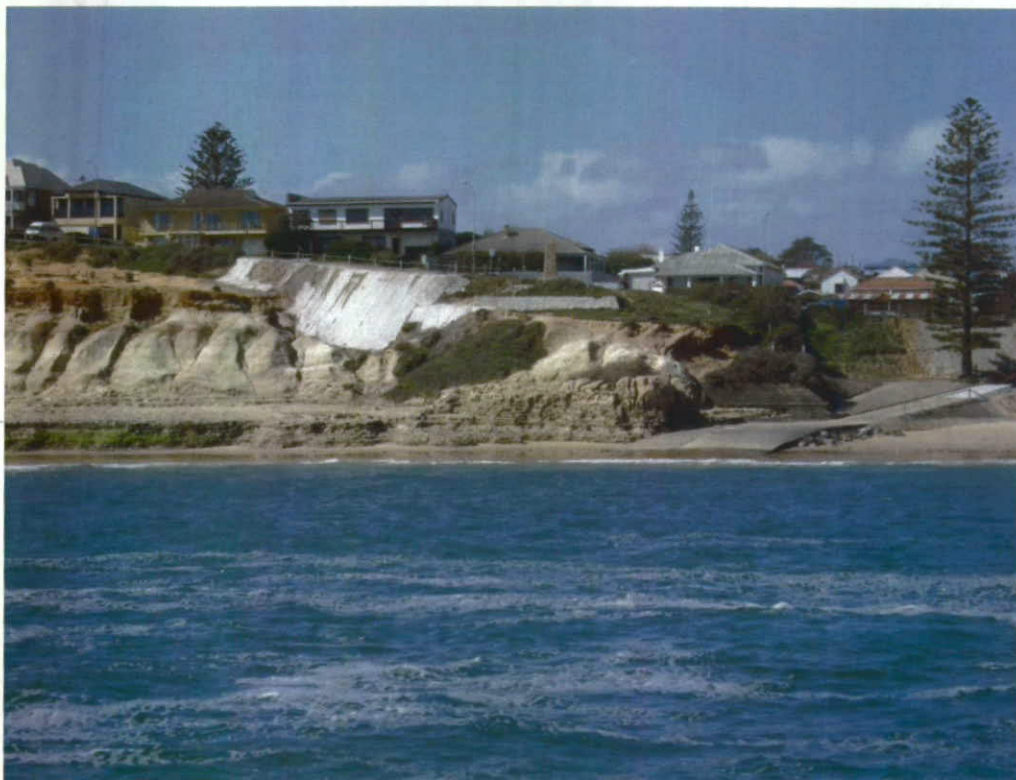
Plate E: General view Zone K, L and M. Remediated slope central, boat ramp to the right.

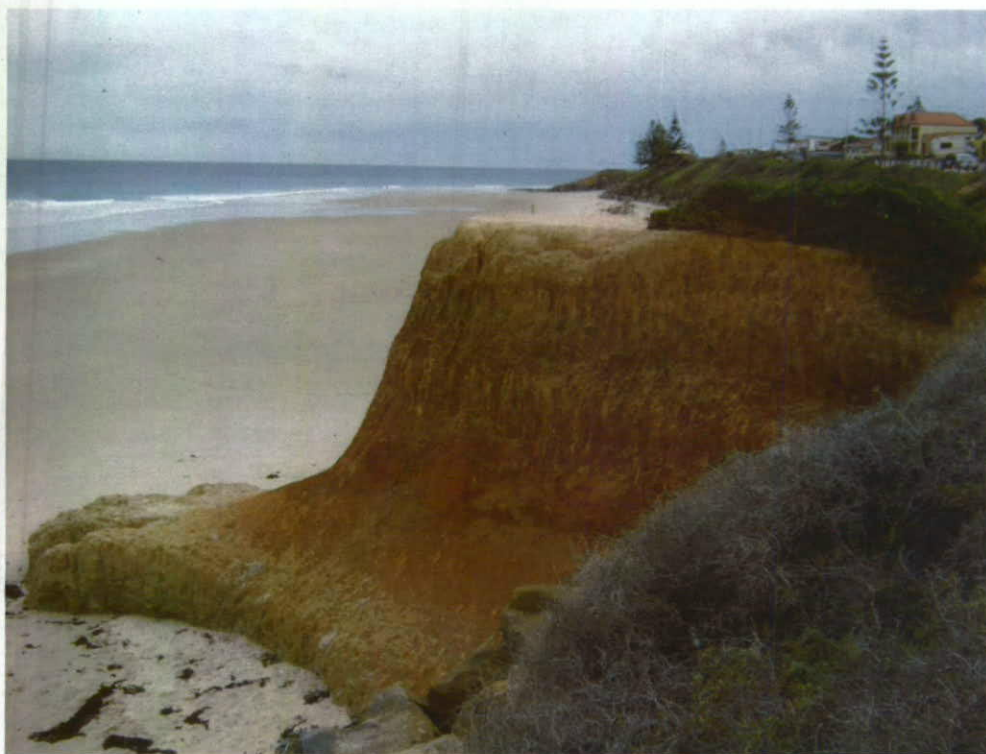
Plate 1: View looking north at a natural soil plateau adjacent to the public toilets at the end of Beach Road, near vertical slopes of dessicated clay.

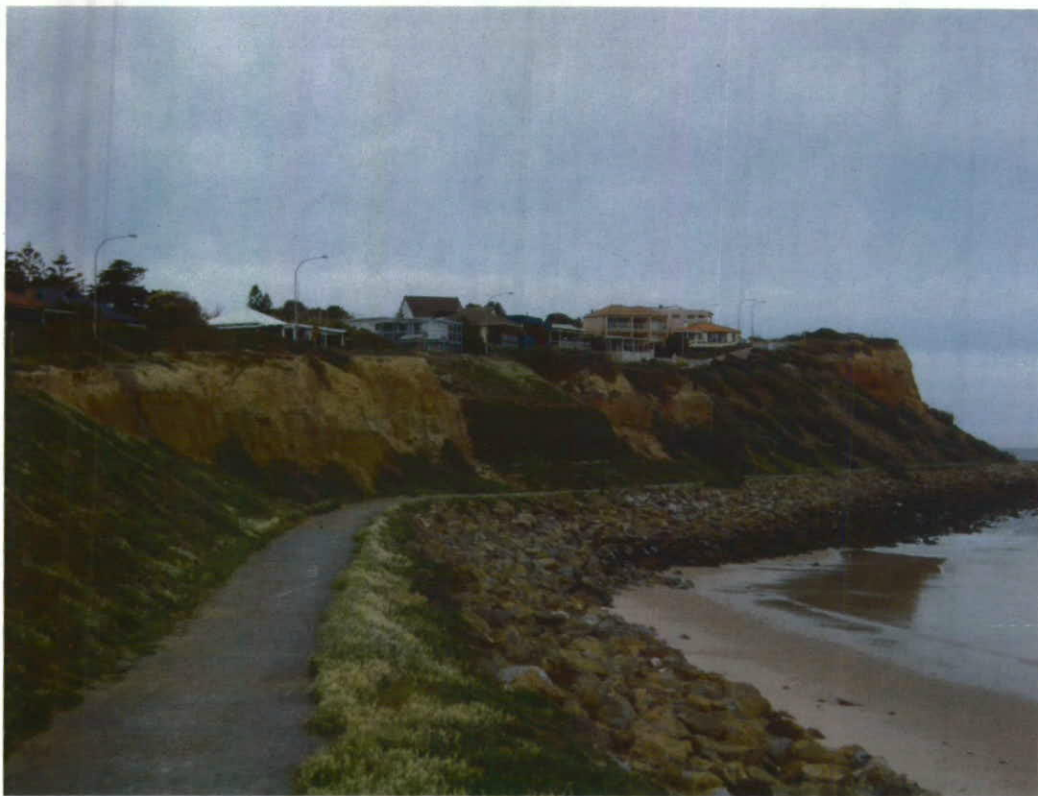
Plate 2: View looking south, from north end of the site, at Witton Bluff, along the pedestrian path.

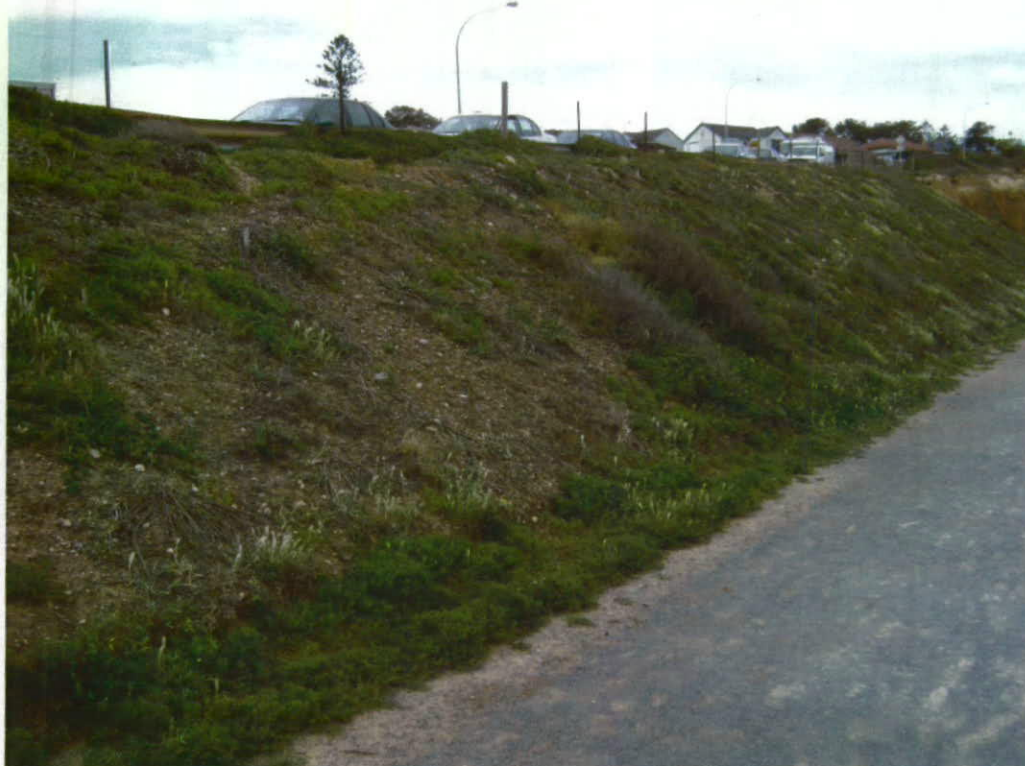
Plate 3: General view of the slope, from the walking path, looking to south at a zone of 1V:1H (45°) slopes. Patchy vegetation with jute and enviromat covering the slope.

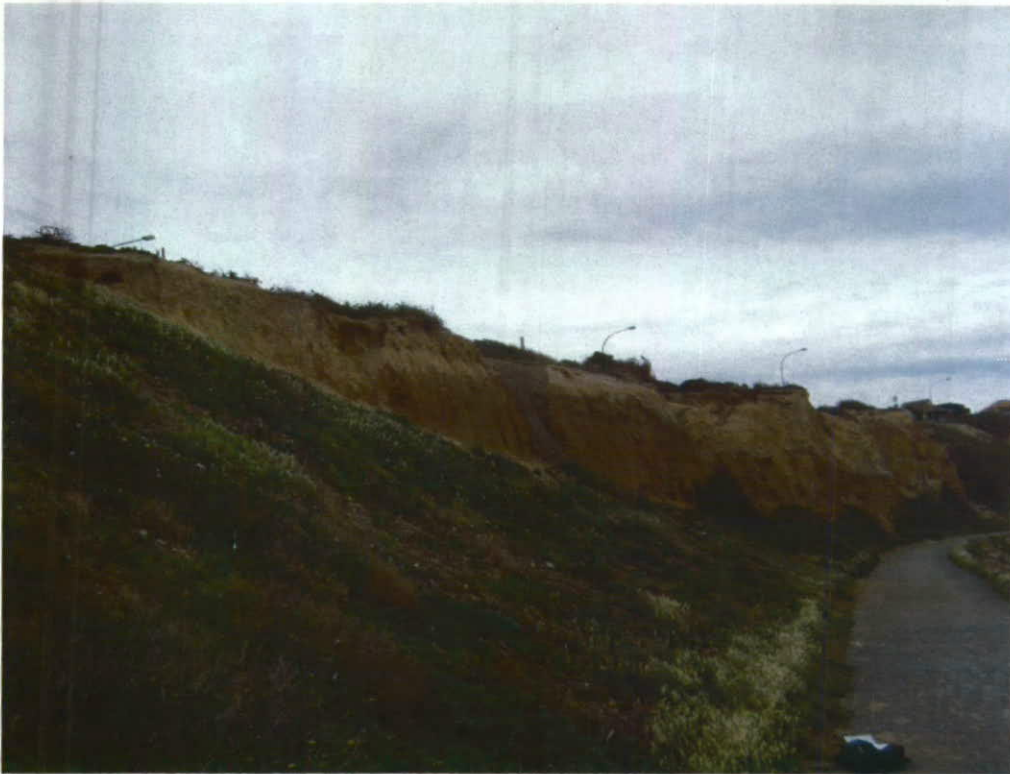
Plate 4: General view from the walking path, looking to south, at a zone with slopes 1V:1H (45°) to 2V:1H (60°). Zone has a danger sign 'Falling Rock' in the middle of the area adjacent to the walkway.

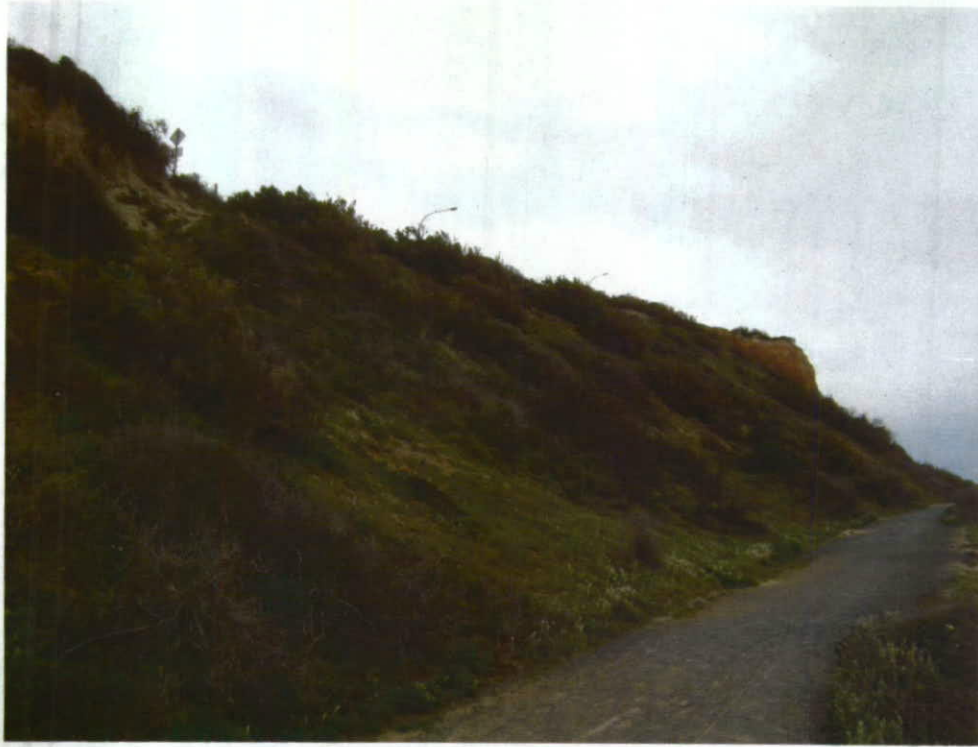
Plate 12: General view from walkway looking south towards a cliff zone of typical 1V:1H (45°) vegetated slopes.

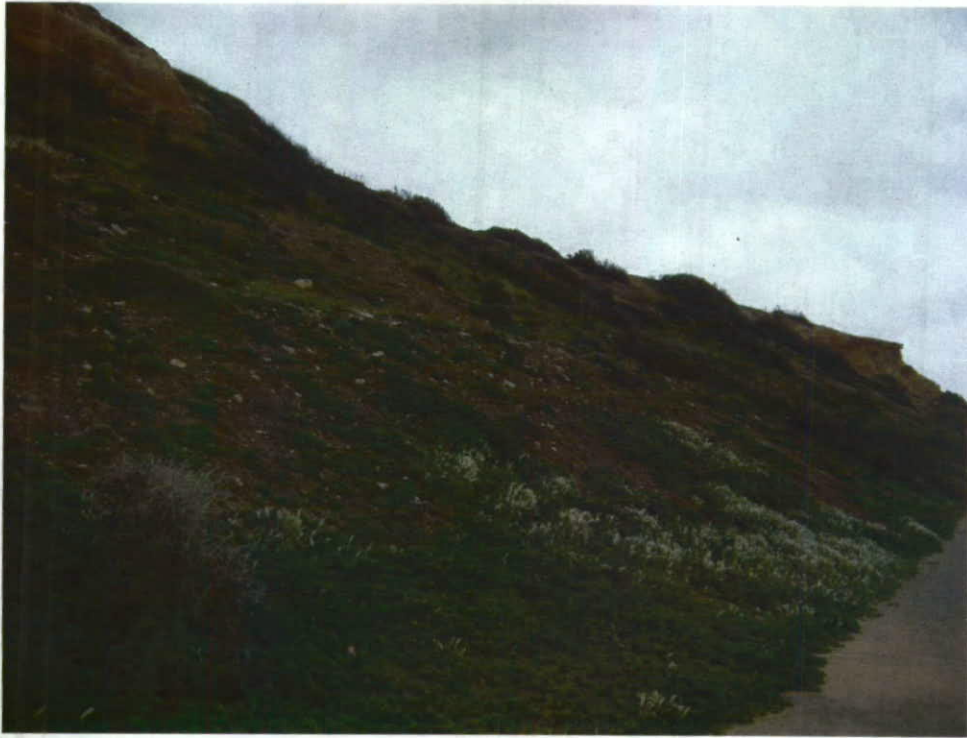
Plate 19: View from north towards a cliff zone of typical 1V:1H (45°) sparsely vegetated slopes.

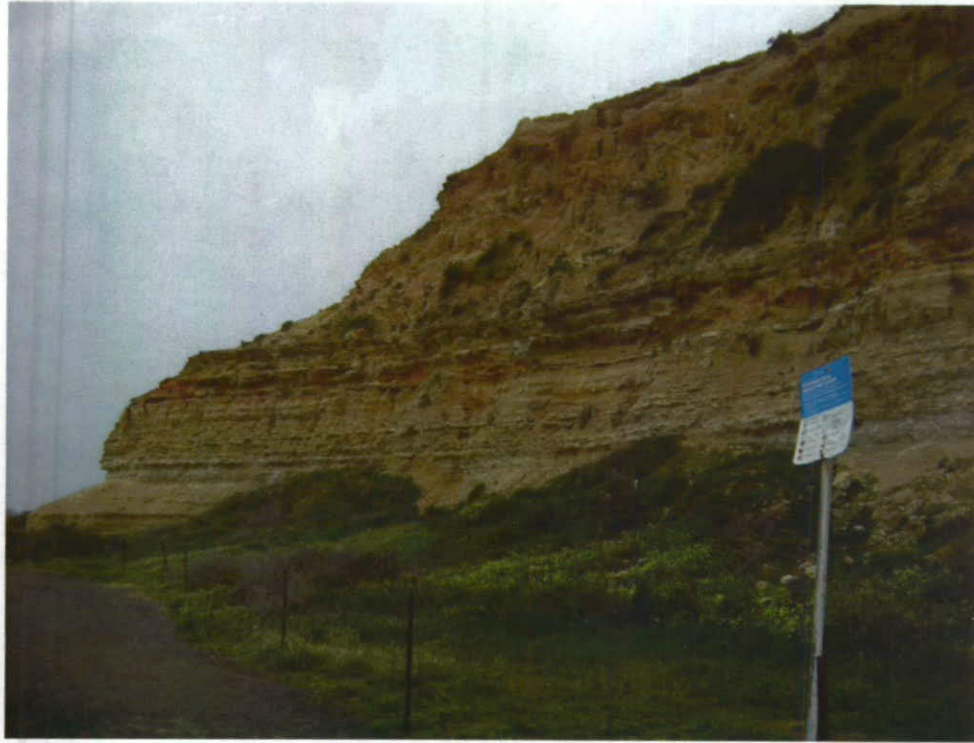
Plate 25: View looking north at the headland containing a lower slope (Plate 22) and mid slope clays of the Blanche Point Limestone (Plate 23) and an upper sandy slope (Ngaltinga Formation). Cliff zone of typical 1V:1H (45°) with predominantly non vegetated slopes.

1. Increase the number of warning danger signs at the toe of the cliff and upon the old wave cut platform between Short Street and Anderson Avenue – allow for another 3 to 4 signs.
2. Ensure that the fence is repaired at the base of Zone H (near Plate 25), at Witton Bluff look out (Plate 21) and surrounding the Monument (Plate 46).
3. Undertake regular inspections to assess if there has been any further deterioration in the condition of the cliff and backscars. Initially it is suggested that these be undertaken on an annual basis with more frequent, or one off inspections, carried out after heavy rainfall or storm events. Particular attention should be paid to Zones B, D, F, I, K and M where the backscars are above the lower public pathways. Should the long term measures need to be implemented then these would likely be the priority areas.

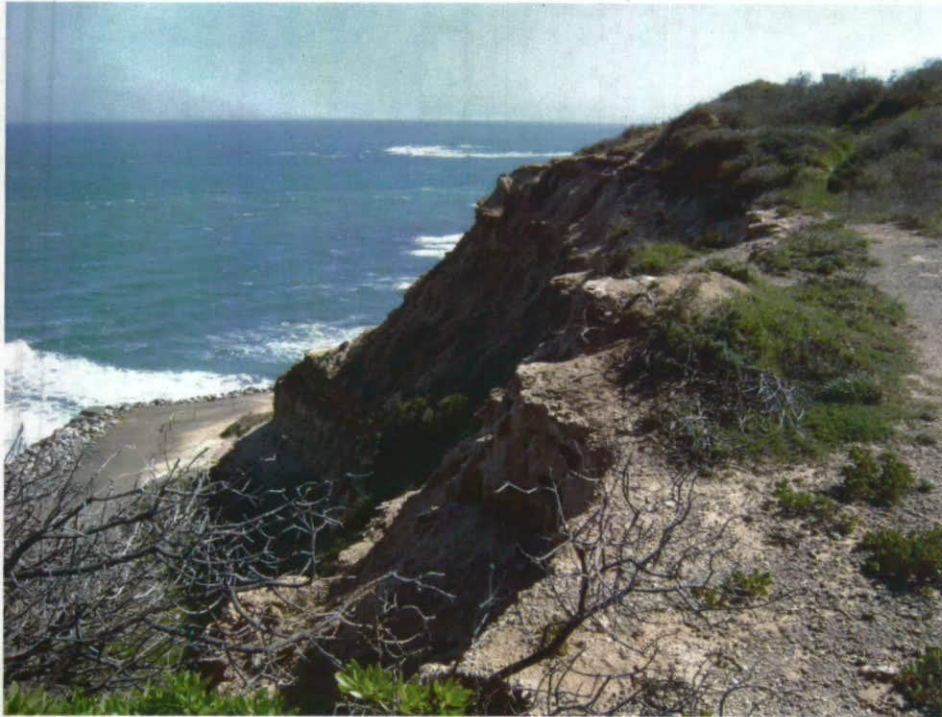
Plate 29: View looking north from the crest of the slope towards the headland off Benny Avenue.

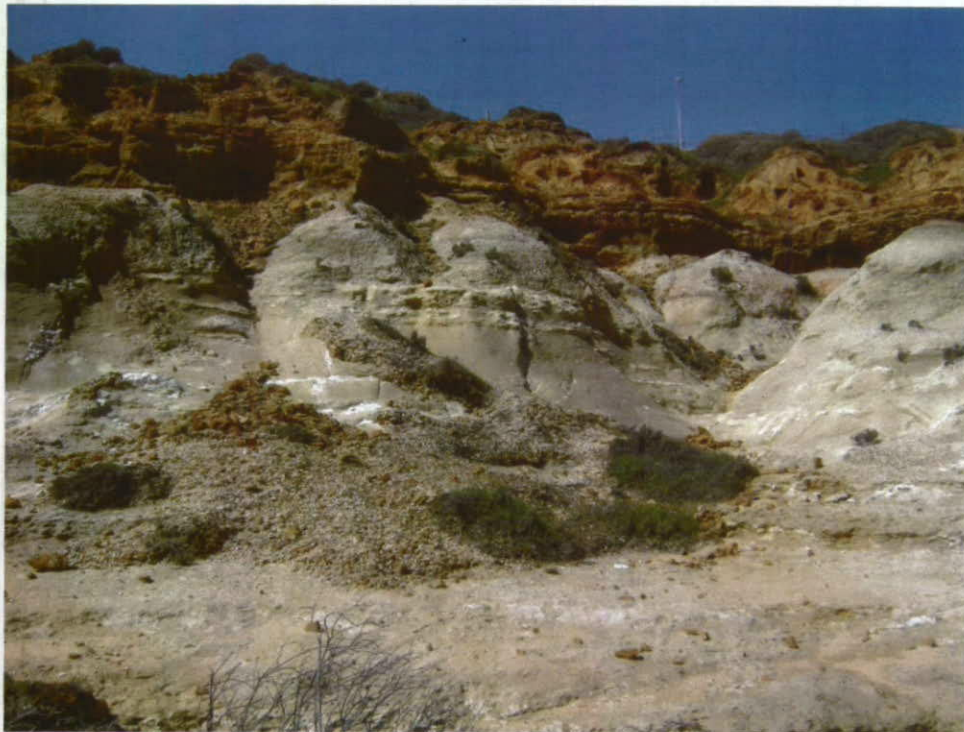
Plate 30: View looking east at the general cliff profile above the old wave cut platform that extends from Anderson Avenue to the Port Noarlunga Boat Ramp. Typical observations were the presence of small rocks from the sandy mid slopes onto lower rounded smooth slopes and old wave cut platform.

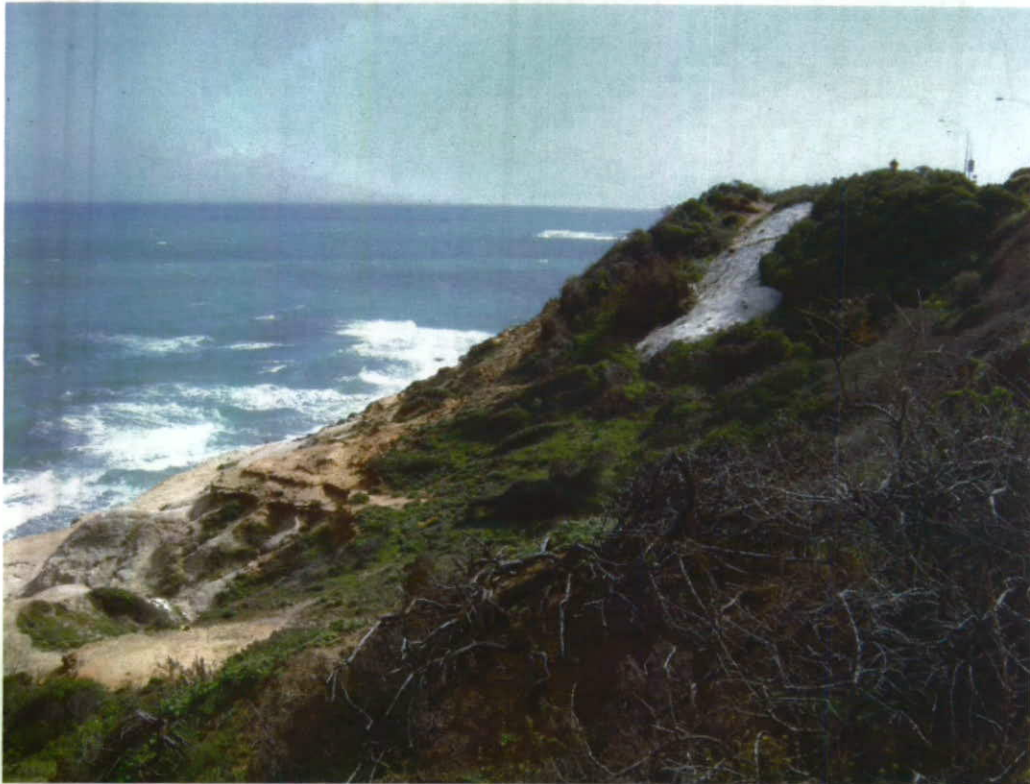
Plate 31: View looking north across an old backfilled backscar and white hydromulch and jute covered remediated slope. Upper slope is well vegetated.

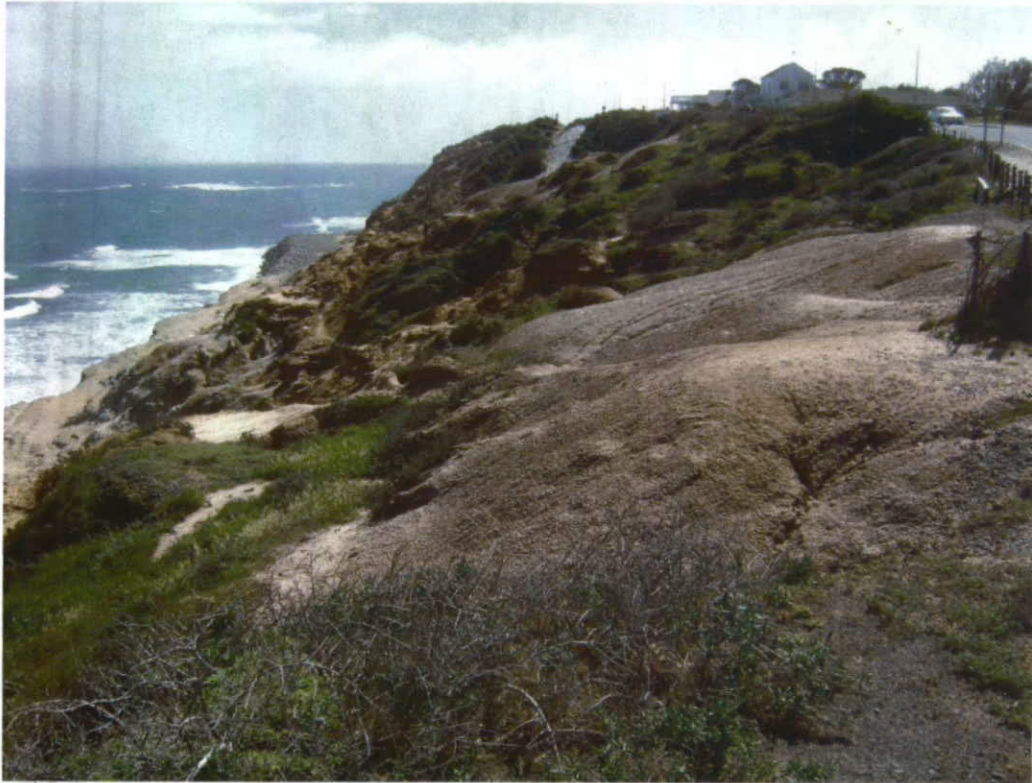
Plate 43: General view north at slopes 30 m high, 1V:1.7H (30° inclination), crest at edge of road.

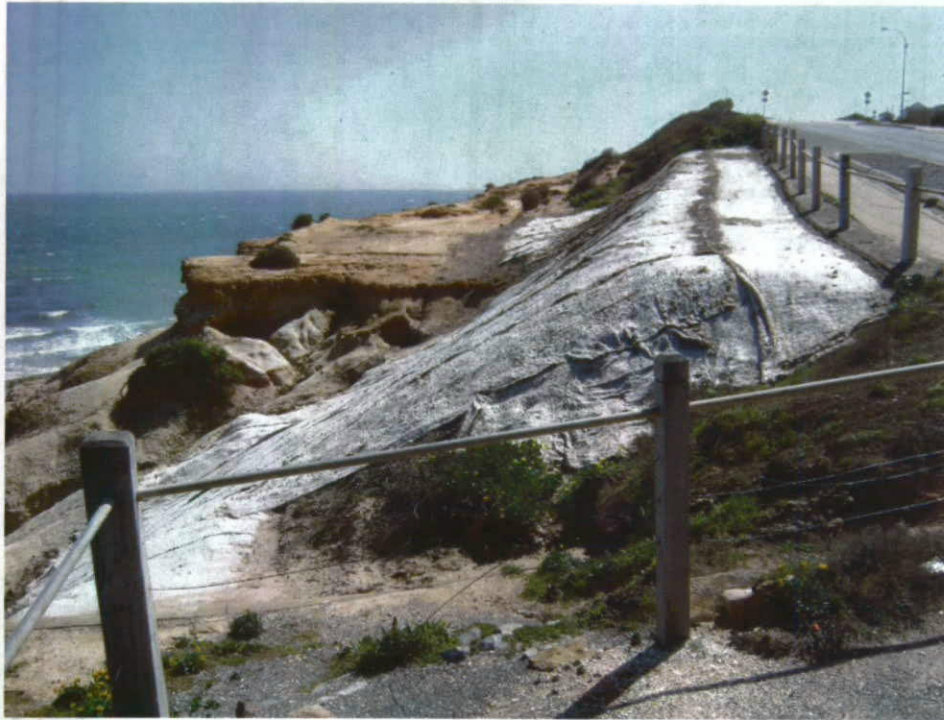
South of Zone J, the cliff zones extend to the edge of the footpath at shallow slopes (1V:1H), soils susceptible to erosion has necessitated remedial works in Zone L where gully erosion of soils led to the undercutting of the footpath along the Esplanade (Plate 46). Note that the erosion protection matting covering this area is damaged.

Plate 46: View looking north at the remediated slope north of the monument.

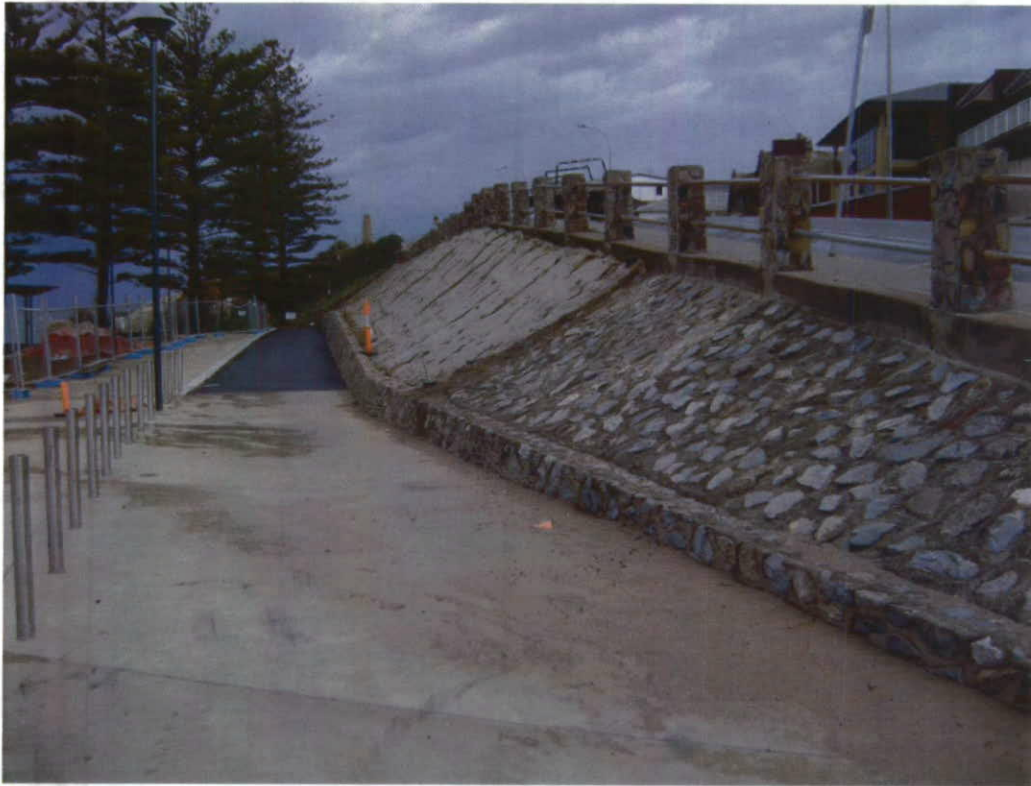
Plate 50: View looking north along Zone O and Zone N. To the left of the orange beacon, work was in progress placing the erosion protection matting and planting seedling in the slope.
