Document Ref: ADL2020-0176AB Rev2

**RE: Geotechnical Stability Assessment
Witton Bluff Base Trial**

The City of Onkaparinga (Council) have engaged CMW Geosciences Pty Ltd (CMW) to undertake a cliff stability assessment along the Witton Bluff Base Trail (WBBT) from Christies Beach to Port Noarlunga, SA.

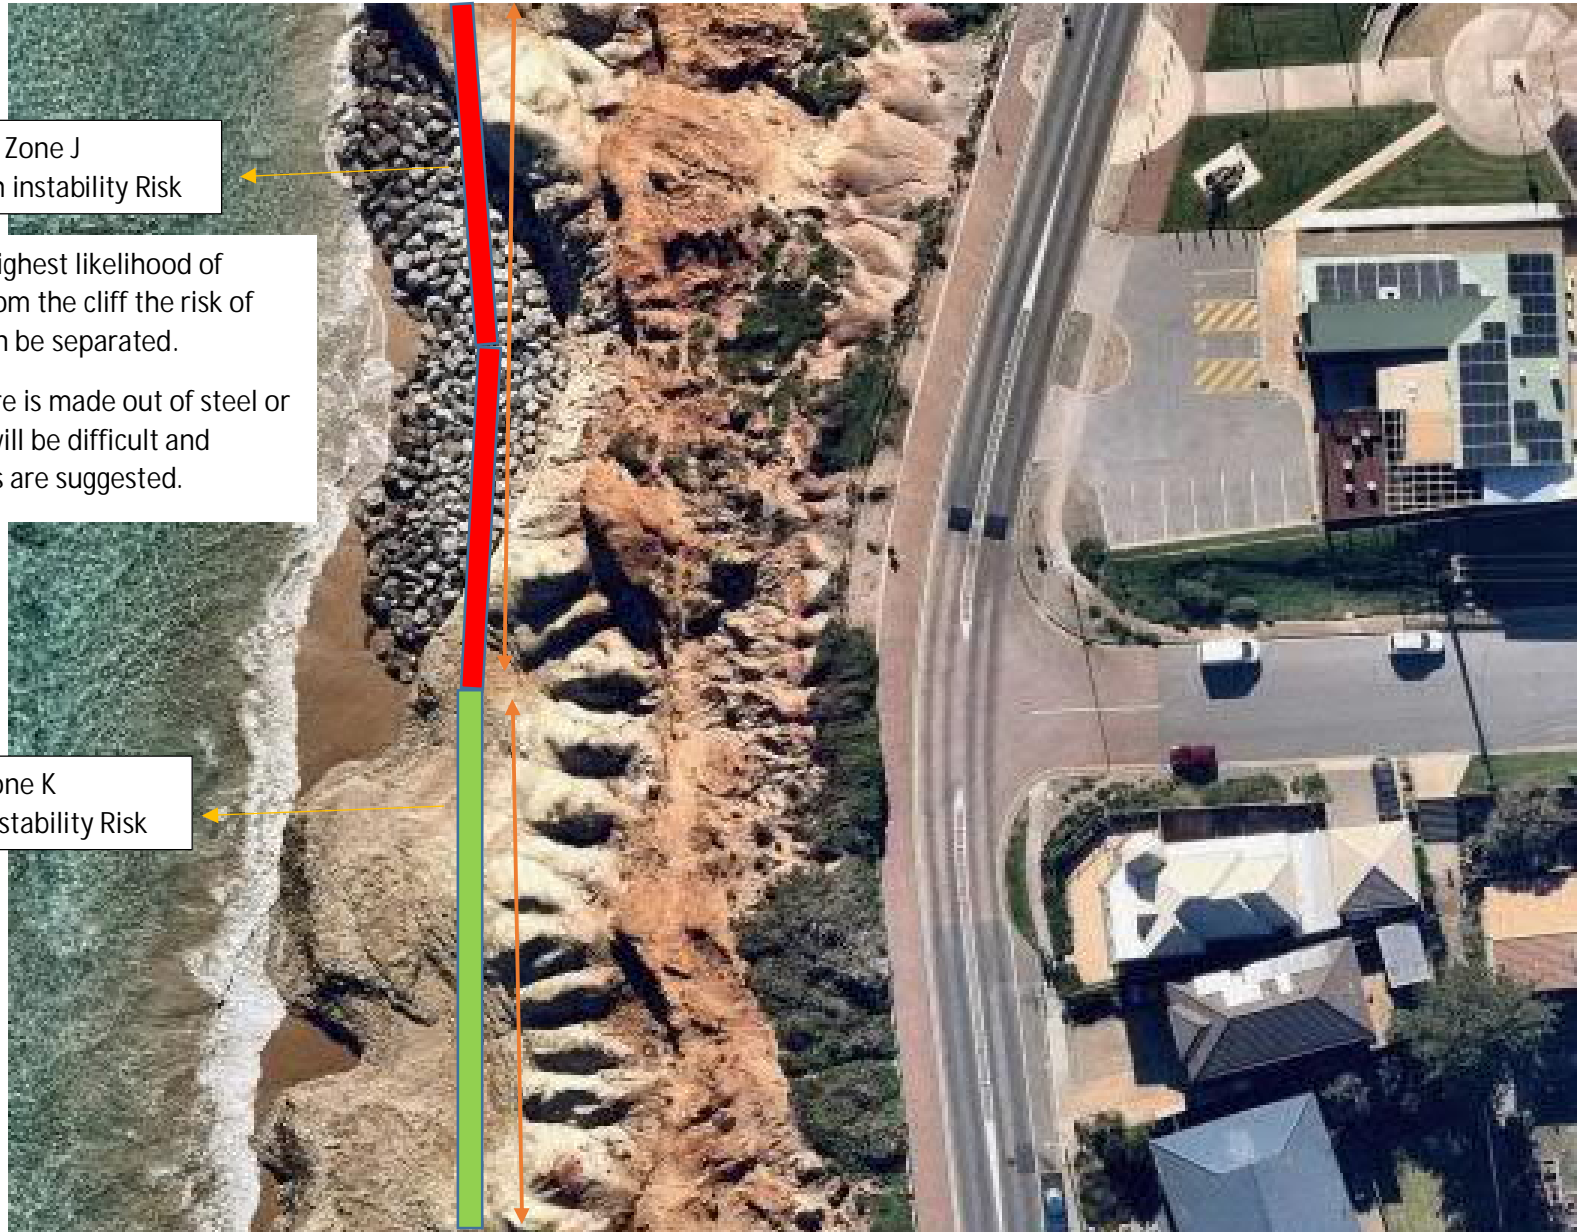
Cliff Zone K
Low instability Risk

It is noted that this Zone J present the highest likelihood of instability but if the walkway is offset from the cliff the risk of interaction with falling soil and rocks can be separated.

Is it recommended to make this structure is made out of steel or wood and be a small diameter footing will be difficult and therefore gravity not bored pile footings are suggested.

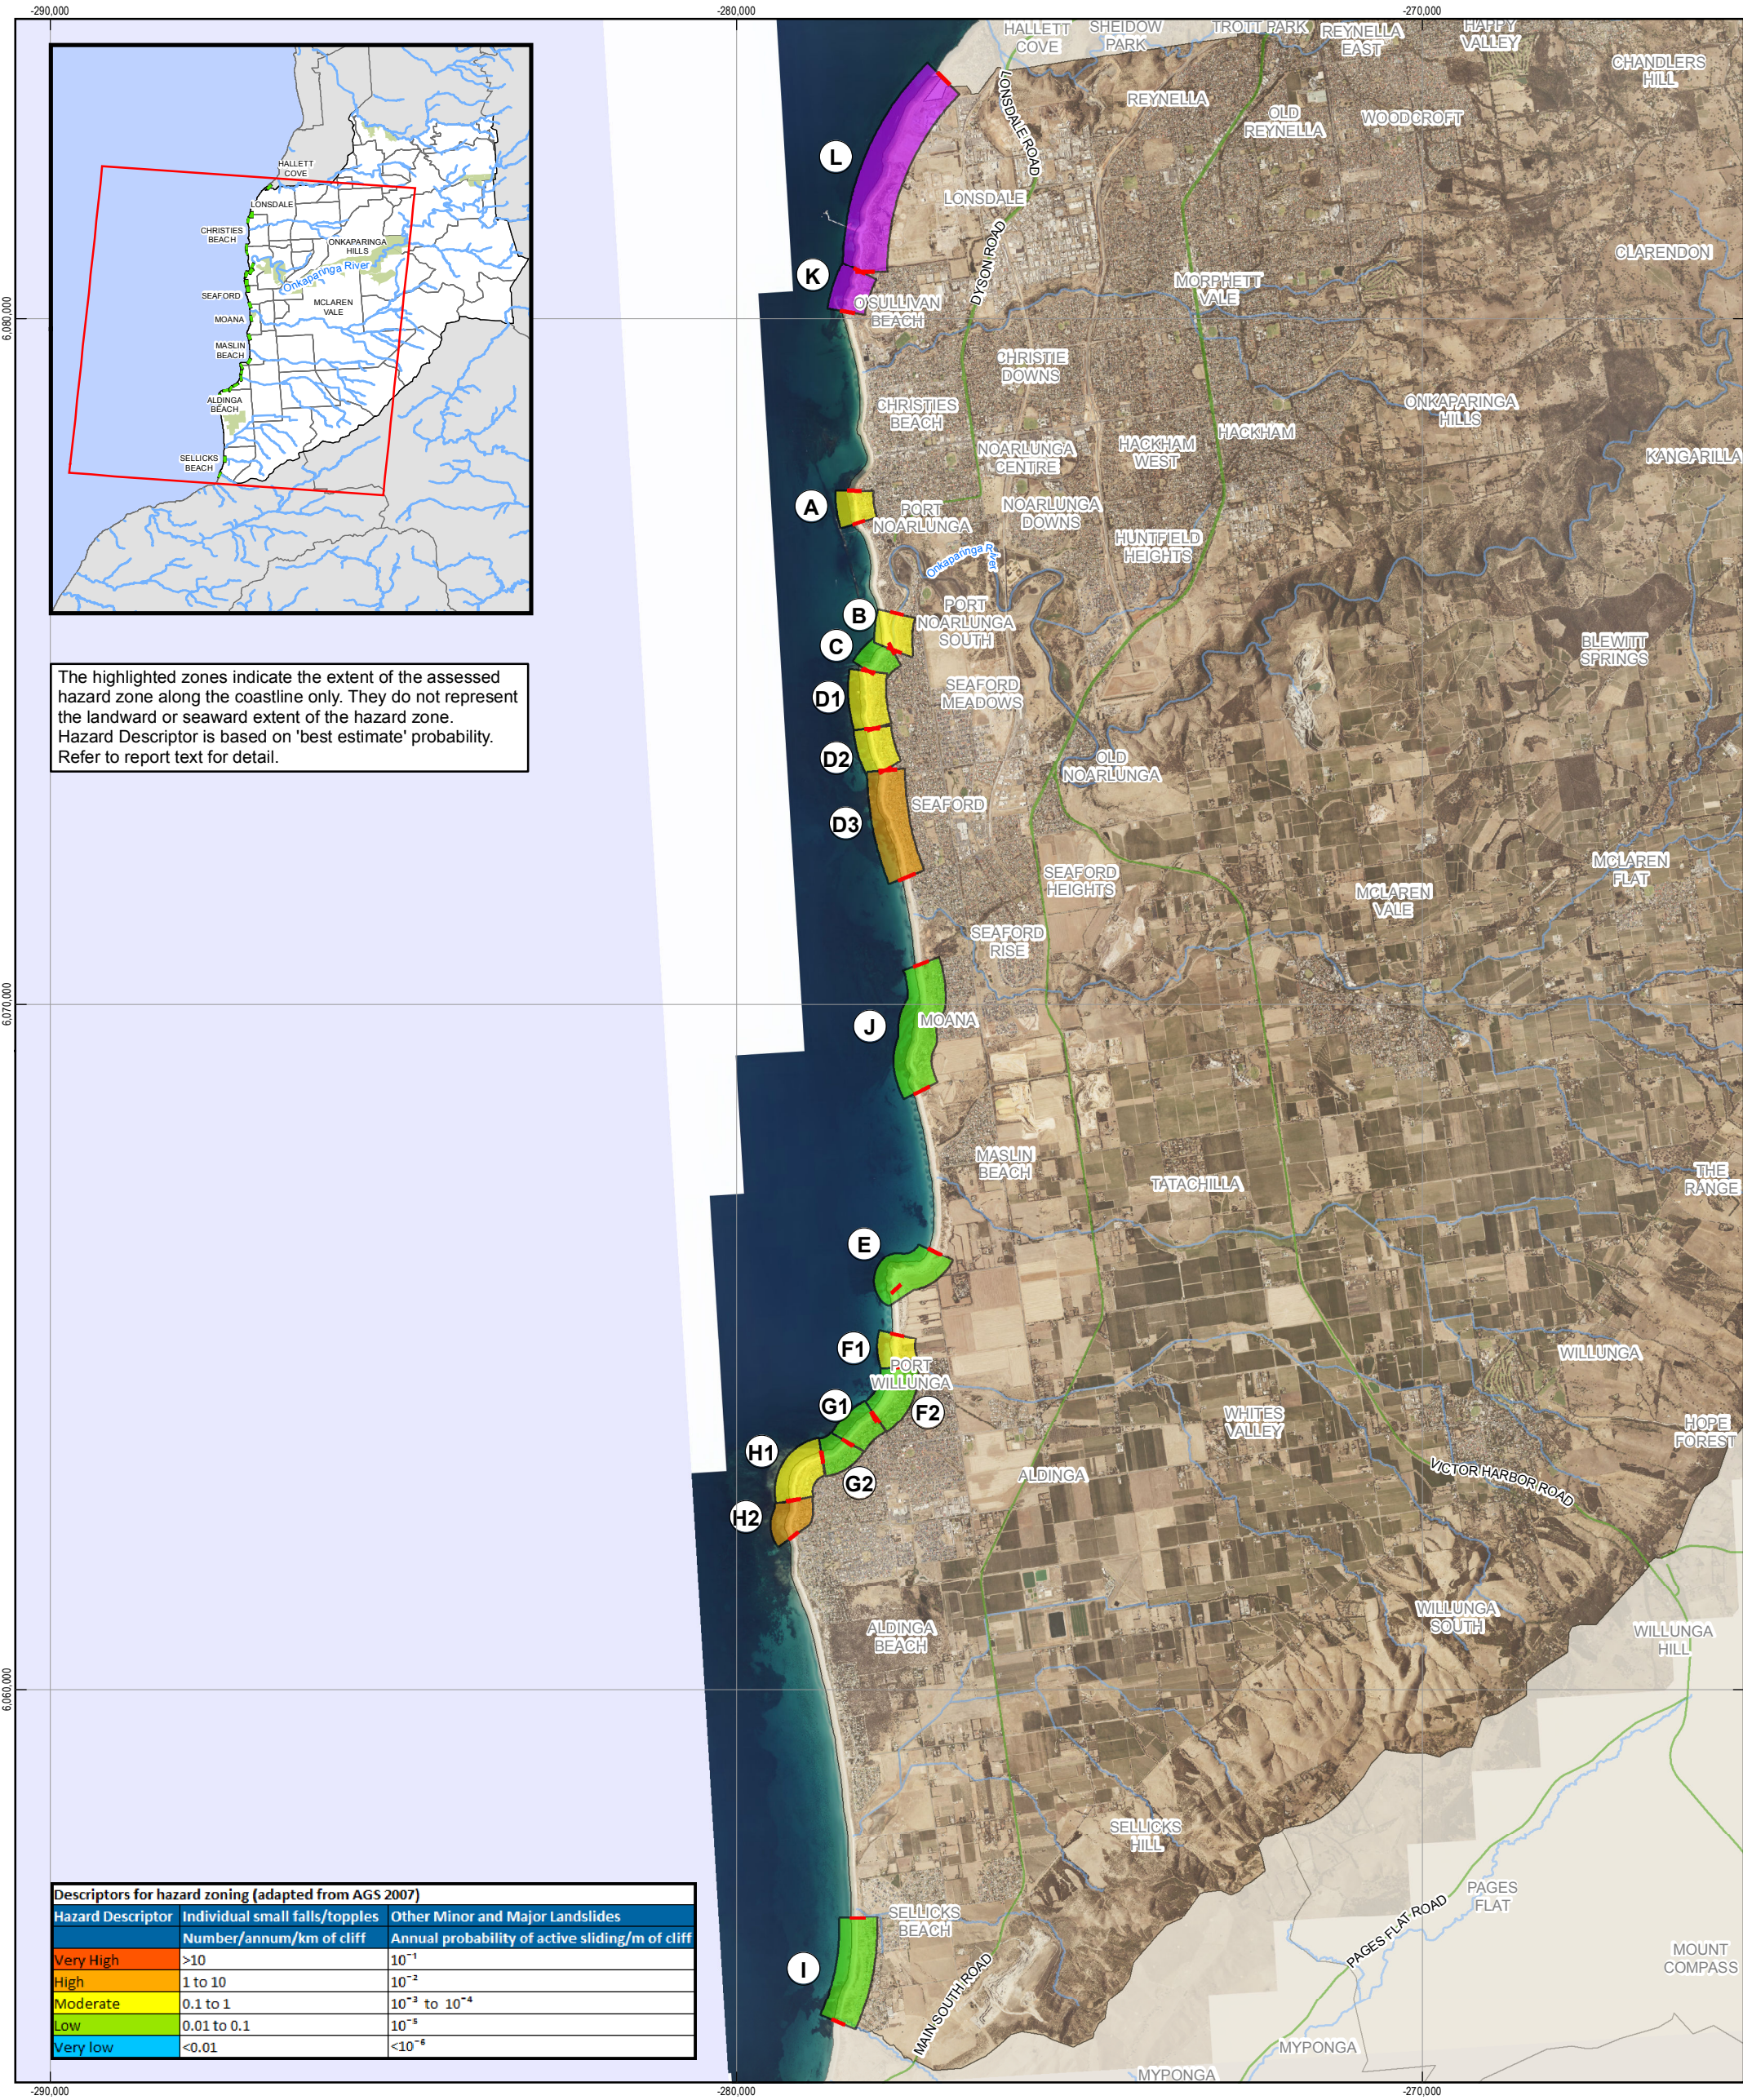
The risk to property for Minor and Major landslides has been presented geographically in Figure 3 – Risk to Property, Minor Landslides and Figure 4 – Risk to property, Major Landslides respectively.

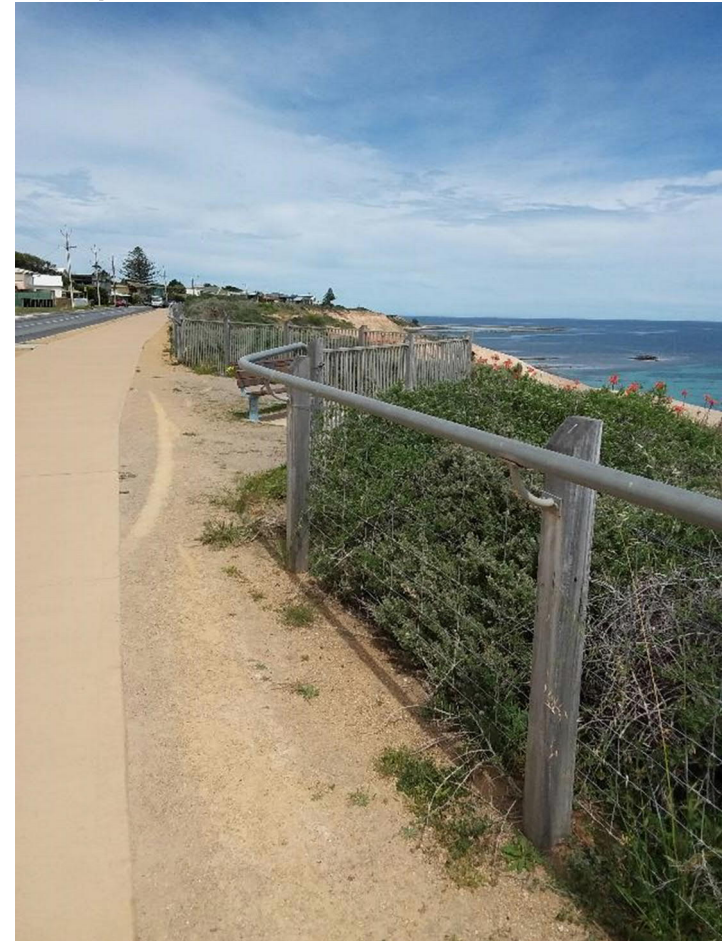
Soil and Rock Catch Fence

Modern fence systems
installed as part of the
footpath upgrade

Advantages:
Simple to build and fix
Durable
Allow vegetation to
grow through
Unsightly
Large openings
Can have more than 1
high strength strand
Bicycle standard
compliant
